Federal Aviation Administration, Fairbanks Flight Standards District Office

AIRWORTHINESS NEWSLETTER

For Inspection Authorization Holders, A&Ps and Repairmen

August 2001

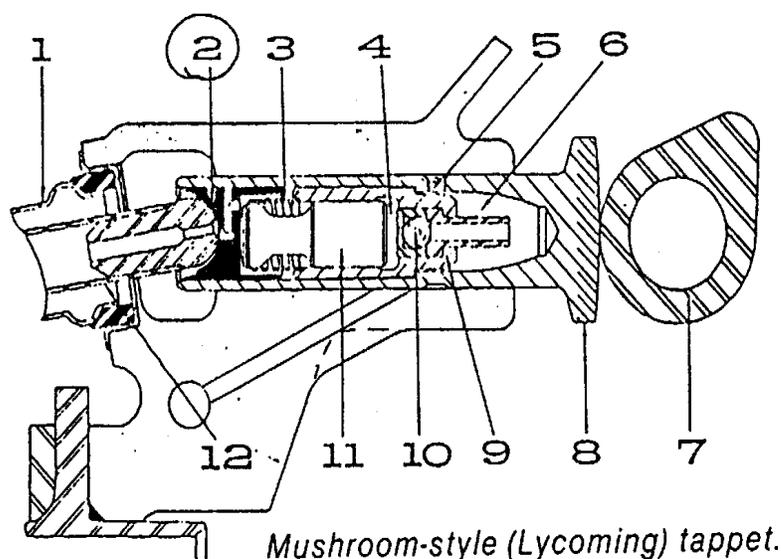
Would you believe you could leave out a push rod mechanism socket (inadvertently of course) and the engine would still run just fine? Believe it, two such incidents recently occurred in our district. This was much to the disbelief and embarrassment of the mechanics involved, and incurred major expense to the aircraft operators. Both engines in this case were Lycoming TIO-540 series engines.

The subsequent investigation into this matter found the engine tappet assembly has the capacity to not only pump itself up with oil to compensate for wear, as normal, but to also compensate for the missing socket. Now this is quite an accomplishment considering the socket takes up approximately ¼ inch of the mechanism travel.

Although the engines initially ran fine, in a matter of just a few hours both valve push rod mechanisms self-destructed. Without the socket in place the push rod is not secured at the socket end and lubricating oil is not properly routed. The push rod, not being contained,

bounces around causing damage to the tappet body, the shroud tube/seal, the push rod itself, and can even damage the crankcase. Also of interest, the Lycoming tappets are the mushroom-style, and to replace them you have to split the crankcase—one engine had to be replaced because it was at a remote site.

1. Shroud Tube
2. Push Rod Socket
3. Plunger Spring
4. Oil Pressure Chamber
5. Oil Hole
6. Oil Supply Chamber
7. Camshaft
8. Tappet Body
9. Cylinder
10. Ball Check Valve
11. Plunger
12. Push Rod

So, let's review what we have learned from this experience so we may prevent another such occurrence. Both incidents occurred during an aircraft inspection when discrepancies were written to repair leaking push rod shroud seals. To change the seals, a disassembly of the push rod mechanism is required. On the reassemble procedure, let's review the Lycoming Operator's Manual. Under *Cylinders* it states, "the hydraulic tappets, push rods, rocker arms, and valves must be assembled in the same location from which they were removed." The sockets (part of the tappet) were inadvertently left out. How do you assure yourself that you have installed all the parts? Again, let's go to the Manual, it states, "on re-assembly it will be necessary to remove and bleed the hydraulic tappet plunger assembly so that dry tappet clearance can be checked." There you have it, following re-assembly, the dry tappet clearance must be checked and the plunger assembly must have been bled of oil, so it is flat, to get the proper dry clearance check. Remember, the engine run-up will not show the missing part.
