May 4, 2005

Dear Maintenance Technician:

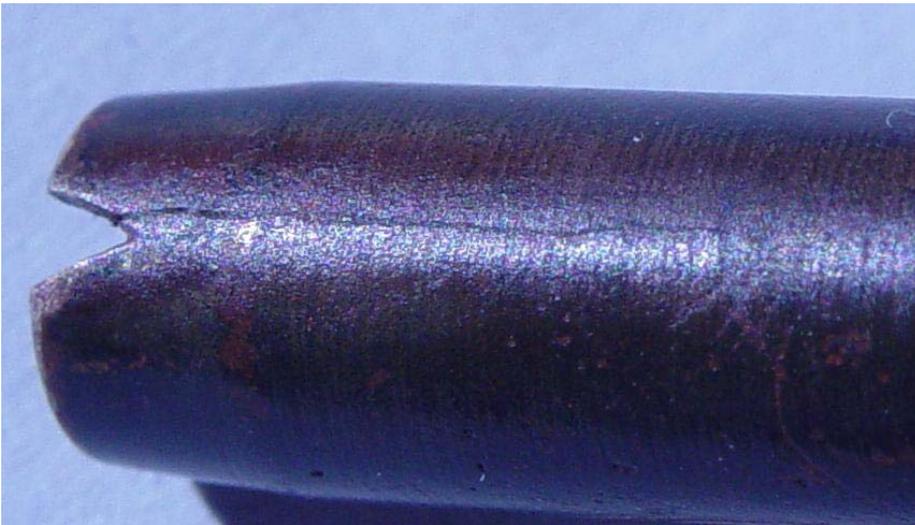
Currently, we have found three instances of turnbuckles on small Piper aircraft that have had cracks originating around the "V" notch at the location where a safety clip may be installed. The cracks run lengthwise on the buckle from the "V." The cracks are about 5/8 to 3/4 of an inch long. The cracks have all been on NAS-649 series turnbuckles. The latest turnbuckle has a manufacturer stamp date on it of 1973. A photograph of the typical crack is attached for your convenience.

As additional information, the NAS series turnbuckle has been superseded by the MS21251M series turnbuckle. A copy of the Data Specification Sheet MS21251M has been included. Of special note, look at the reference in the specification (item seven). It specifically states, "A turnbuckle with a manufacturing date of 1978 or older shall not be used for replacement repairs since stress relieving was not required prior to this date." This may be part of the problem with the older turnbuckles and associated cracking from the "V" notch cutouts for the safety clips.
