U.S. Department
of Transportation
**Federal Aviation
Administration**

ADVISORY CIRCULAR

AVIATION MAINTENANCE ALERTS

**ALERT
NUMBER
359**

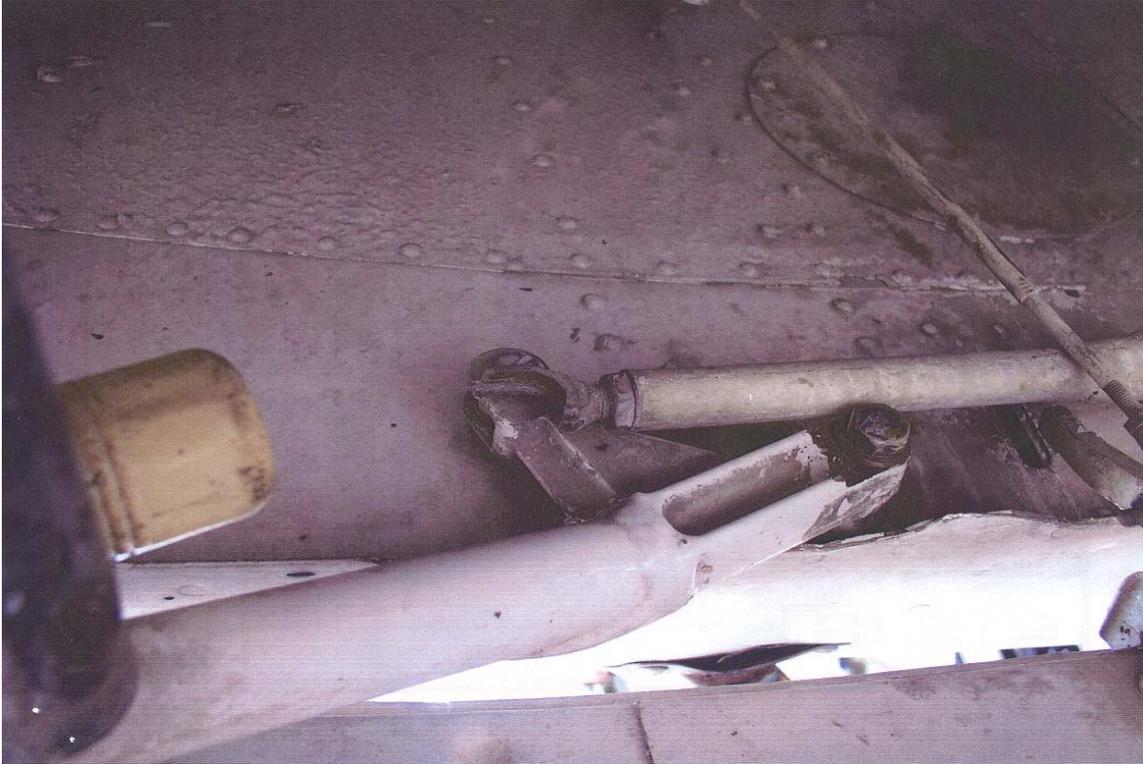
Beech: 58; Broken Rod-End on Nose Gear Retract Tube; ATA 3220

An unknown submitter provides the following description and photograph. "The nose gear would not lock down because of a broken rod-end (*P/N ADNE5-323*) on the nose gear retract rod. This rod-end connects the retract rod to the aft nose gear drag brace. (*This defect*) resulted in a nose gear-up landing."

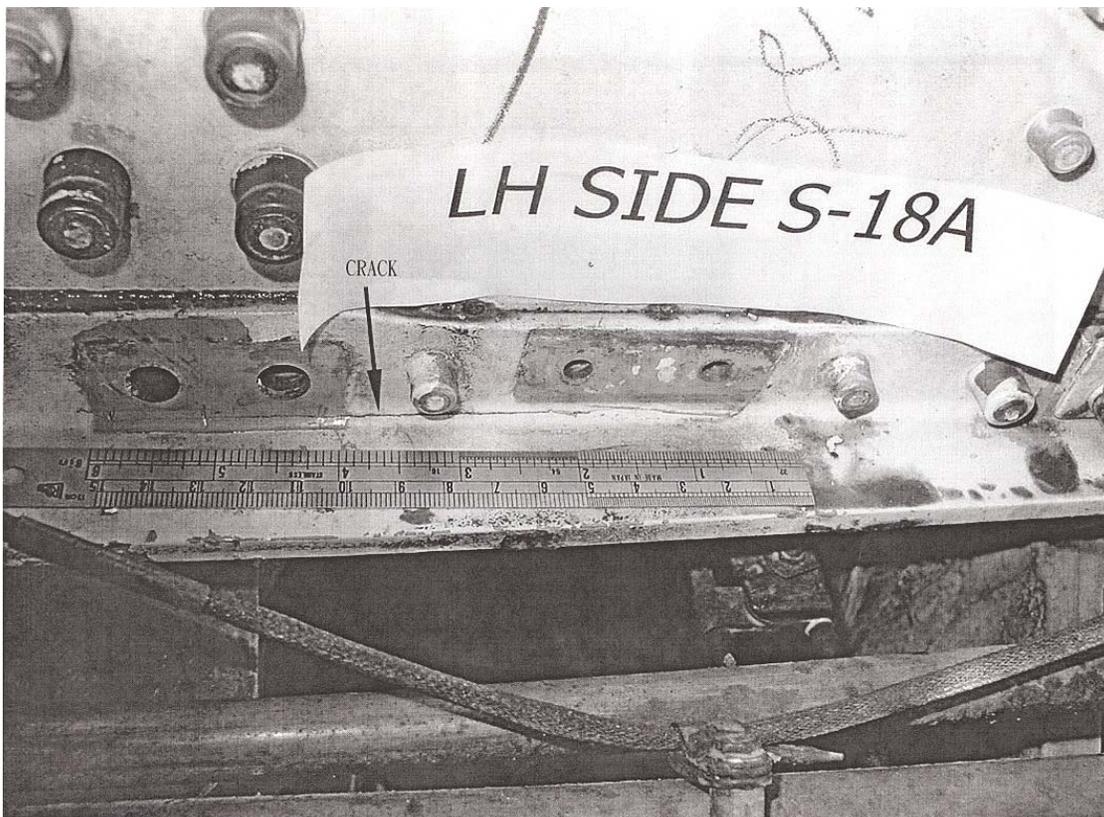
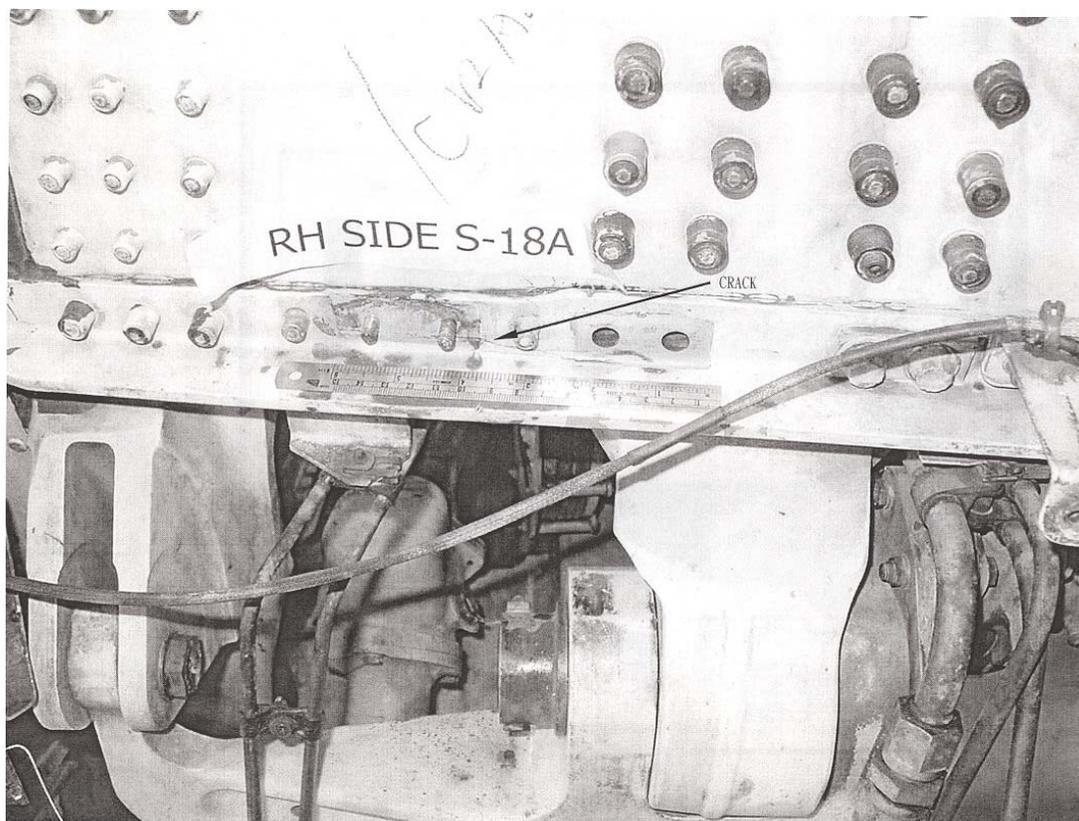
Boeing: B727-200; Cracked Fuselage Stringers; ATA 5313

A quality assurance manager for an FAA certificated repair station (*located in Asia*) submitted this defect report and photographs. In part, the writer states, “This aircraft was input to Air Asia for a 4C check (*time/inspection type*) and CPCP (*corrosion prevention control program inspection*). During the CPCP (*activity*) visual inspection found a five inch long crack on both L/H and R/H fuselage stringers (S18A) between BS940 and BS945 (*bulkhead station reference points*).”

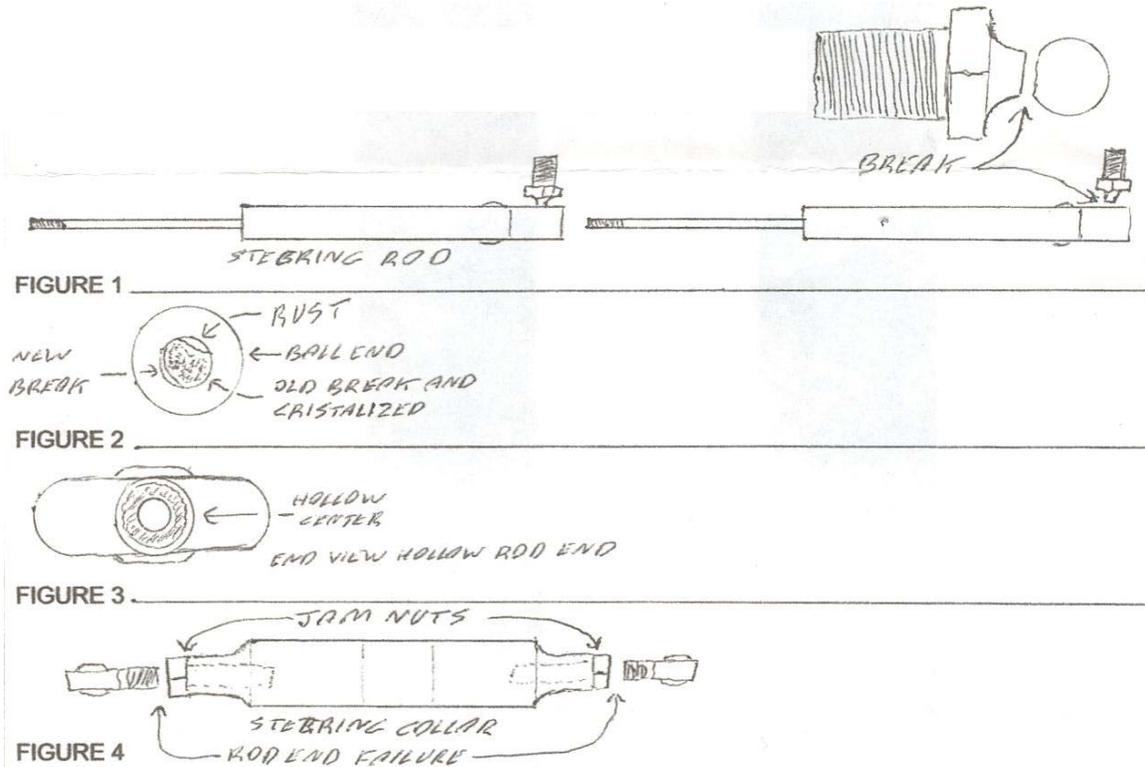
Cessna: 172D; Broken Ball-End on Steering Rod; ATA 3250

(Failure) of this rod-end (*ball*) left the R/H steering rod as the only steering (*input*) for the nose gear. (Note: the 'rods' are not solid rods; they are designed to push and not pull—they slip inside when pulled.) It requires both rods to steer (*the aircraft*); the R/H pedal and L/H rod will turn the nose to the right, and the L/H pedal and R/H rod will turn it to the left.

"This aircraft had 3,321.80 hours total time. The McFarland FAA/PMA replacement Cessna part only had 216.92 hours. The rod-end (*ball*) had been cracked for a period of time (*prior to this failure as evidenced*) by rust in the crack—the remaining metal looked crystallized (see figure 2).

"After an extensive inspection of the broken parts it was found that the Cessna rod-ends (P/N S1107-3) also had thread cracks with rust. These rod-ends thread into the nose gear steering collar (Cessna P/N 0743011-4). The ball-end attaches to the nose gear steering rod (either the Cessna P/N 0543022-1, or in this case the McFarlane P/N MC0543022-1). Rod-end (P/N S1107-3) is a hollow, threaded shaft style (see figure 3) that threads into the steering collar. Both the L/H and R/H rod-ends failed at the jam-nut (see figure 4). There was no entry (*into the log books*) on the replacement of the L/H or R/H rod-ends (P/N S1107-3).

"The aircraft had been in a (*previous*) accident where the plane undershot the landing area and nosed over in snow. There was damage and repairs to the wings—and to the belly skin immediately behind the nose gear and firewall. This Cessna (1986-88) was equipped with a Landis Nose Fork (Model PA28-206) using an 8.50 x 6 nose wheel, tire, and tube. After (*the accident*) it had the Cessna heavy duty nose fork and a 6.00 x 6 wheel, tire, and tube.

"My recommendations:

"Cessna Parts—replace the hollow rod-ends (P/N S1107-3) with a solid rod-end (P/N MS21151-3 or equivalent) by field approval, thereafter every 4,000 hours. If not...then replace the (*original*) hollow rod-ends every 2,000 hours or whenever damage to either the nose gear or aircraft could cause extra stress—even if there is no visible sign of damage.

"Landis Nose Fork—(with the 8.50 x 6 wheel, tire, and tube installed)—replace the hollow rod-ends (P/N S1107-3) with a solid rod-end (P/N MS21151-3 or equivalent) by field approval, thereafter every 3,000 hours. If not...then replace the (*original*) hollow rod-ends every 1,500 hours or whenever damage to either the nose gear or aircraft could cause extra stress—even if there is no visible sign of damage."

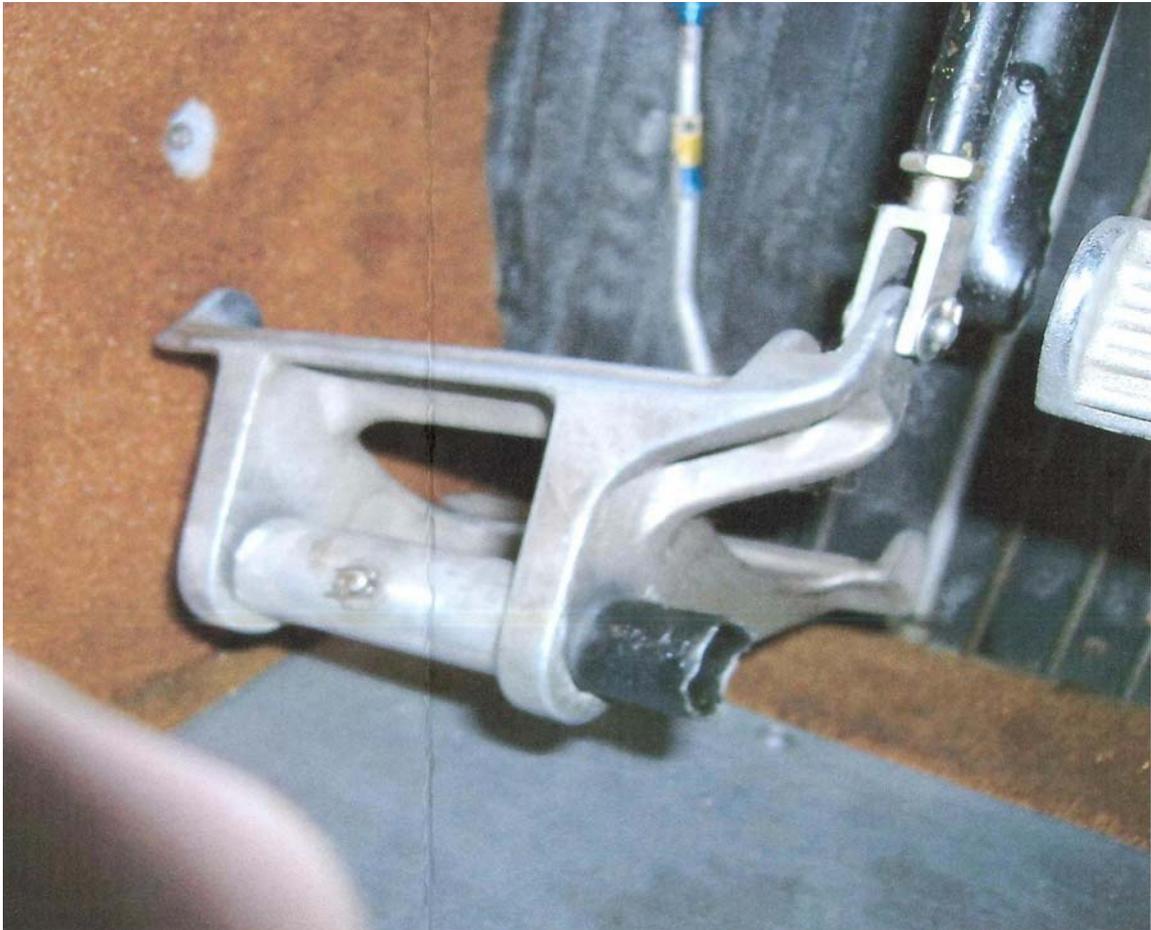
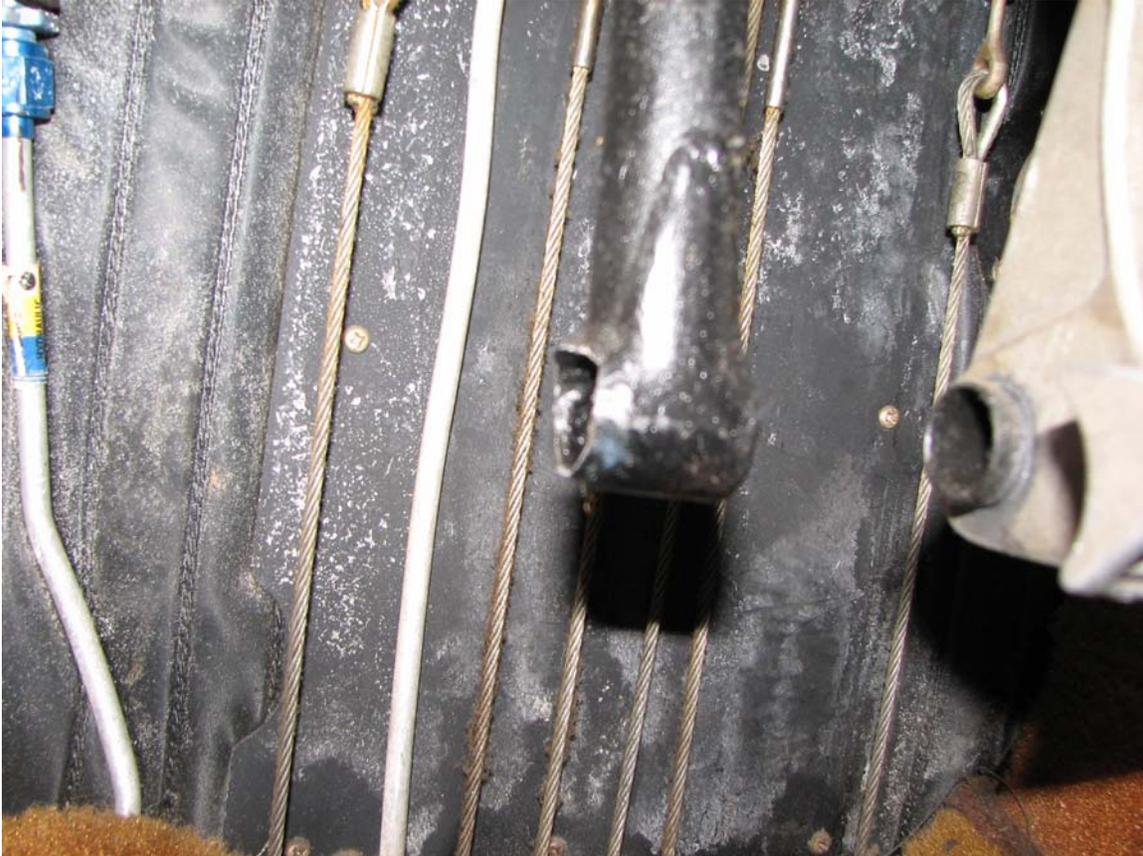
PIPER**Piper: PA24-260; Failed Rudder Torque Tube; ATA 2720**

An unidentified submitter states, “During maintenance run-up and taxi check (after maintenance) the left rudder torque tube broke off (*P/N 2223900*). It appeared to have been cracked for some time prior to failing during taxi. It is suggested the area be cleaned and inspected with a 10X magnifying glass. A borescope with a side view end could also be inserted in the tube to inspect if from the inside. If this had happened during landing and had broken at initial brake application, the aircraft would probably have departed the runway.

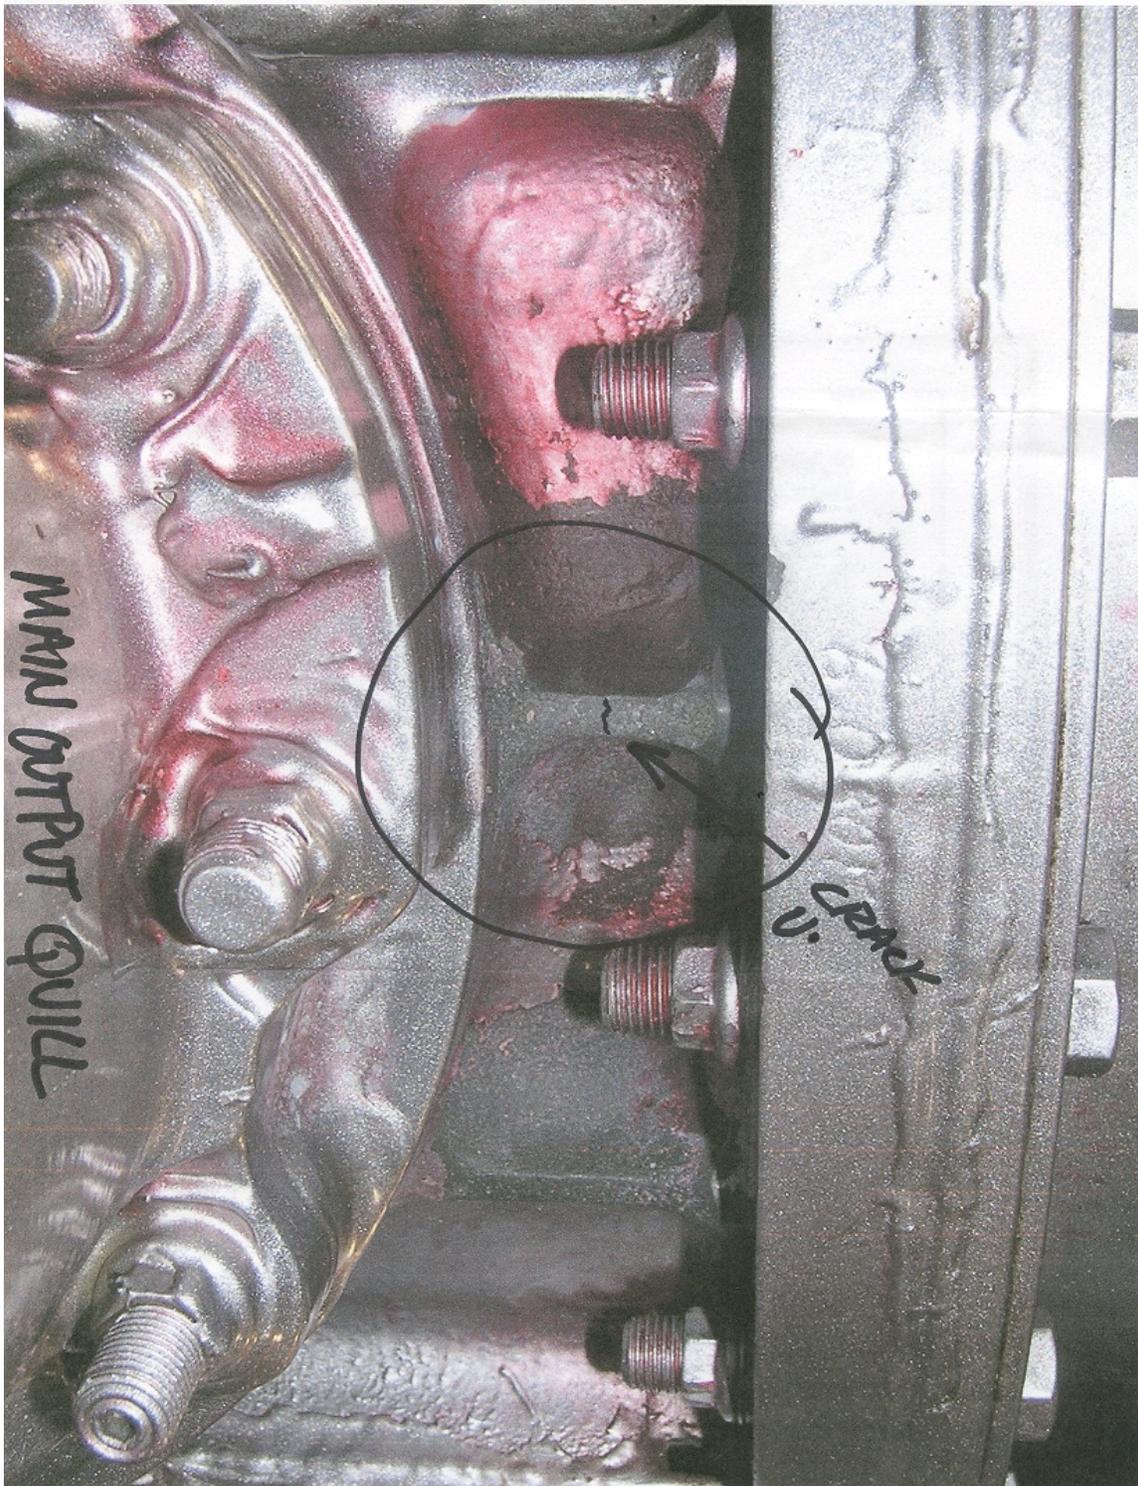
Bell: UH1F; Cracked Gearbox Web Casting; ATA 6320

A technician for a helicopter operator writes, "A crack was found on the main gear box (transmission) in the vertical cast webbing above the engine to transmission drive quill (P/N204-040-016-005). The military technical manual allows ¼ inch radius/polish into the webbing. This crack has been found on three transmissions on other aircraft, with one penetrating the gear box (*sufficiently*) to leak fluid."

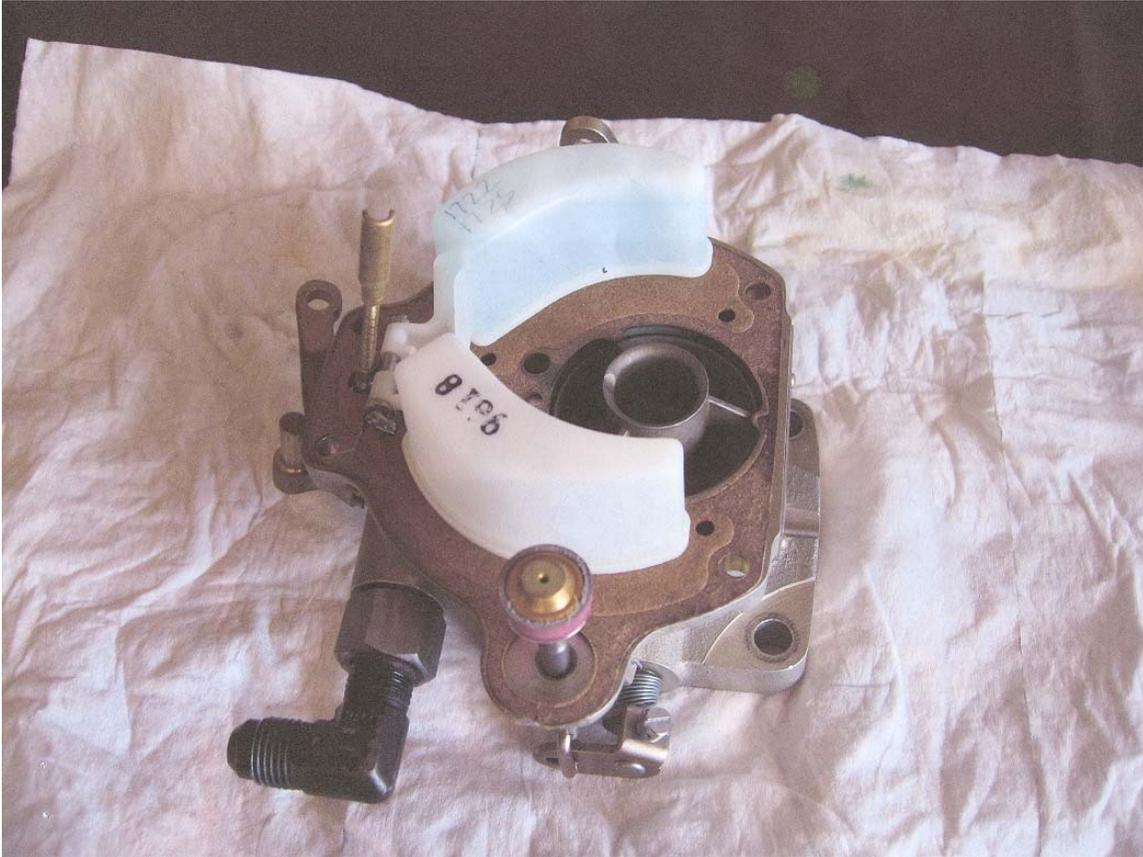
Lycoming: O-320-D2A; Sinking Carburetor Float; ATA 7322

A mechanic and pilot from Tennessee says, “The engine died on final to the airport. I pumped the throttle and the engine started running. When I retarded the throttle the engine again died. I could not get the engine to restart on the ground. Then engine was started the next day showing a fuel flow of 11 to 12 gallons per hour at idle. I removed the carburetor and (*found*) one pontoon of the plastic 90 per cent full of fuel.” (*Aircraft is a Van’s RV-9A. Precision Airmotive carburetor, model number LW-1586; float P/N 30-804. Included note says the “...seam failed at the glue line.”*)

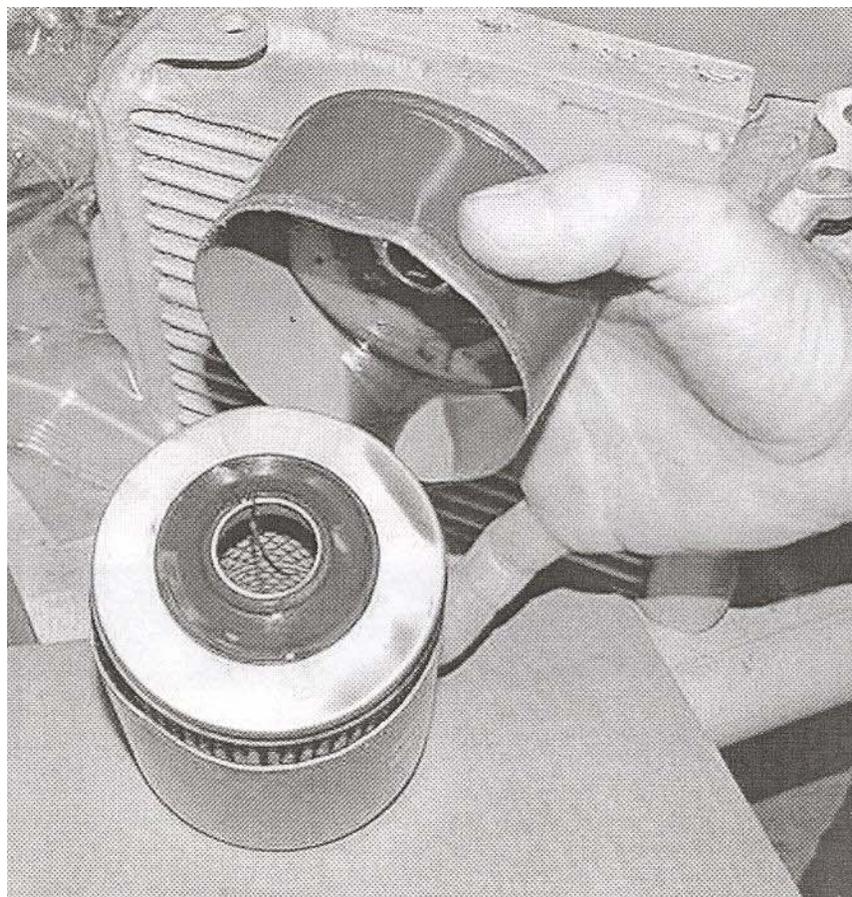
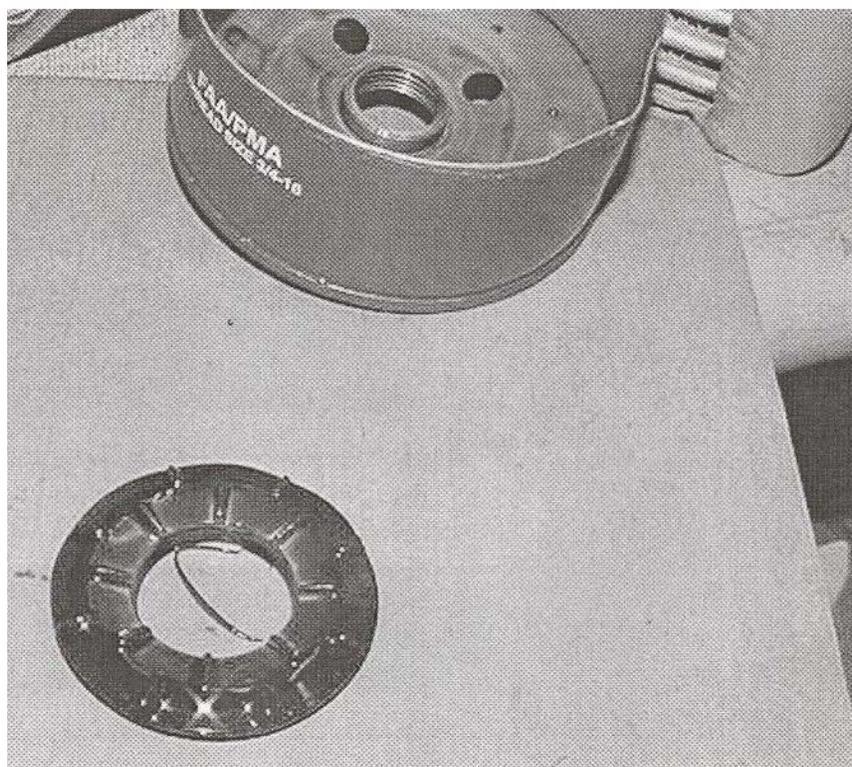
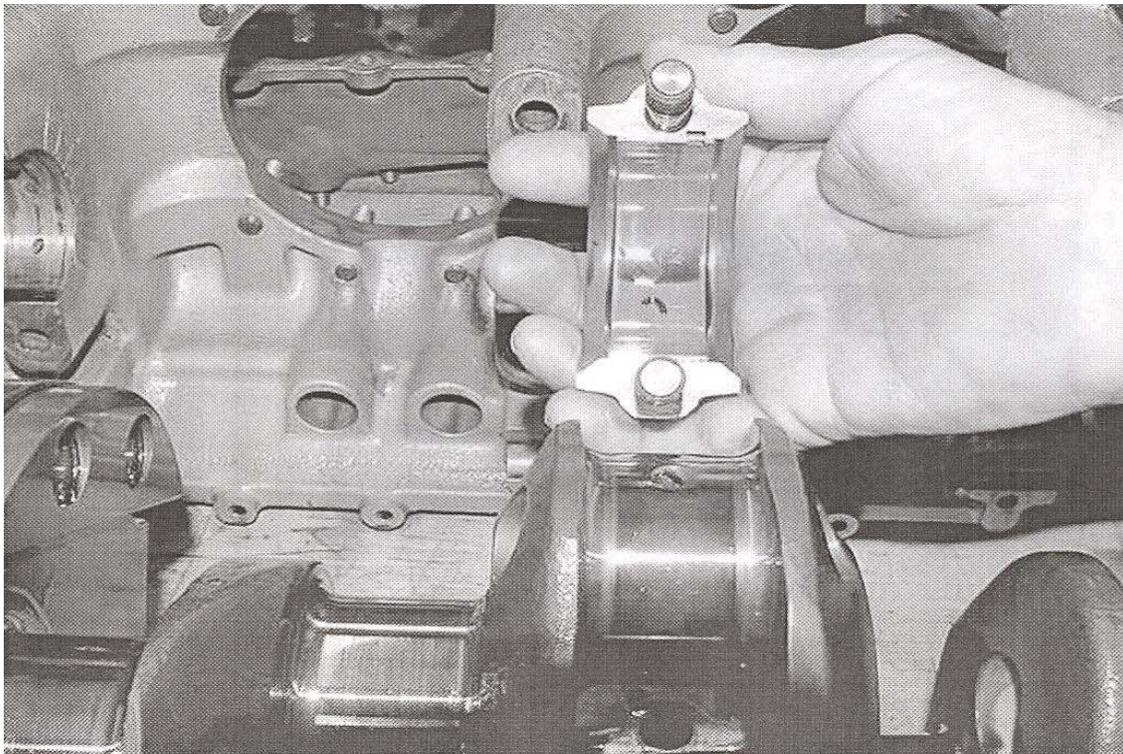
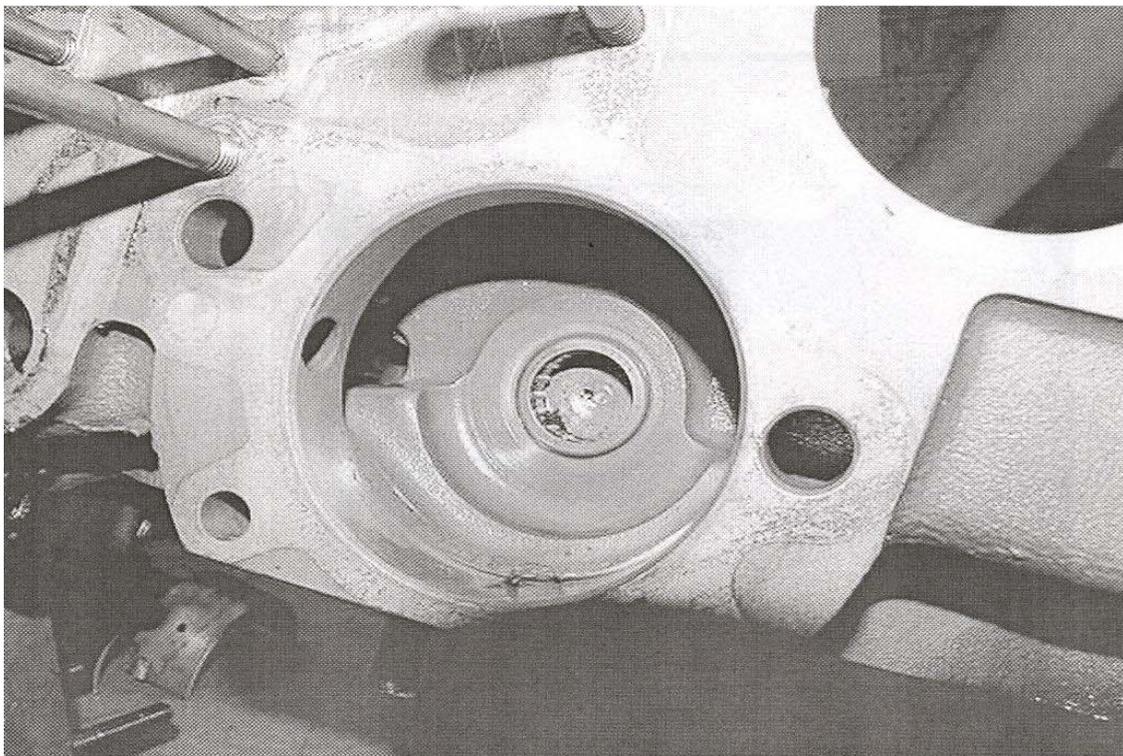
Kelly Oil Filter: ES48109; Defective Filter; ATA 8550

A technician for an operator writes, “On disassembly of this engine rubber debris was found in the oil passage that feeds the starter adapter pilot bearing—the passage was plugged. Upon splitting the engine case debris was found in the oil passage to the #3 main bearing. Both oil cooling jets to this bearing were plugged with rubber debris. The right (*jet*) was plugged with a piece 5/8 inch long, the left a piece 3/16 inch. One piece of rubber debris was located in the oil passage to the #5 bearing.

“This engine had utilized Kelly Aerospace oil filters (P/N ES48109) prior to the engine disassembly. (*Opening this engine’s Kelly filter indicated ...*) the top rubber seal within the filter was damaged—and this damage may have occurred at the time of the filter manufacture. (*Any debris*) from this filter would not be caught by the filter (*material*) because the rubber seal is located on the oil exiting portion of the filter. This debris...may restrict the lubrication to some parts of the engine and eventually result in an engine failure.”
