**Federal Aviation
Administration**

ADVISORY CIRCULAR

AVIATION MAINTENANCE ALERTS

**ALERT
NUMBER
368**

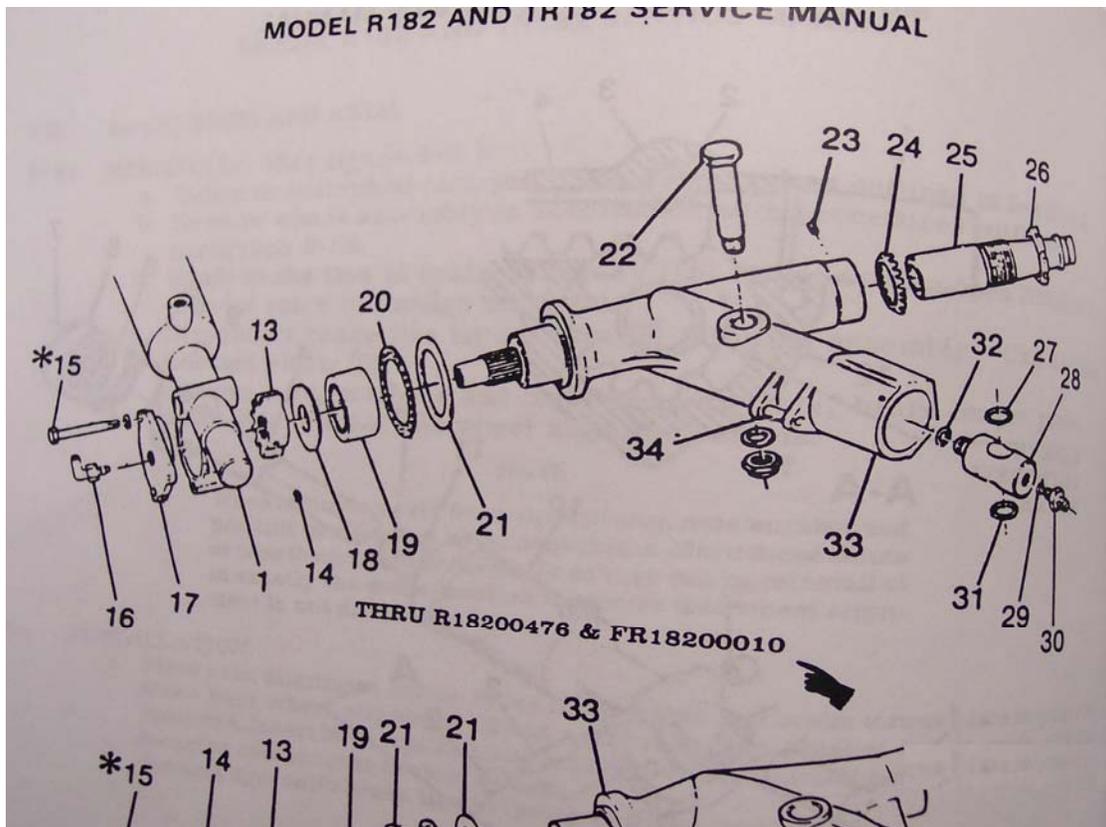
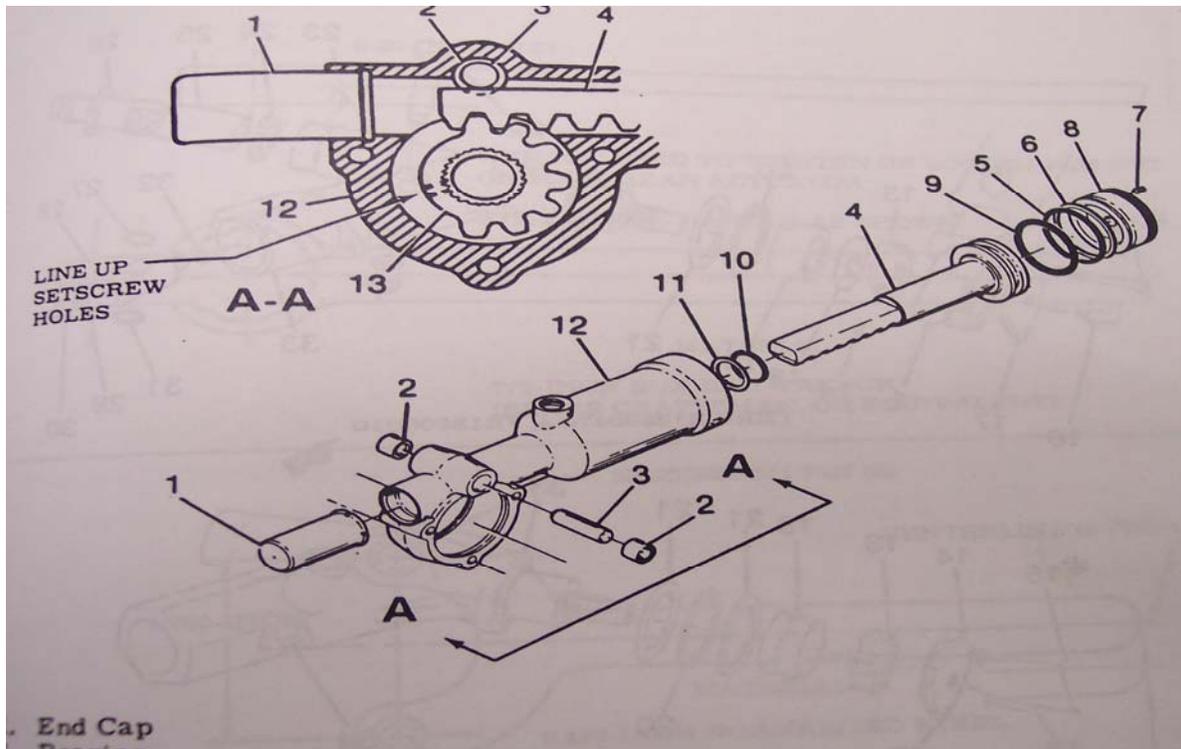
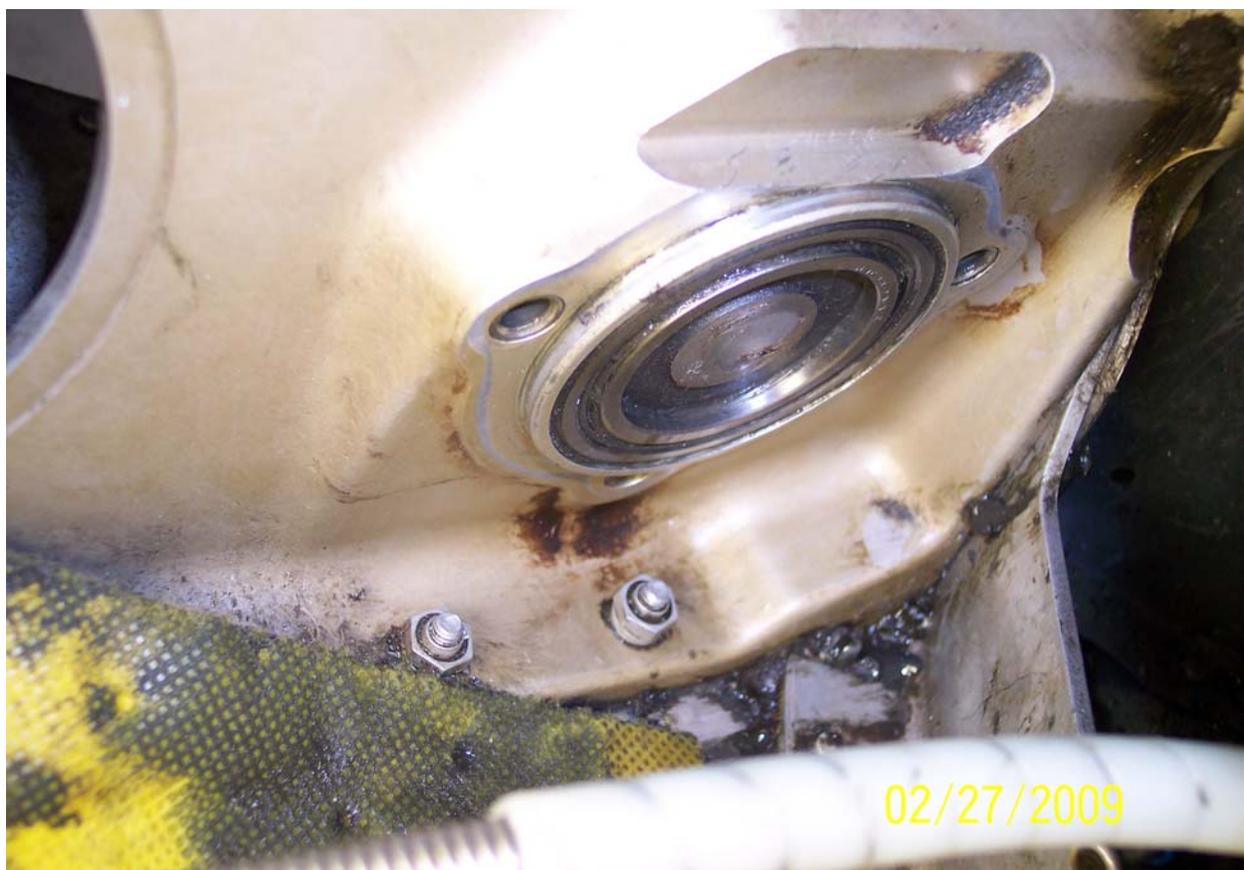
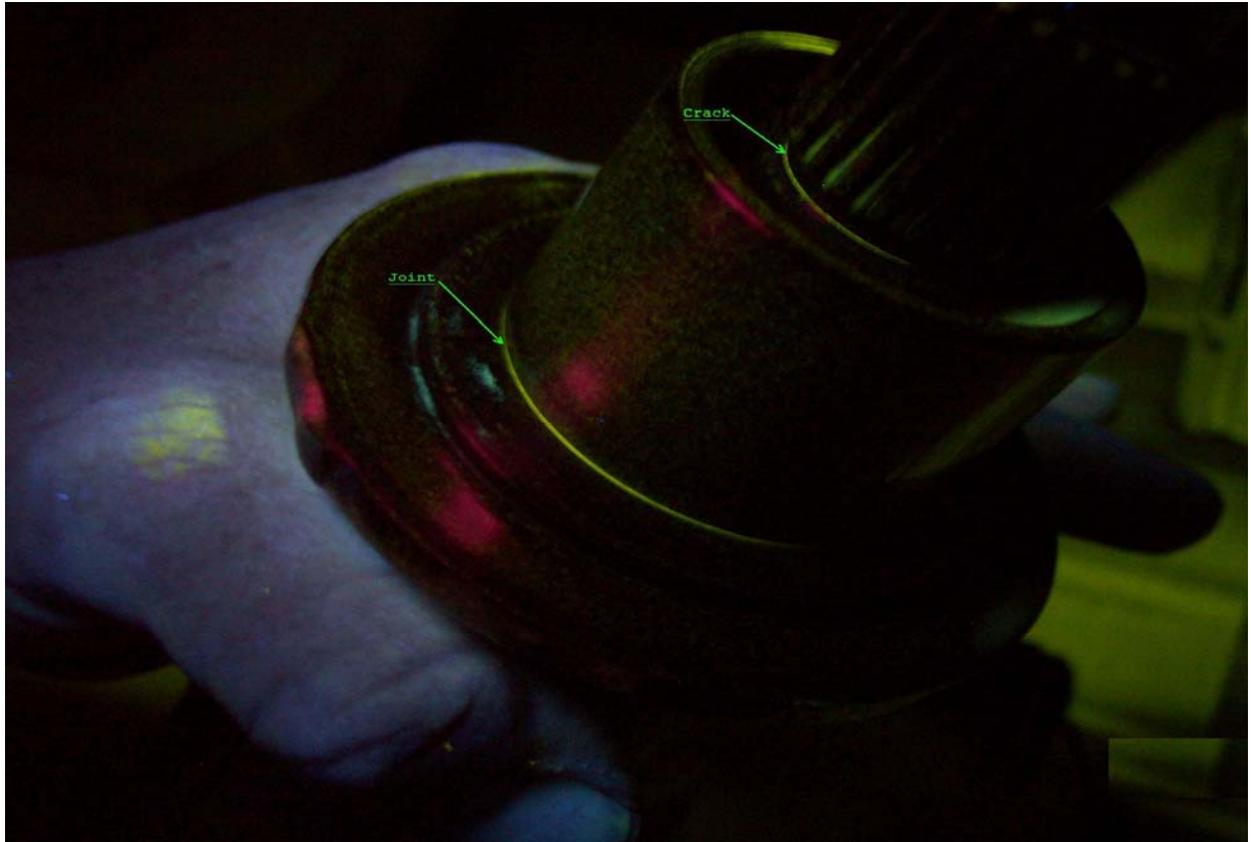
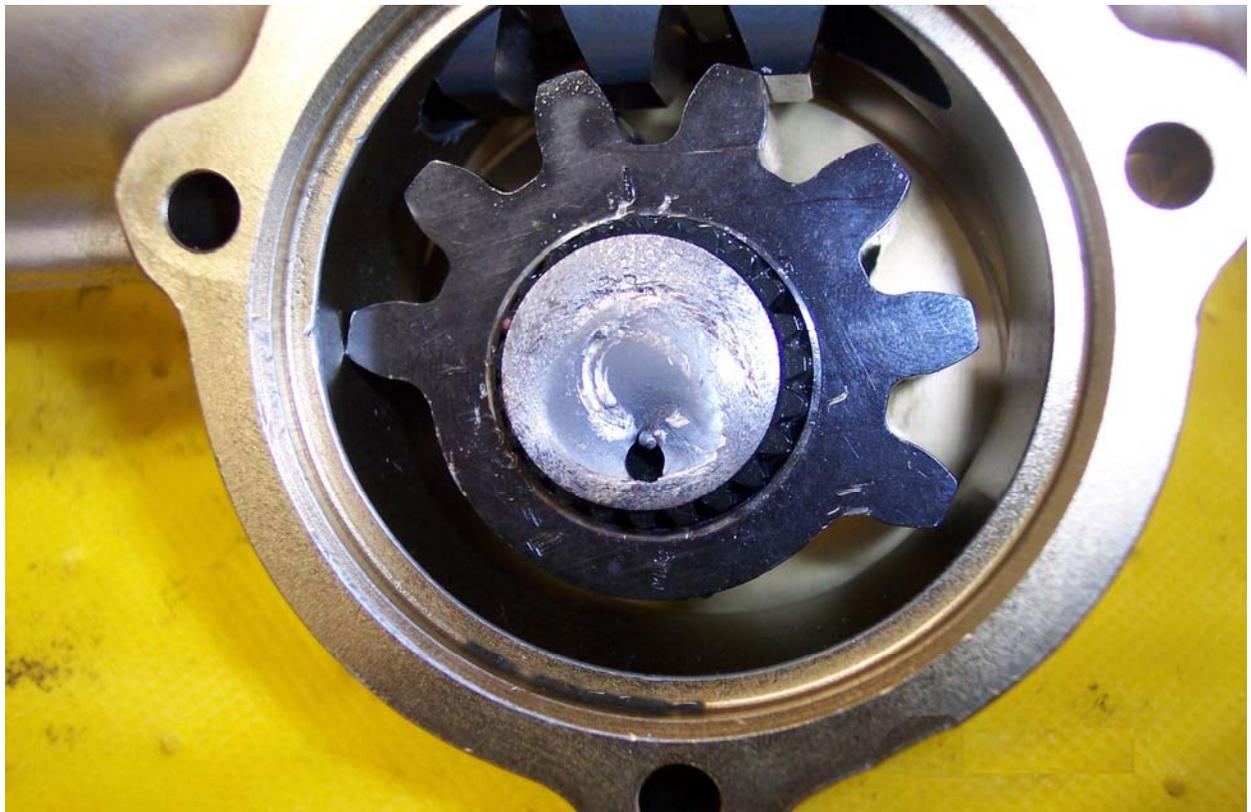
"During slow flight maneuvers the instructor noticed the green, landing gear 'safe light' was not illuminated. The student observed the left gear was hanging out—and swinging. The gear was cycled, but the left main remained free and disconnected. After contacting dispatch the instructor elected to retract the right and nose gears and land gear-up. Maintenance found the left gear pivot had sheared at the spline shaft. The right gear was removed and Zyglo checked. Close inspection found the right pivot was cracked three quarters of the circumference around the spline shaft, nearing complete failure. This crack area is not normally accessible during regular inspections without removing the gear actuator. Cessna has been notified of the problem. At this time there are no replacement steel pivots available for these aircraft." (Gear pivot P/N: 22411143.)

(Okay Pat.... How many times did you take this last shot to get such a clean picture? I can almost stick my finger in there. At 500% magnification in MS Word, a scratch/crack line can just be discerned at the 5 o'clock position—initiation point? Readers might surmise and note their own failure start point for later comparison against "electron scrutiny" –should it become available. Thanks again for your continuing support and efforts.)

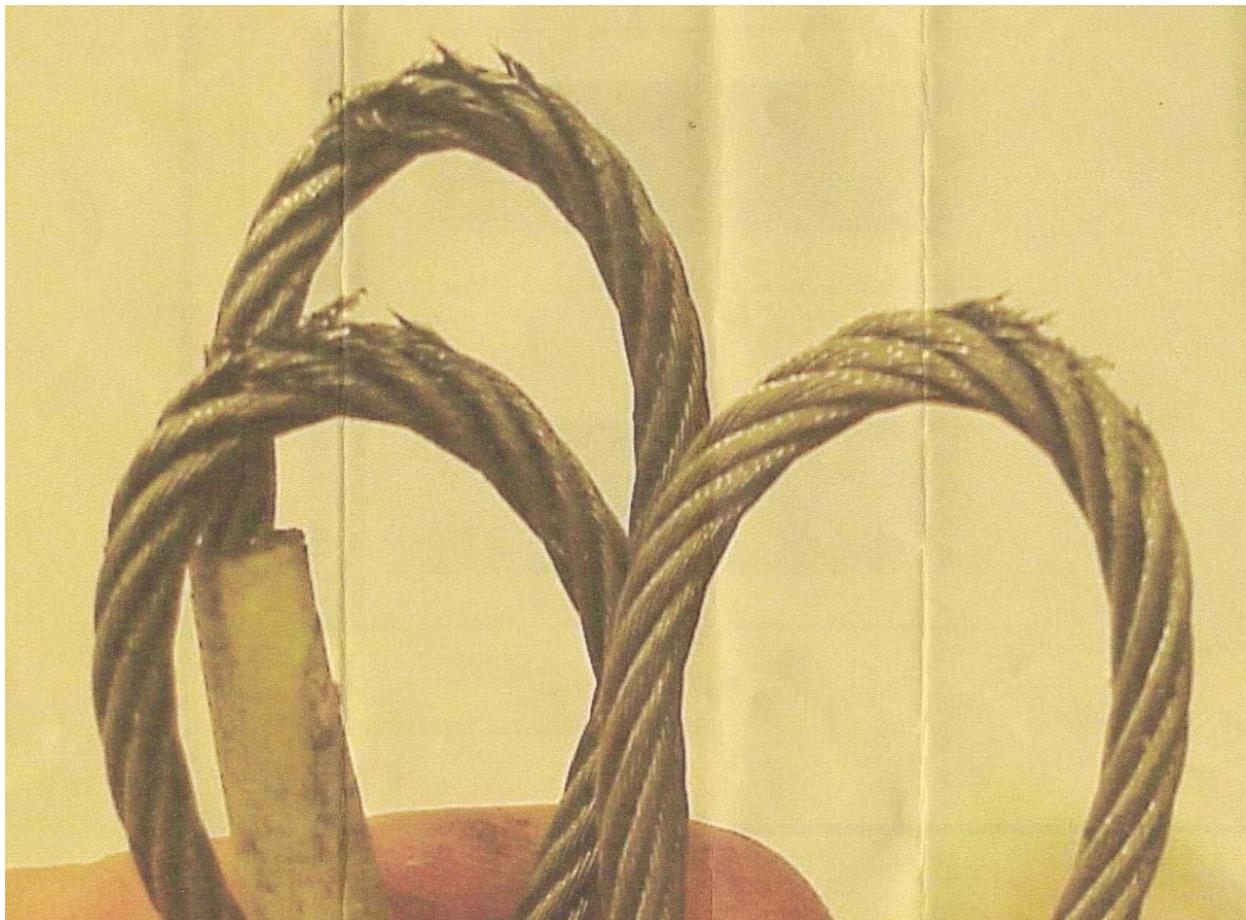
An A&P holding an *Inspector's Authorization* writes, "(I) found the left aft aileron cable frayed at wing station 58.94—the pulley was frozen. No defects were found on the other cable systems. (During) replacement of this cable it was also found frayed at wing station 87.29. The pulleys at this station were turning freely. When installing the new cable I also noticed the forward aileron cable with broken strands at (the same) wing station 87.29. (It too required new cable installation.)

"I suggest everyone be reminded of these locations (including wing station 106.79) as these access panels are in the wheel well with the pulleys off to the side and down. (This) is a hard area to inspect, (requiring) the ailerons to be moved to their travel limits for complete (cable) inspection. These cables were broken in small, localized spots." (Left aileron cable P/N's: 5000008-66 and -67. Aircraft total time: 5,567.2 hours).

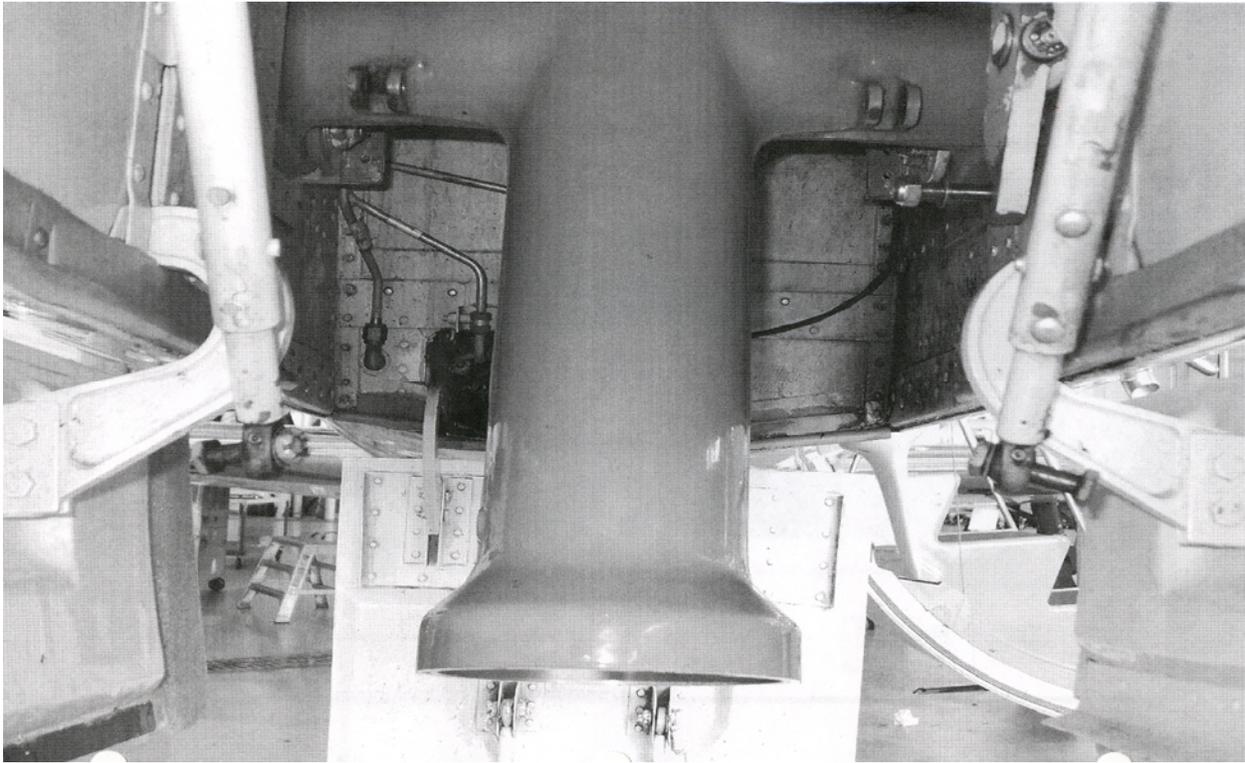
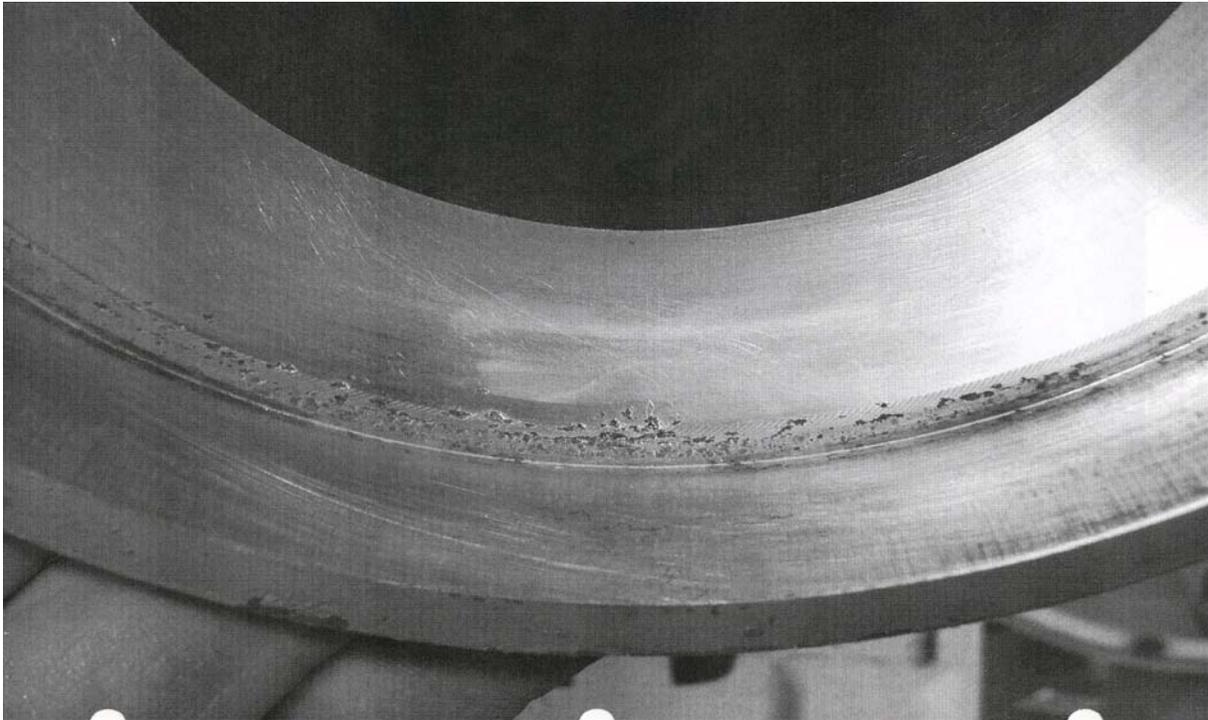
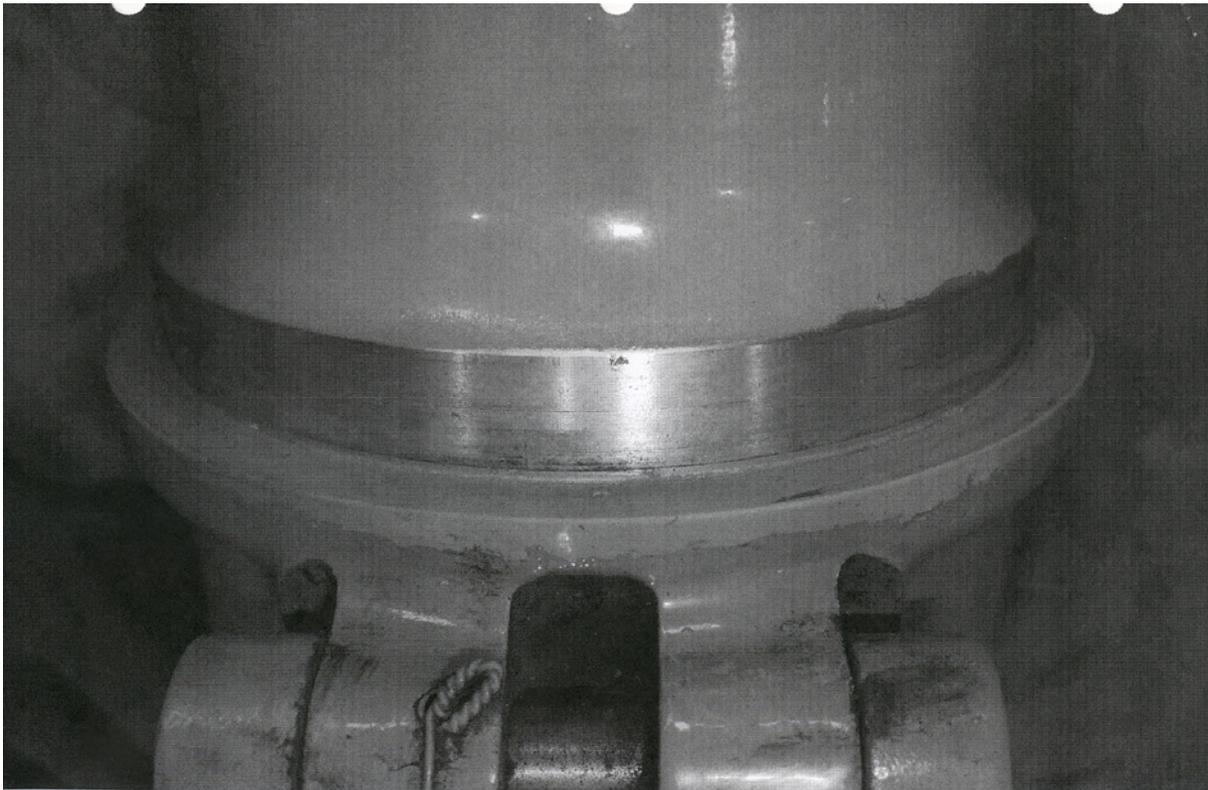
Cessna: 560XL; Nose Gear Trunnion Corrosion; ATA 3221

A repair station technician states, "While working an unscheduled nose gear vibration (popping) discrepancy, we found bearing P/N MS27642-68G to be rough when turned. Upon further inspection we found corrosion and pitting between the steel bearings and the aluminum nose landing gear trunnion assembly. (*This*) trunnion (P/N 6642611-9) should be treated to prevent dissimilar metal corrosion."

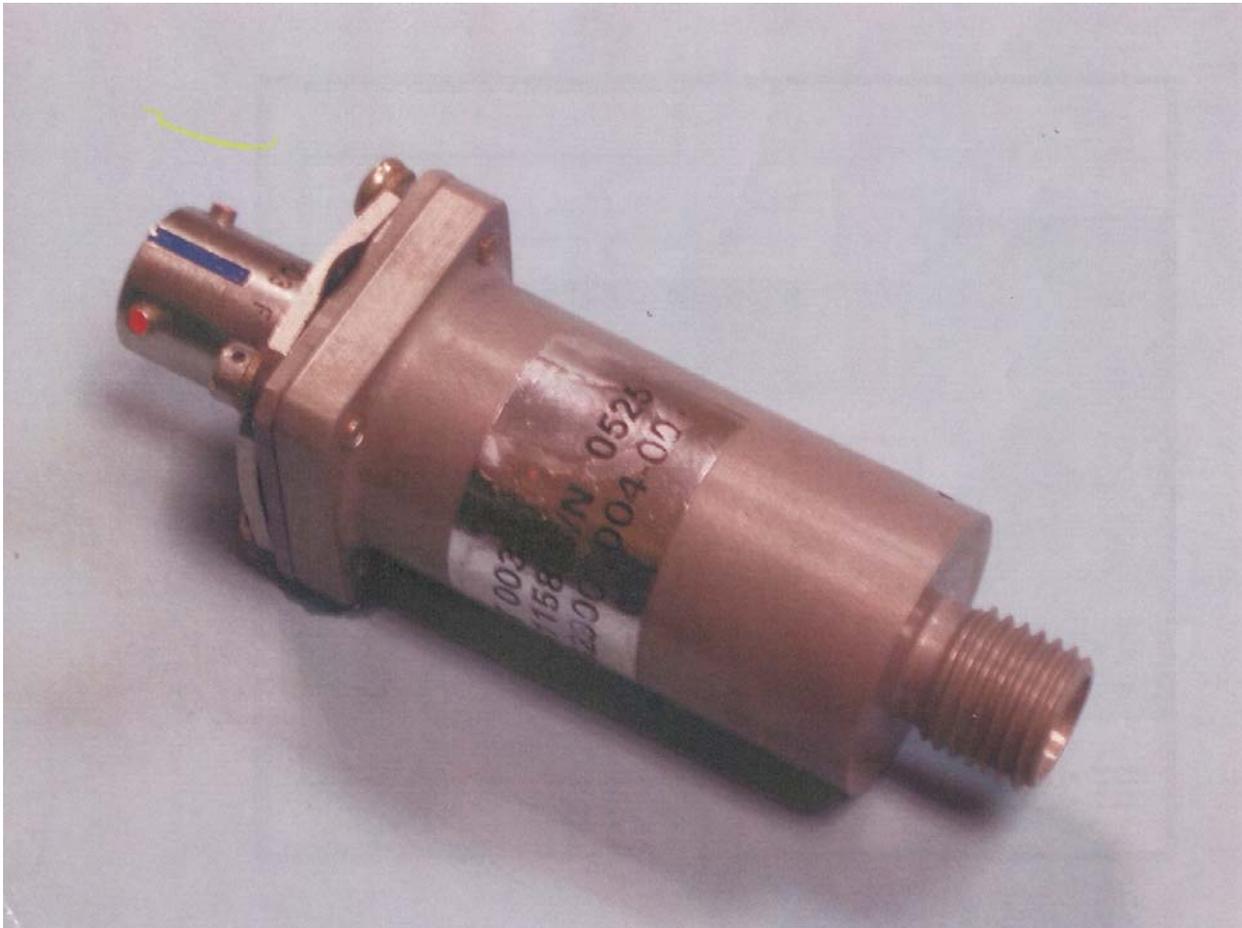
Learjet: 45; Failed Hydraulic Pressure Switch; ATA 2915

"The left hydraulic pressure switch (S9) failed in flight," says an anonymous mechanic, "resulting in loss of hydraulic fluid and failure of both left and right hydraulic pumps. This necessitated a flight diversion to an alternate airport with an emergency declaration." (Pressure Switch P/N: 7629001004-001.)

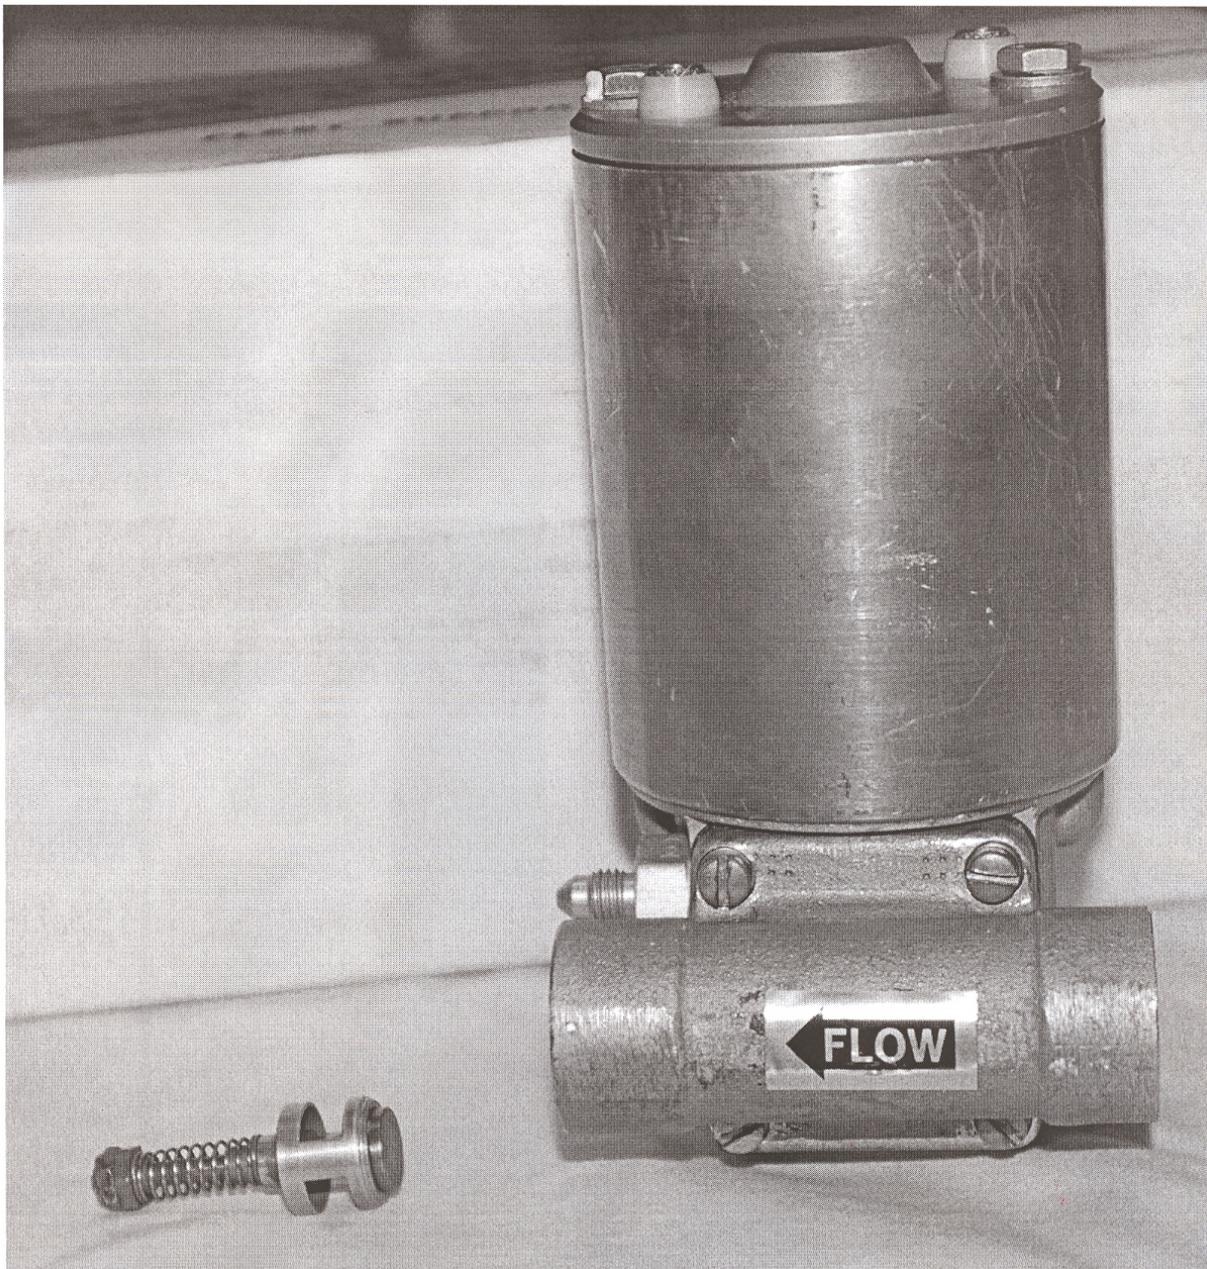
Piper: PA31-350; Failed Electrical Fuel Pump; ATA 2822

An unidentified mechanic relates the following description. "*(The aircraft was departing the field...)* when he reported he lost substantial power to the left engine just after take off, and that the left low pressure fuel boost pump light on the aircraft annunciator panel illuminated. He (*effected a safe landing at an airport*) and called for aircraft maintenance. The aircraft technician on location could not find any problems with the engine during run-up other than the electric, low pressure fuel boost pump not supplying rated pressure. (Note: the electric, in-line low pressure boost pump is intended for flight above 15,000 feet MSL and can be deferred, as per our Part 91 MEL (*minimum equipment list*)). The aircraft (*initiated its take-off roll for departure...*) when the left engine again lost power at (approximately) 40 knots airspeed. (*Subsequent*) trouble shooting of the engine fuel pump and fuel nozzles revealed no problems. The in-line low pressure fuel pump was removed (*revealing*) the bypass valve assembly in the pump had dislodged from the pump body and acted as a fuel (*flow*) restriction to the emergency electric fuel pump. We have been operating the Piper Navajo Chieftain aircraft for 20 years and have never seen this happen until now."

(Parker Hannifin Pump, P/N 2B6-64. Time since overhaul: 2,098.4 hours. The FAA Service Difficulty Reporting System (SDRS) reflects 11 entries for this part number.)
