NATIONAL TRANSPORTATION SAFETY BOARD

RUNWAY OVERRUN DURING LANDING
AMERICAN AIRLINES FLIGHT 1420
MCDONNELL DOUGLAS MD-82, N215AA
LITTLE ROCK, ARKANSAS
JUNE 1, 1999

**NTSB/AAR-01/02
PB2001-910402
Notation 7195A
Adopted October 23, 2001**

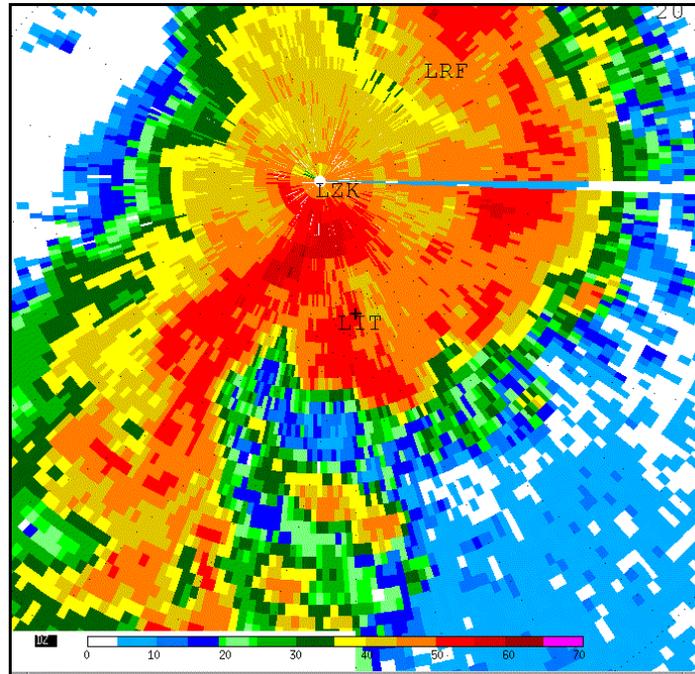
Figure 9. 0.4° Base Reflectivity Scan at 2345:57

The WSR-88D's 0.4° elevation scan of base reflectivity that was completed at 2345:57 indicated that the area over the airport and the approach end of runway 4R reached reflectivities of 54 dBz, or level 5 (intense) activity, and that the area approximately 5 miles west of runway 4R reached maximum reflectivities of 61.5 dBz, or level 6 (extreme) activity. Figure 9 shows the base reflectivity product for this time period.

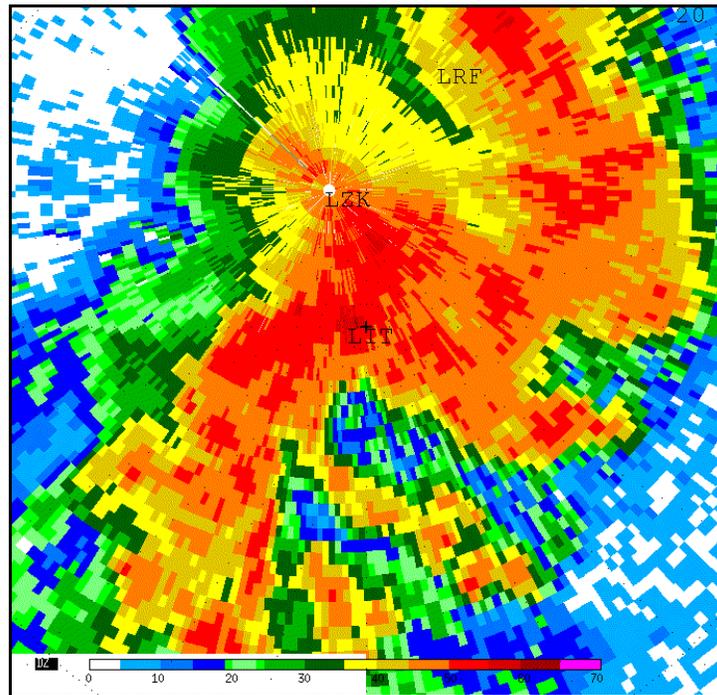
Figure 10. 0.4° Base Reflectivity Scan at 2351:59

At 2351:59, the 0.4° base reflectivity image depicted a maximum of 52 dBz, or level 5 (intense) activity, along the flight track, with maximum reflectivities of 60 dBz, or level 6 (extreme) activity, located 1 1/2 miles to the northwest. Figure 10 shows the base reflectivity product for this time period. Also, the 1.5° elevation scan at 2353:03 indicated returns of 58 dBz, or level 6 activity, with maximum reflectivities of 62.5 dBz 1/2 mile from the approach end of runway 4R.

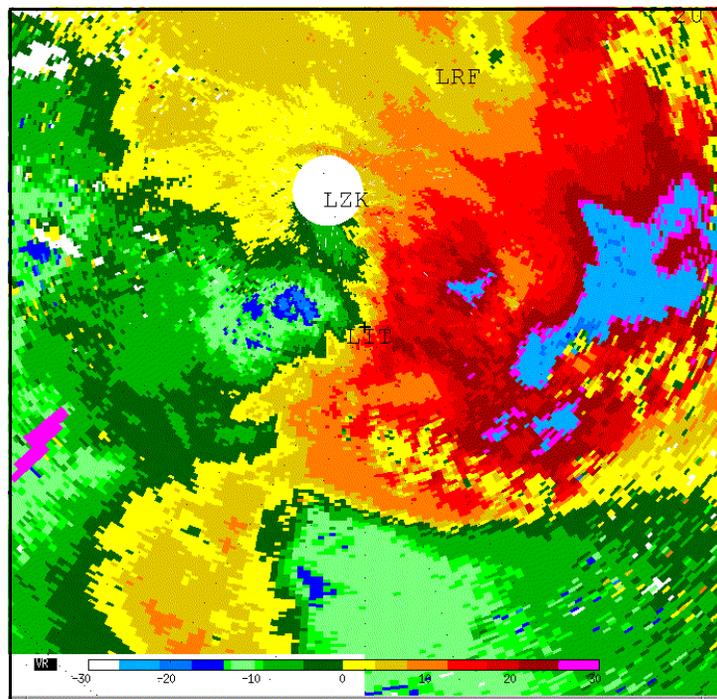
Figure 11. Radial Velocity Image Surrounding the Time of the Accident

The WSR-88D's radial velocity image (showing components of the wind speed that are coming directly toward or away from the radar) for 2346:29 indicated that winds from the northwest at 15 meters per second (30 knots) were over runway 4R. Figure 11 shows the radial velocity image for this time period with the airplane's flight track. At 2352:30, the radial velocity image depicted winds from the northwest at 18 meters per second (36 knots) over the runway with winds reaching 30 meters per second (60 knots) within 1/2 mile of the approach end of the runway.

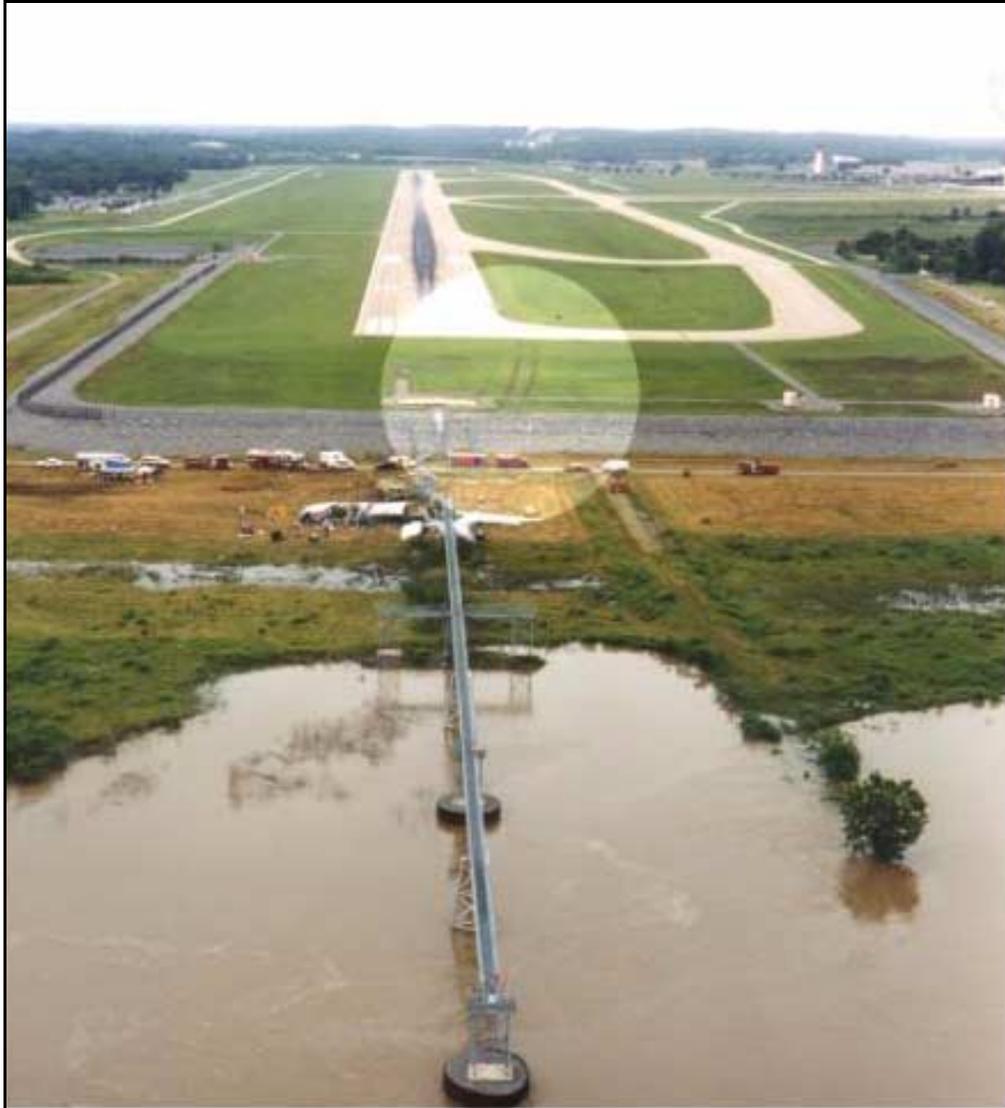
Figure 12. Aerial Photograph of Runway 4R/22L, Airplane Wreckage, and Runway 22L Approach Lighting System

Figures 12 through 14 are photographs of the airplane wreckage. Figure 12 shows the airplane wreckage, the tire tracks off the end of runway 4R, and the damage to the runway 22L approach lighting system.⁷⁷ Figure 13 shows the airplane wreckage and the runway 22L approach lighting system. Figure 14 shows a closer view of the airplane and the runway 22L approach lighting system. Additional details about the airplane wreckage are presented in sections 1.12.2 through 1.12.4.

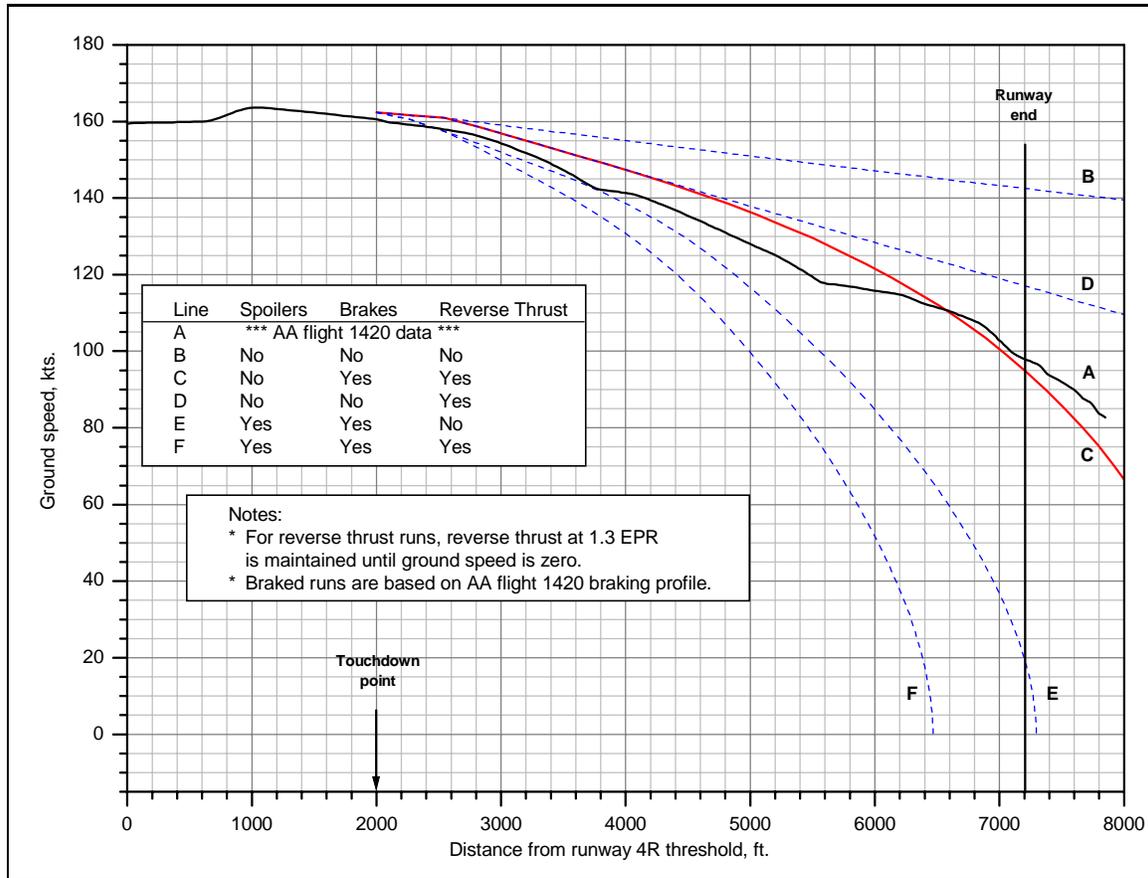
Figure 16. Effects of Spoilers, Brakes, and Reverse Thrust on Stopping Distance

With no braking, spoilers, or reverse thrust, the airplane would depart the runway with a ground speed of about 142 knots, which is 45 knots faster than the flight 1420 airplane. With no spoilers or brakes but with a constant, symmetrical reverse thrust at

1.3 EPR, the airplane would leave the runway at 117 knots, which is 20 knots faster than the flight 1420 airplane. With no spoilers but with 1.3 EPR reverse thrust and the flight 1420 braking profile, the airplane would have departed the runway at 95 knots. This computer run matched the flight 1420 data best and indicated that the accident airplane experienced a braking coefficient of at least 0.21 to 0.23 at speeds between 160 and 140 knots, respectively.⁹⁶ Figure 16 shows the results of the computer runs compared with the flight 1420 profile.

Two additional computer runs demonstrated that proper spoiler deployment is critical to deceleration and stopping distance. Without reverse thrust and with the spoilers deployed and the flight 1420 braking profile, the airplane would depart the runway at 20 knots, which is 75 knots less than the airplane with no spoilers but with reverse thrust and braking. With constant reverse thrust, deployed spoilers, and the flight 1420 braking profile, the airplane could have stopped about 700 feet before the end of the runway.

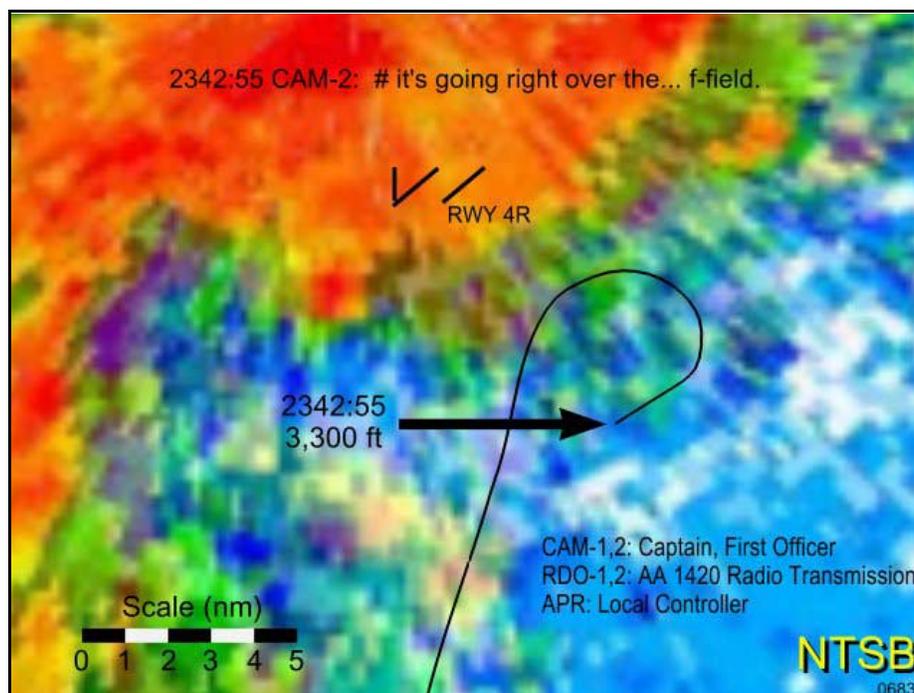
Figure 20. Weather and Flight Information for 2342:55

The flight crew continued to receive, but did not discuss, wind reports from the controller. The flight crew's actions and conversations during this phase of the approach largely consisted of steps to expedite the approach to the airport. For example, at 2342:40, the first officer asked the captain if he wanted to conduct a "short approach" and "keep it in tight." The captain accepted the suggestion but with the qualification "if you see the runway, 'cause I don't quite see it." (The airport was off the right, or first officer's, side of the airplane.) The first officer began to radio the controller at 2342:54 to suggest a visual approach but interrupted this transmission 1 second later when he stated to the captain, "it's going right over the...field." In a postaccident interview, the first officer indicated that he was referring to a temporary obstruction of his view of the airport because of clouds. The first officer's next transmission, 4 seconds later, informed the controller that "we got the airport" and that "we're going between clouds." Figure 20 shows a map of the weather conditions at 2342:55 and flight 1420's location.

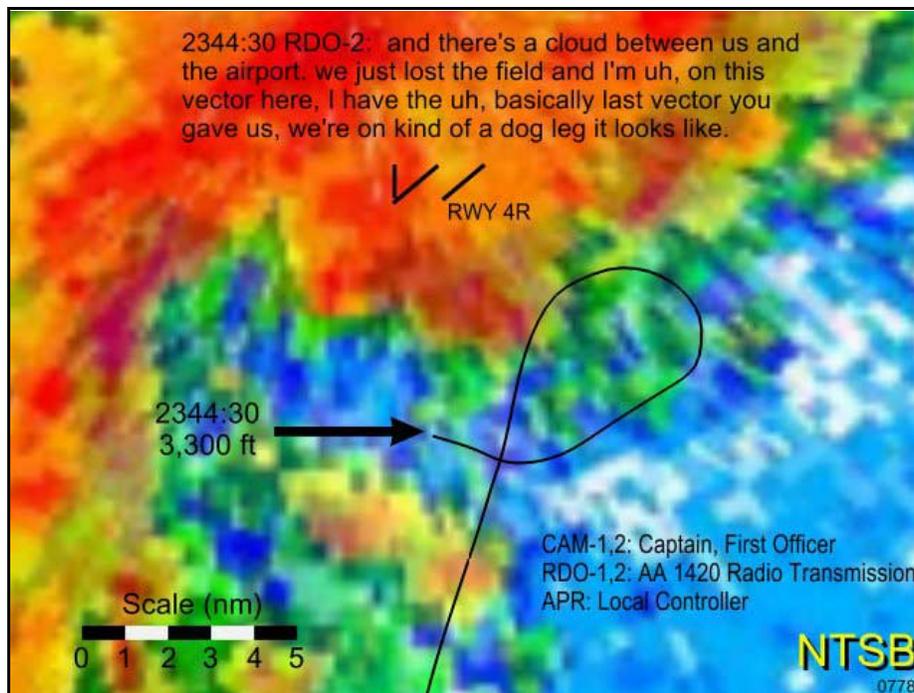
Figure 21. Weather and Flight Information for 2344:30

At 2344:19, the captain stated, "see we're losing it. I don't think we can maintain visual." The first officer notified the controller at 2344:30 that visual contact with the airport had been lost because of a cloud between the airplane and the airport. The controller then cleared the airplane to fly a heading of 220° for radar vectors for the ILS approach to runway 4R. (ATC radar indicated that, at this time, flight 1420 was about 6 miles south of runway 4R, heading westbound and away from the runway. Weather radar data indicated that heavy rain was occurring at the airport at the time that the airplane was flying on the 220° heading.) Figure 21 shows a map of the weather conditions at 2344:30 and flight 1420's location.

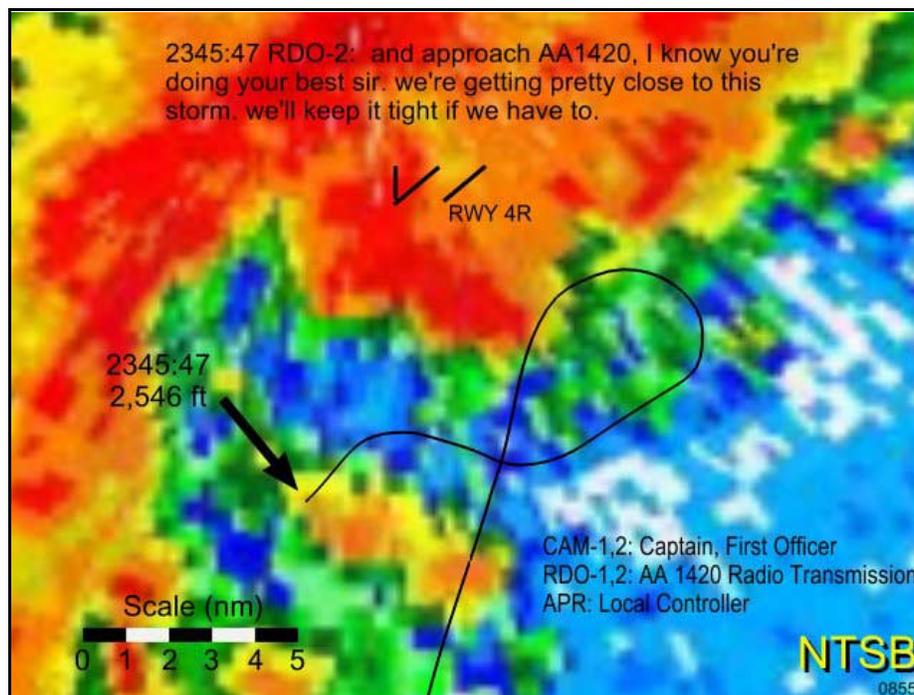
Figure 22. Weather and Flight Information for 2345:47

The weather south of the airport became the next focus of the flight crew's attention. NWS radar data indicated that, in the 6 minutes before the accident, a line of thunderstorms, with several large areas of intense and extreme activity, was encompassing the Little Rock airport area and runway 4R approach path. At 2345:47, the first officer told the controller "we're getting pretty close to this storm. we'll keep it tight if we have to." The controller indicated to the flight crew that, "when you join the final, you're going to be right at just a little bit outside the marker if that's gonna be okay for ya." The captain stated, "that's great," and the first officer told the controller, "that's great with us." Figure 22 shows a map of the weather conditions at 2345:47 and flight 1420's location.

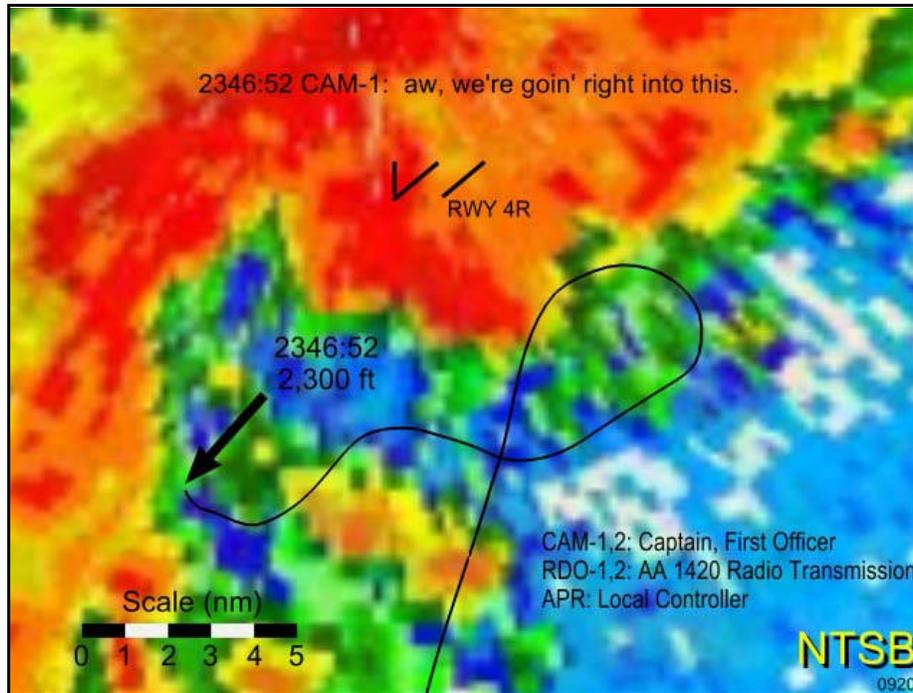
Figure 23. Weather and Flight Information for 2346:52

stated, “aw, we’re goin’ right into this.” Figure 23 shows a map of the weather conditions at 2346:52 and flight 1420’s location. About this point in the approach, the flight crew should have regained the use of the airborne weather radar to depict precipitation levels in front of the airplane. However, the Safety Board could not determine whether the radar was displaying this information or whether the flight crewmembers, given their workload, were able to perceive and interpret the information that the radar was providing.

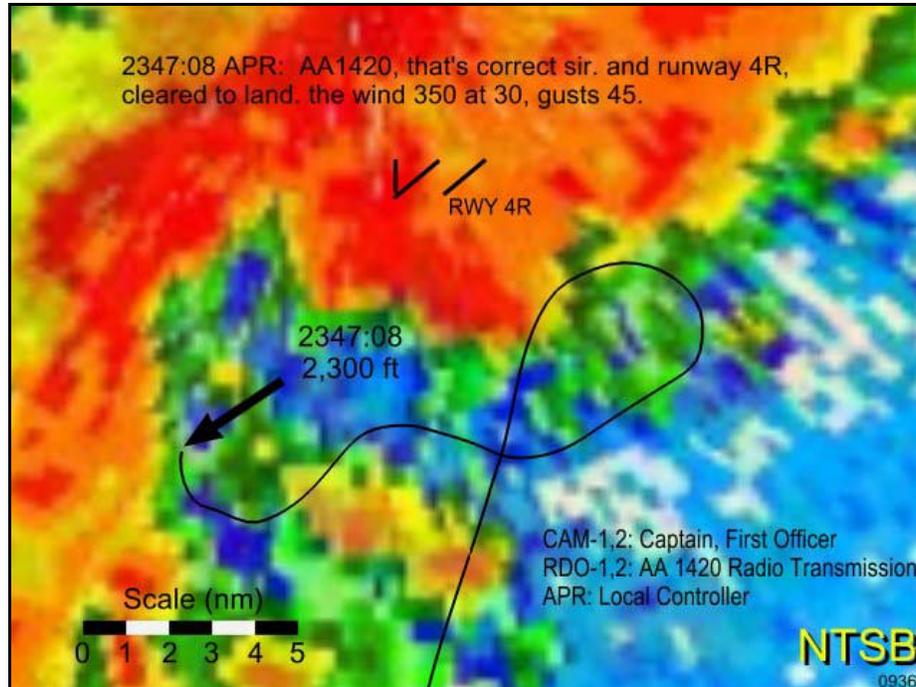
Figure 24. Weather and Flight Information for 2347:08

At 2347:08, the controller cleared flight 1420 to land and stated that the wind was 350° at 30 knots gusting to 45 knots. The CVR indicated that flight crew did not discuss the wind information, the heavy rain that was already falling at the airport, or the depiction of the weather on the airborne weather radar. Figure 24 shows a map of the weather conditions at 2347:08 and flight 1420’s location.

Statements from the CVR and the first officer’s postaccident interviews indicated the flight crew’s concern about the location of the thunderstorm in relation to the airport and the airplane. However, the Safety Board concludes that, because the first officer was able to maintain visual contact with the runway as the airplane was vectored for the final approach course, both flight crewmembers might still have believed that flight 1420 could arrive at the airport before the thunderstorm. The Board understands that some other flight crews might continue an approach to a runway under the same circumstances. On the other hand, the Board also recognizes that the approaching storm and the reports of heavy rain, dropping visibility, and increasing crosswinds (from 10 to 30 knots with

gusts to 45 knots) would be sufficient for some flight crews to hold until the storm passed or proceed to an alternate airport.

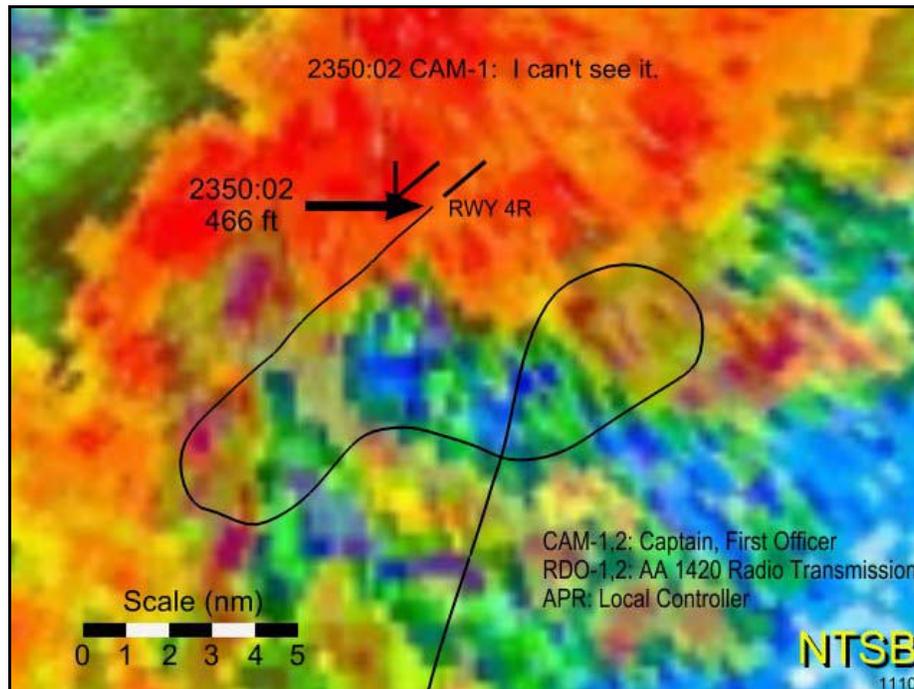
Figure 26. Weather and Flight Information for 2350:02

At 2350:02, the captain stated, "I can't see it." Calculations based on FDR data indicated that the airplane was between 5 and 20 feet above the decision height at that time. The Safety Board was not able to determine whether the captain's comment referred to his loss of visual contact with the runway or with its environment. Figure 26 shows a map of the weather conditions at 2350:02 and flight 1420's location.
