# SPECIAL AIRWORTHINESS INFORMATION BULLETIN

No. CE-01-24  
May 30, 2001

This Special Airworthiness Information Bulletin (SAIB) provides you, an owner or operator of Rolladen-Schneider Models LS-6, LS-7 and LS-8, with safety information received from the German Civil Airworthiness Authority (Luftfahrt-Bundesamt) identifying a potential safety problem on the following:

- Potential of Canopy Jamming - Technical Bulletin (TB) Numbers 6036/2, 7011/2 and 8004/2

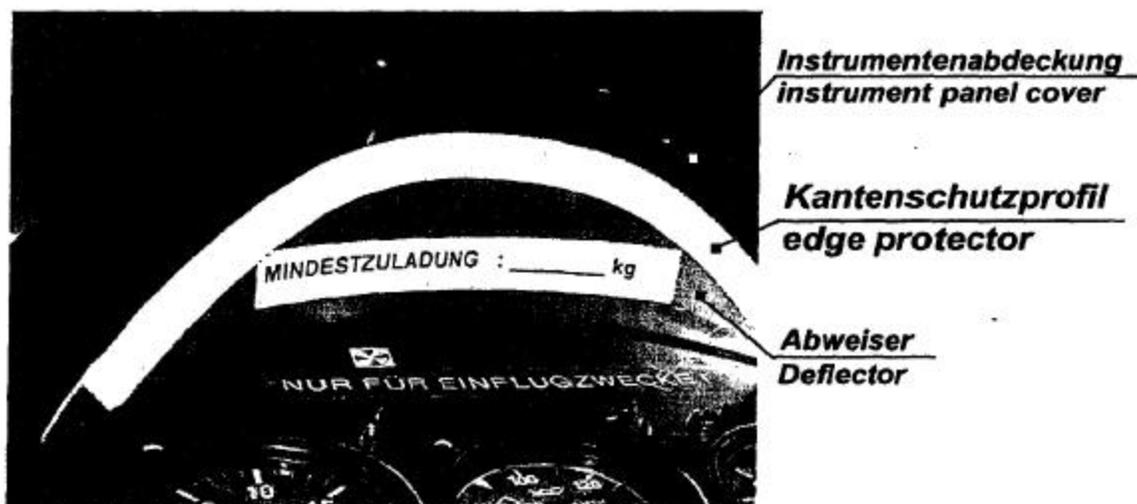
### Deflector with edge protector:

Reason: A deflector on the upper instrument panel edge avoids possible jamming of the instrument panel between the canopy mounted panel cover after actuation of the canopy emergency jettison.

### Modification of the Deflector

1. Drill blind rivets. If need be, unscrew upper instruments (Hexagon head 2.5 mm und ratchet with 7mm socket) and place them on top of the second row.
2. Mark new fixing holes 10mm (0.4 in) offset from originals and drill. This enables to use the existing holes at the instrument panel edge.
3. Shorten straight edge of deflector by 10 mm, soften edge and paint black. Maximum depth of deflector after trimming is 100 mm (3.94 in).
4. Rivet deflector back to top of instrument panel, facing towards the pilot (Blind rivets  $\varnothing$  4mm\*6.5, large washers  $\varnothing$ 4.3 \* 12 \* 1mm DIN 9021-St).
5. Push edge protector (as long as instrument panel allows) onto deflector edge.

Should the instrument panel cover be too short to allow the protector to fit underneath, contact manufacturer stating model and serial number.

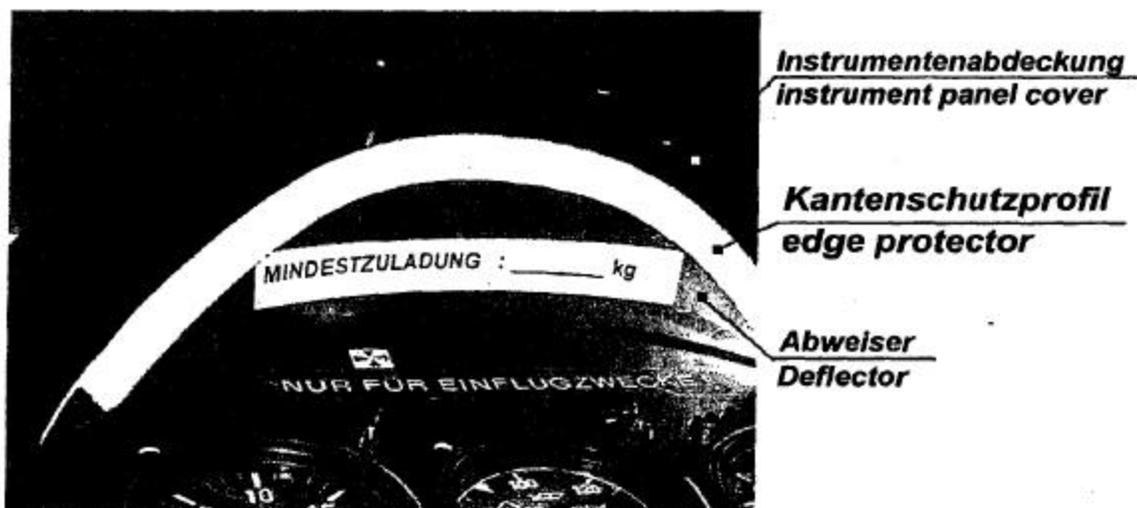
### Deflector with edge protector:

Reason: A deflector on the upper instrument panel edge avoids possible jamming of the instrument panel between the canopy mounted panel cover after actuation of the canopy emergency jettison.

### Modification of the Deflector

1. Drill blind rivets. If need be, unscrew upper instruments (Hexagon head 2.5 mm und ratchet with 7mm socket) and place them on top of the second row.
2. Mark new fixing holes 10mm (0.4 in) offset from originals and drill. This enables to use the existing holes at the instrument panel edge.
3. Shorten straight edge of deflector by 10 mm, soften edge and paint black. Maximum depth of deflector after trimming is 100 mm (3.94 in).
4. Rivet deflector back to top of instrument panel, facing towards the pilot (Blind rivets Ø 4mm\*6.5, large washers Ø4.3 \* 12 \* 1mm DIN 9021-St).
5. Push edge protector (as long as instrument panel allows) onto deflector edge.

Should the instrument panel cover be too short to allow the protector to fit underneath, contact manufacturer stating model and serial number.

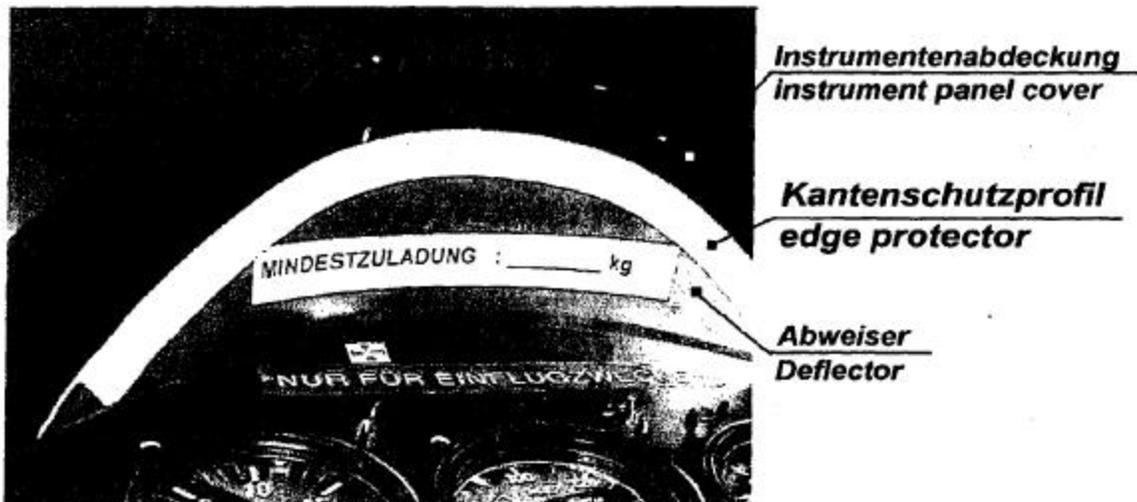
### Deflector with edge protector:

Reason: A deflector on the upper instrument panel edge avoids possible jamming of the instrument panel between the canopy mounted panel cover after actuation of the canopy emergency jettison.

### Modification of the Deflector

1. Drill blind rivets. If need be, unscrew upper instruments (Hexagon head 2.5 mm und ratchet with 7mm socket) and place them on top of the second row.
2. Mark new fixing holes 10mm (0.4 in) offset from originals and drill. This enables to use the existing holes at the instrument panel edge.
3. Shorten straight edge of deflector by 10 mm, soften edge and paint black. Maximum depth of deflector after trimming is 100 mm (3.94 in).
4. Rivet deflector back to top of instrument panel, facing towards the pilot (Blind rivets  $\varnothing$  4mm\*6.5, large washers  $\varnothing$ 4.3 \* 12 \* 1mm DIN 9021-St).
5. Push edge protector (as long as instrument panel allows) onto deflector edge.

Should the instrument panel cover be too short to allow the protector to fit underneath, contact manufacturer stating model and serial number.
