# SPECIAL AIRWORTHINESS INFORMATION BULLETIN

No. CE-04-33  
December 11, 2003

This Special Airworthiness Information Bulletin informs you, owners and operators of the **Commander Aircraft Company (Rockwell International) Model 112 and 114 aircraft** listed below, of the potential for cracking in the flange radius of the Wing Station (WS) 66.00 Leading Edge Rib aft attach angle.

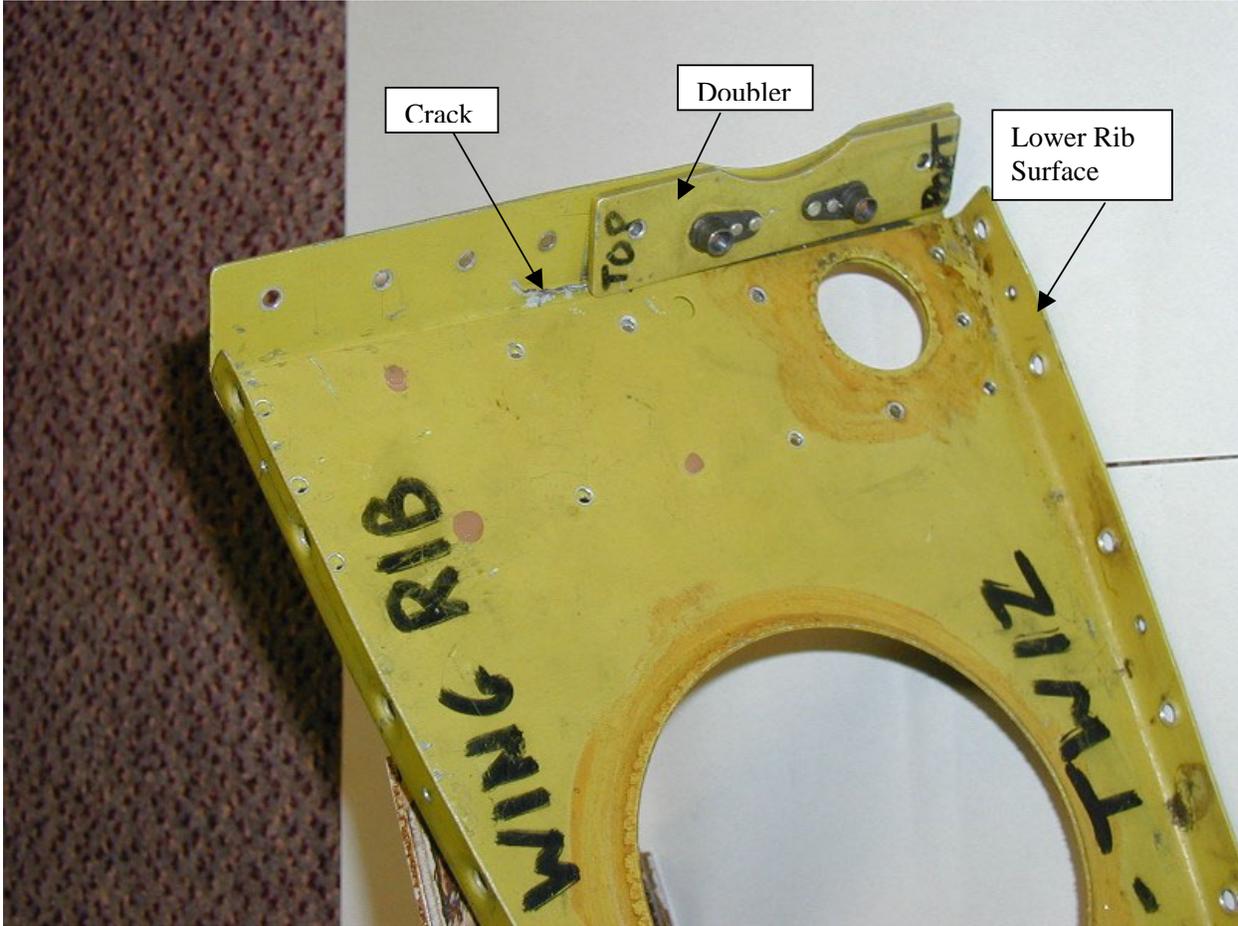
We received a report of cracks in the left and right WS 66.00 Leading Edge Rib aft attach angles on a Model 114 airplane. On the above listed Commander Model 112 and 114 airplanes, the aft end of the WS 66.00 Leading Edge Rib attaches to the auxiliary front spar by a "zee" angle. The reported cracks travel up the zee bend radius between the 2 legs where the angle attaches to the rib and auxiliary spar. A doubler plate with captive nuts covers the lower half of the forward face of the aft flange, masking the crack until it grows above the end of the doubler (see attached figures).

Figure 1. Front View Showing Crack Extending Above The Aft Flange Doubler

We strongly recommend that, starting at the next maintenance interval, and at each annual inspection thereafter, you visually inspect the WS 66.00 Leading Edge Rib aft attach angle and surrounding area for cracks. These actions will help insure the continued airworthiness of your airplane.

Using a flashlight and extension mirror, inspect for evidence of cracking, paying particular attention to the aft flange radius. Gain access through the wheel well and insert the inspection mirror through lightening holes in the auxiliary spar web and WS 66 rib. You can gain alternate access through the lower wing access panel, centered at WS 78.3 between the WS 66.00 and WS 82.5 ribs forward of the auxiliary spar.

Replace any part found cracked before continued flight. Report any cracks found, including crack location and size, to the FAA point of contact listed below.

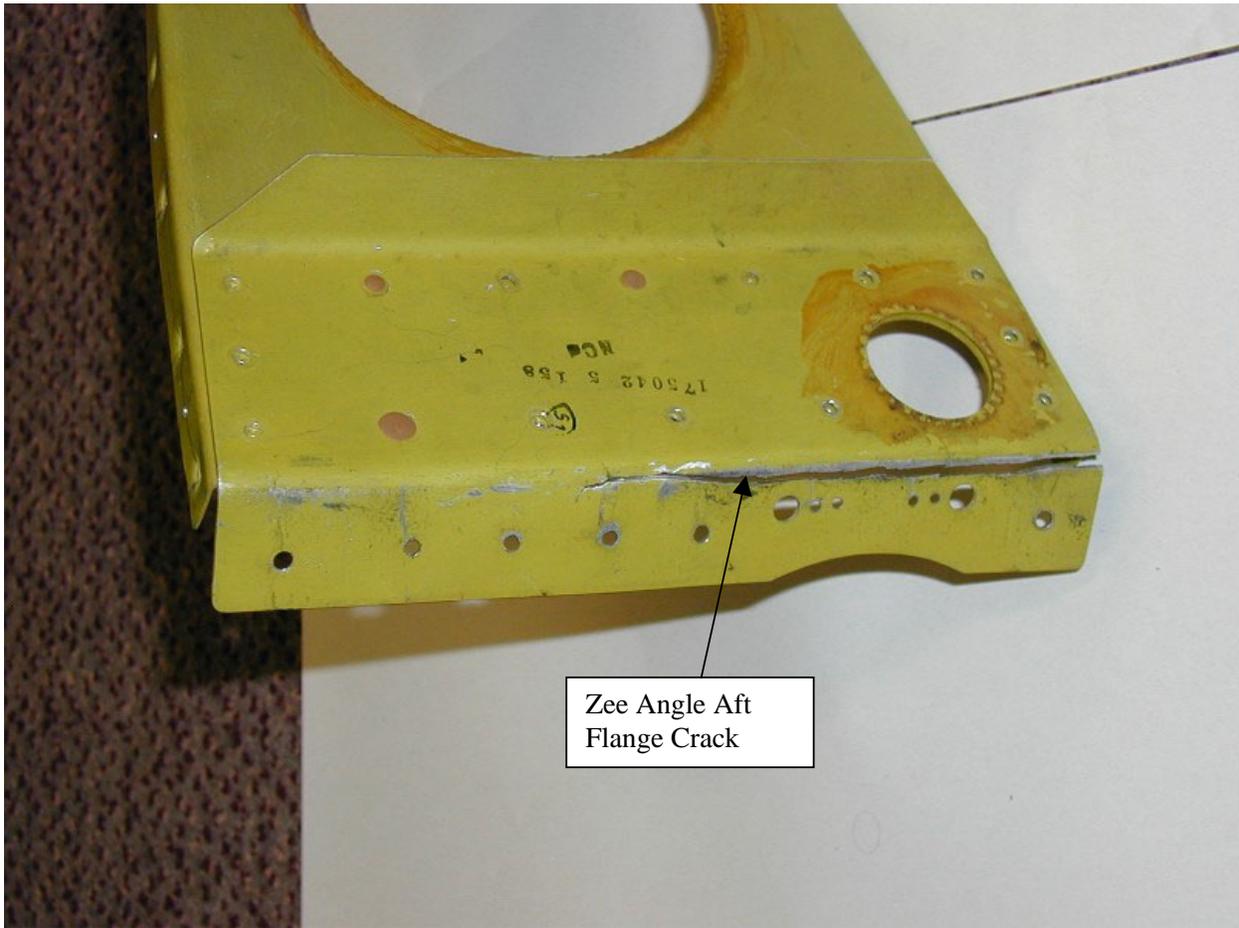
Figure 2. Aft View of Crack Extending Up Aft Flange Radius

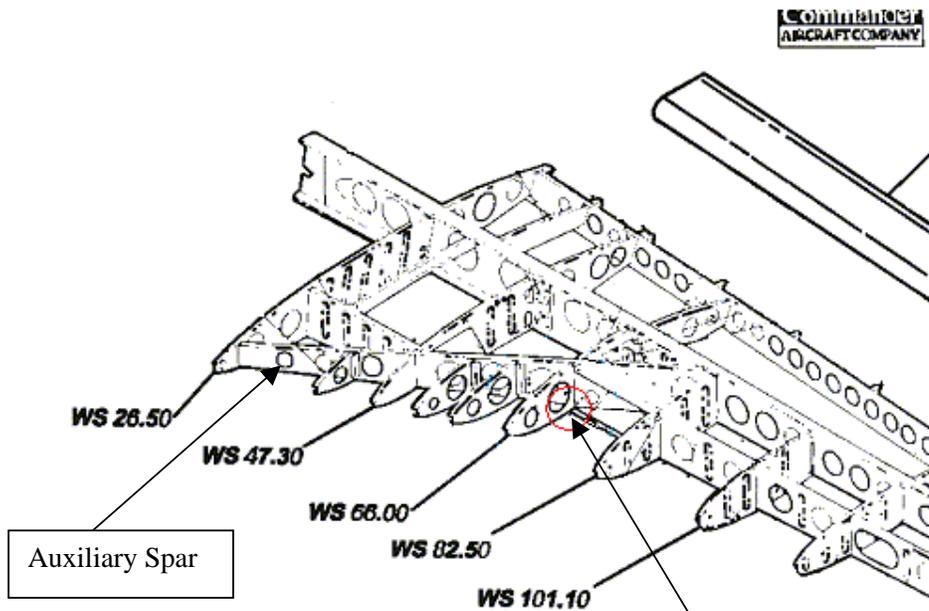
Figure 3. WS 66.00 Rib Crack Area
