SPECIAL AIRWORTHINESS INFORMATION BULLETIN

CE-04-85
September 10, 2004

This Special Airworthiness Information Bulletin (SAIB) provides you, owners and operators of **Diamond Aircraft Model DA 40** airplanes, with safety information regarding inspection/replacement of the fuel selector/fuel valve universal joints.

NO. MSB 40-030/1

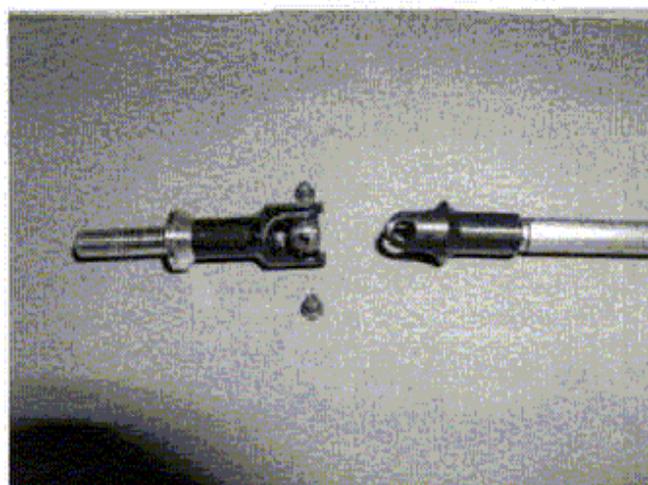
It has been found that the pins of the universal joints may come loose during operation. This can result in loss of capability to select the fuel tank to supply fuel.

The picture below shows two of the pins separated from the joint.
Inspection can be done in assembled condition. For better view rotate fuel selector in steps at least for 360 °.

Picture 1: Universal joint with two pins separated

4. In case of one or more of the under 1.8.3 listed defects have been found, replace complete universal joint kit as follows:
 - 4.1 Remove front seat RH (AMM, Chapter 25-10-00)
