**AC NO:** AC 20-52

MAINTENANCE INSPECTION NOTES FOR  
DOUGLAS DC-6/7 SERIES AIRCRAFT

AUGUST 24, 1967

DEPARTMENT OF TRANSPORTATION  
Federal Aviation Administration

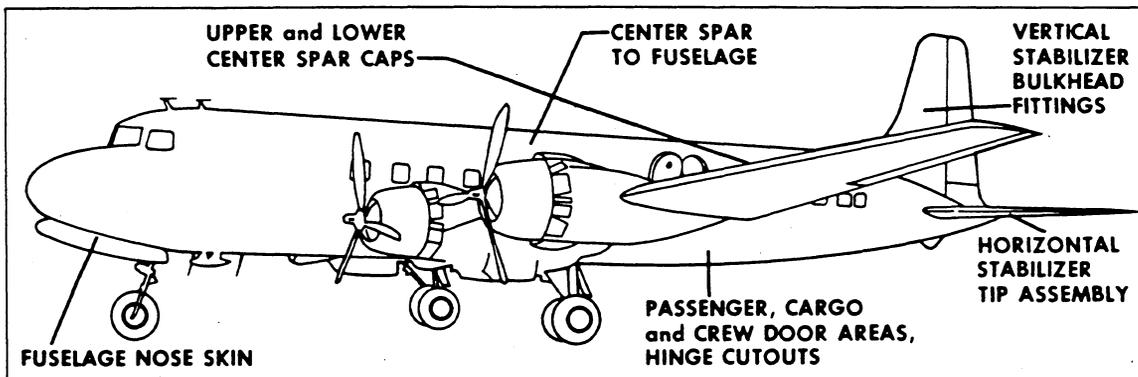
**FIGURE 1- AREAS SUBJECT TO FATIGUE CRACKS**

- (1) Wing to fuselage attach fittings at center spar.
  - (2) Horizontal stabilizer and tail stub front spar attach fittings.
  - (3) Fuselage nose skin plating.
  - (4) Main crew/cargo entrance door latch plates.
  - (5) Rear fuselage frame and transverse floor beams.
- c. Corrosion Prone Areas. Figure 2 refers to some of the corrosion prone areas in the aircraft. Manufacturer's service bulletins and manuals have been issued to provide detailed repair instructions.

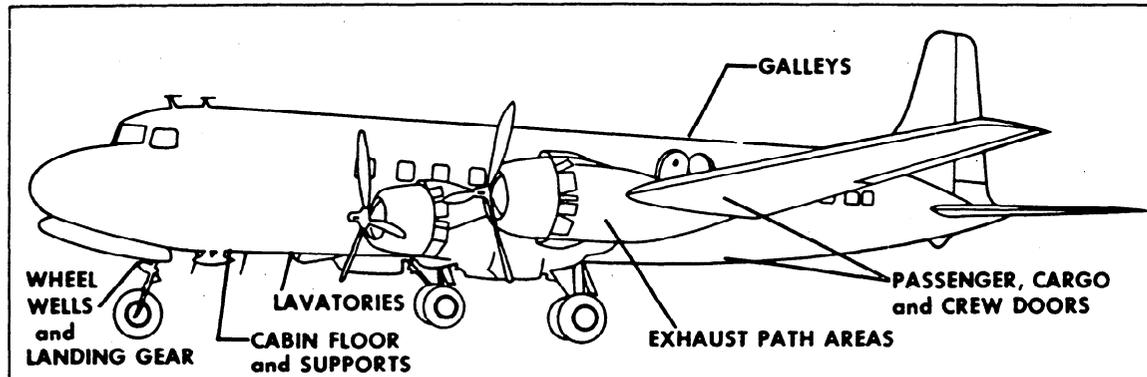
**FIGURE 2 - AREAS SUBJECT TO CORROSION DAMAGE**

- (1) Exhaust path areas.
- (2) Battery areas and vents.
- (3) Lavatories, galleys, and cabin floors.
- (4) Wheel wells and landing gear.
- (5) Joints between extruded aluminum sections and laminations.
