SPECIAL CERTIFICATION REVIEW

Eclipse Aviation Corporation Model EA500 Airplane

September 12, 2008

*Prepared for the Federal Aviation Administration
Associate Administrator for Aviation Safety*

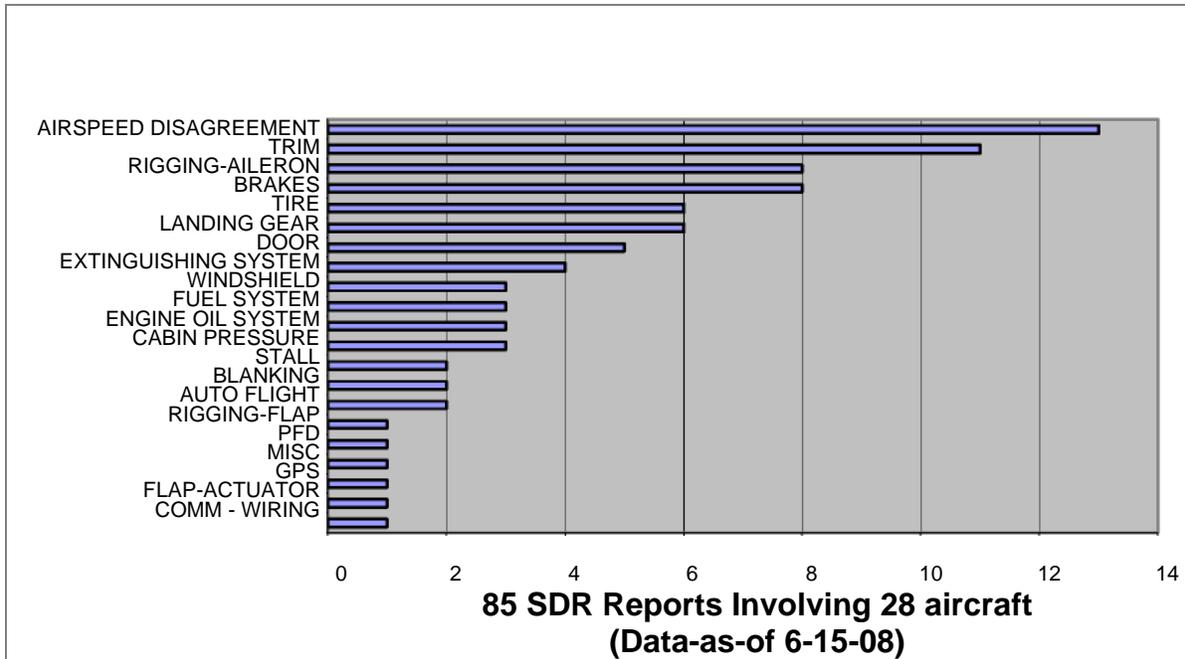
Figure 4—Eclipse 500 SDR Classification

The SDR data was classified into general categories to help identify trends and records pertinent to the SCR Team's four focus areas. The 85 events were classified into 21 categories, which are shown in figure 4. Of these categories, the highest number of reports (13 reports) involved "airspeed disagree" messages displayed on the PFD, with the next highest report count (11 reports) related to the airplane's trim systems. It should be noted that these categories should not be considered definitive because some of the categories are interrelated. For example, an aileron rigging issue could manifest itself as a trim issue or vice versa.

The SDR data contained two reports characterized as blanking events. However, complete loss of the display was not indicated in either report. One event involved smoke from the MFD, followed by dimming of the display. The second event involved pixelation of the PFD on final approach. In both cases, the displays were replaced to correct the problem.

A review of the SDRs revealed a large number of aileron/roll trim problems, several pitch trim problems, and a single rudder trim event. Several of the aileron/roll trim issues were related to excess friction and aileron rigging; the root cause of the pitch/rudder trim issues has not been established, but they seem to be related to the reliability of the actuators.

The largest reported category in the SDR data was airspeed disagree (13 airspeed disagree events were reported). Airspeed disagree events were not experienced during certification flight testing. During initial certification, the airplane was predominately flown in a dry climate and in visual meteorological conditions. Subsequent in-service experience identified water contamination issues with the pitot static system as a source of airspeed disagree issues. The FAA and Eclipse have implemented some mitigations and are continuing to address this issue.
