Report Number NTSB/AAR-86/02

Report Title Air Canada Flight 797, McDonnell Douglas DC-9-32, C-FTLU, Greater Cincinnati International Airport, Covington, Kentucky, June 2, 1983 (Supersedes NTSB/AAR-84/09)

Report Type Aircraft Accident Report June 2, 1983

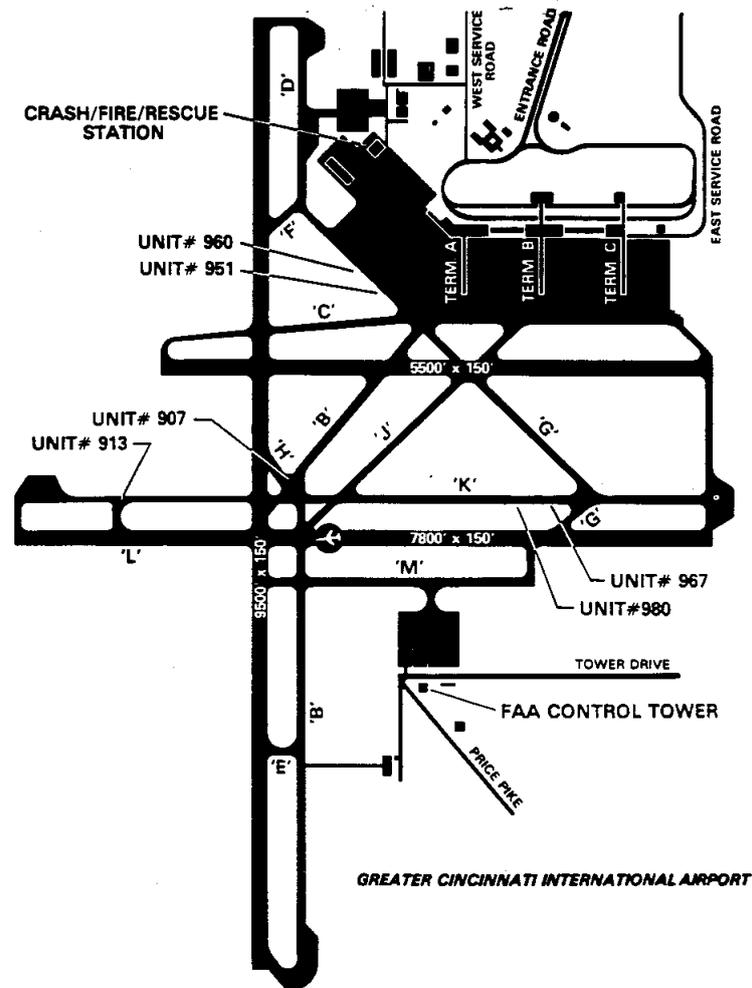
Figure 1.—Standby Positions of Crash/Fire/Rescue Units.

At 1913:38, after Flight 797 was unable to tell him its heading because its heading instruments were inoperative, the approach controller asked the flight to turn left. The controller said that this was an identification turn and that it was also designed to place the airplane closer to the airport. At 1914:03, after observing the target in a left turn, the approach controller said that Flight 797's primary target was now "fully identified." He then told the flight that this was a "no gyro"⁵ radar approach for runway two seven left... and cleared it to descend to 3,500 feet. He then told the flight that it was 12 nmi southeast of the Cincinnati Airport, cleared it to land on runway 27L, and informed it that the surface wind was 220° at 4 knots. He informed the tower of the change of landing runways and the tower directed the fire department to position its vehicles along runway 27L. (See figure 1.)

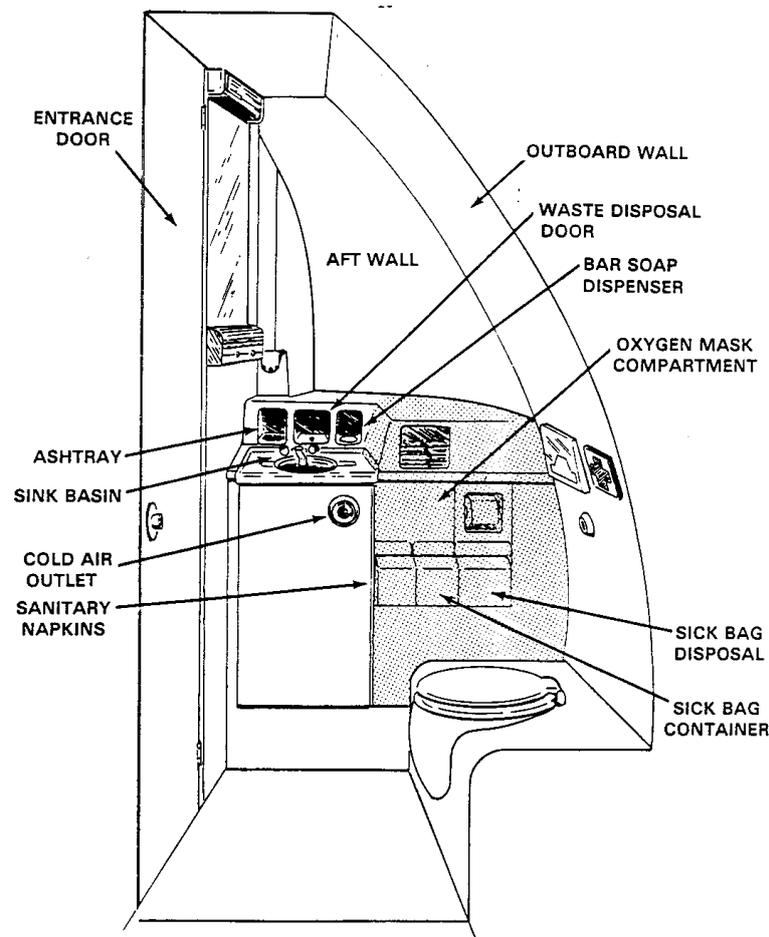
Figure 9.--Diagram of aft lavatory, viewed aft.

The aft lavatory was on the left side of the cabin, and began at FS 965 and extended aft to FS 1019, or just forward of the aft pressure bulkhead. The lavatory's outboard wall conformed essentially to the shape of the airplane's fuselage. There was a vanity section containing a stainless steel sink and amenities located along and extending forward from the aft wall. The commode containing a flushing motor was located along the lavatory's outboard wall. A trash chute and container were located below and behind the sink, and a fresh air supply outlet was positioned below the sink in the door of the vanity. Also, below the trash container, an aluminum shelf was installed. In addition, there was an oxygen outlet located in the oxygen mask compartment in the amenities section. (See [figure 9](#) and [figure 10](#).)

The aft lavatory was damaged extensively by fire and heat. Most of the lavatory's interior walls had been burned away. The entry door, which had been kept closed, was destroyed except within 16 inches of the floor. The aft pressure bulkhead and fuselage skin which comprised the outermost portion of the lavatory enclosure were intact, but were buckled and discolored to dark brown.

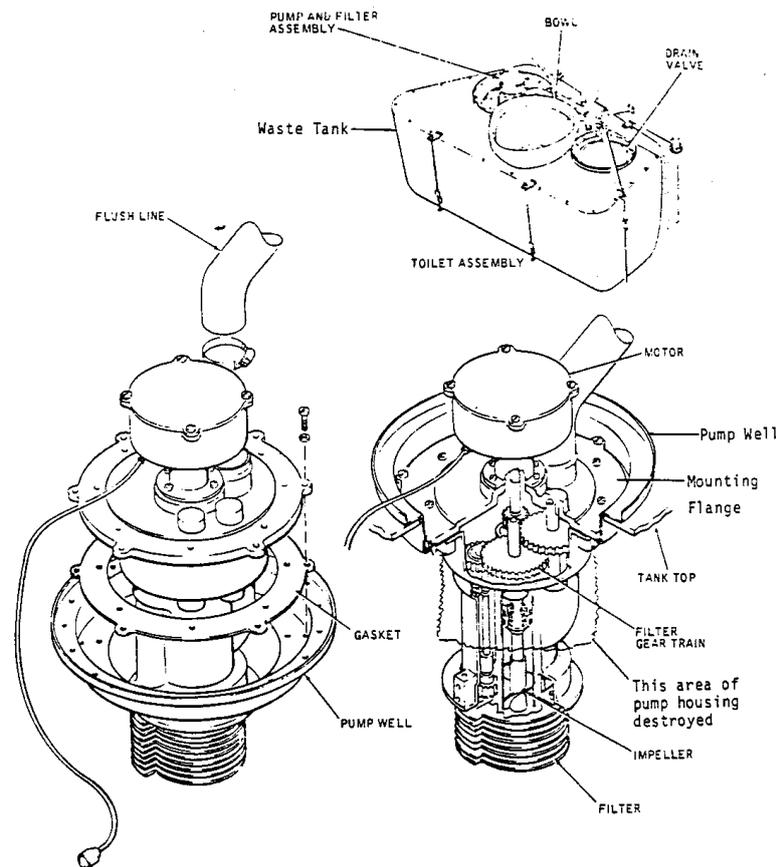
Figure 11.—Lavatory pump and filter system.

The flush motor was found attached to its mounting flange which was attached to the pump well. The flush motor assembly was found in approximately its normal position in the waste tank next to, but detached from, the flush pump and filter assembly. The motor housing was completely melted. Large concentrations of molten metal were found on the forward side of the mounting flange facing the toilet bowl, and on the aft side where the 3-phase electrical leads enter the motor housing. A portion of the wiring harness which supplies a.c. power to the flush timer, flush motor, and flush button was encased in the molten metal on the aft side of the motor. The rotor section of the flush motor was encased in molten metal above the field windings; however, the rotor did not appear to have been damaged extensively by heat. [\(See figure 11\).](#)

The flush pump and filter assembly found in the waste tank was partially intact. The filter and pump mechanisms, which apparently had been located below the water line in the waste tank, were in good condition. Above the water line, the plastic housing for the pump and filter was melted away. This housing also encloses the filter gear train and is part of the assembly used to mount the pump and filter to the pump well. The exposed shaft and gears showed heat damage. The gears, which make up the filter gear train that connects the motor to the pump and filter, were found lying in the waste tank. The plastic mounting ring, which mates the pump and filter housing to the pump well, was found intact among the debris in the waste tank. There was some slight melting of the top surface of the mounting ring. All of the components of the flush motor and pump assembly were removed for further examination.

When the flush motor and its associated mounting were removed from the toilet tank, two wires in the motor harness and all of the wires in the power harness broke just aft of the motor housing due to brittleness. To facilitate removal of the flush motor assembly, the remaining wires of the motor harness were cut a few inches aft of the motor housing and tagged for identification.

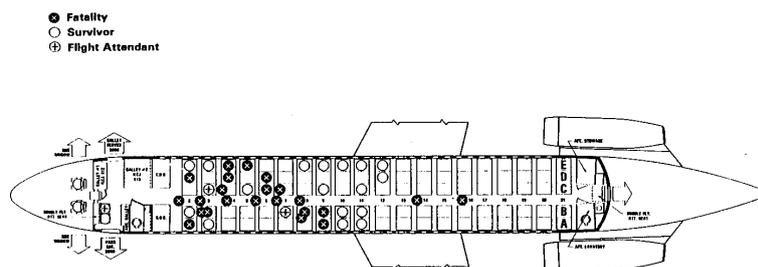
Figure 12.—Diagram of passenger seat locations.

(Denotes Location of Survivors Before Leaving Airplane and Location of Fatalities After the Accident)

Except for two fatalities found in the aisle at rows 14 and 16, the majority of the fatalities were found either in the aisle or seated in rows 2 through 9. [\(See figure 12\)](#) The fatalities at rows 14 and 16 had been seated in seats 8-B and 9-B, respectively.
