Report Number NTSB-AAR-82-8

Report Title Air Florida, Inc., Boeing 737-222, N62AF, Collision with 14th Street Bridge, Near Washington National Airport, Washington, D.C., January 13, 1982.

Report Date August 10, 1982

Organization Name National Transportation Safety Board Bureau of Accident Investigation Washington, D.C. 20594

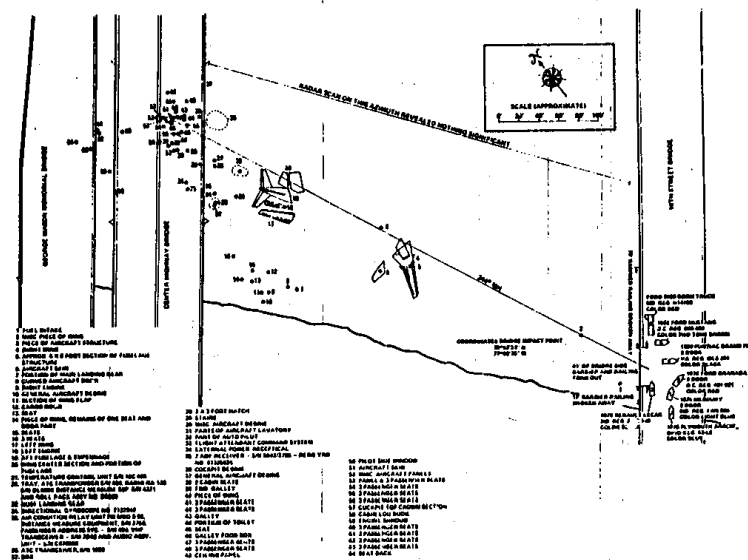
Figure 4. -- Position of Wreckage in the Water.

As the aircraft descended, the right wing was structurally damaged when it hit the boom truck, and shortly thereafter, the aircraft struck the steel barrier and railing on the west side of the 14th Street Bridge at an elevation of about 37 feet mean sea level. Fragments of the right wing remained on the bridge. The remainder of the wreckage sank in the Potomac River in about 25 to 30 feet of water. The wreckage area was confined to the south side of the river between the 14th Street Bridge and the Center Highway Bridge of the George Mason Memorial Bridge. (See figure 4.)

After initial impact, the aircraft broke into several major pieces. The fuselage broke into four major pieces which included: (1) nose section with cockpit; (2) fuselage section between nose section and wing center section; (3) fuselage-to-wing intersection; and (4) aft body structure with empennage attached. The wing structure was separated into three major pieces which included: (1) left wing outboard of the No. 1 engine, including all associated flight control surfaces; (2) wing center section, lower surface, including wing lower surface stubs between the No. 1 engine mounts and the No. 2 engine mounts; and (3) right wing outboard of the No. 2 engine with the outboard 20 feet mostly disintegrated. The left main landing gear was separated from the wing, and the right main gear remained attached except for the wheels and oleo piston. The nose landing gear and its attaching structure were separated from the nose section. Both engines and their pylon structures were separated from the wings. There was no evidence of fire on any of the recovered structure.

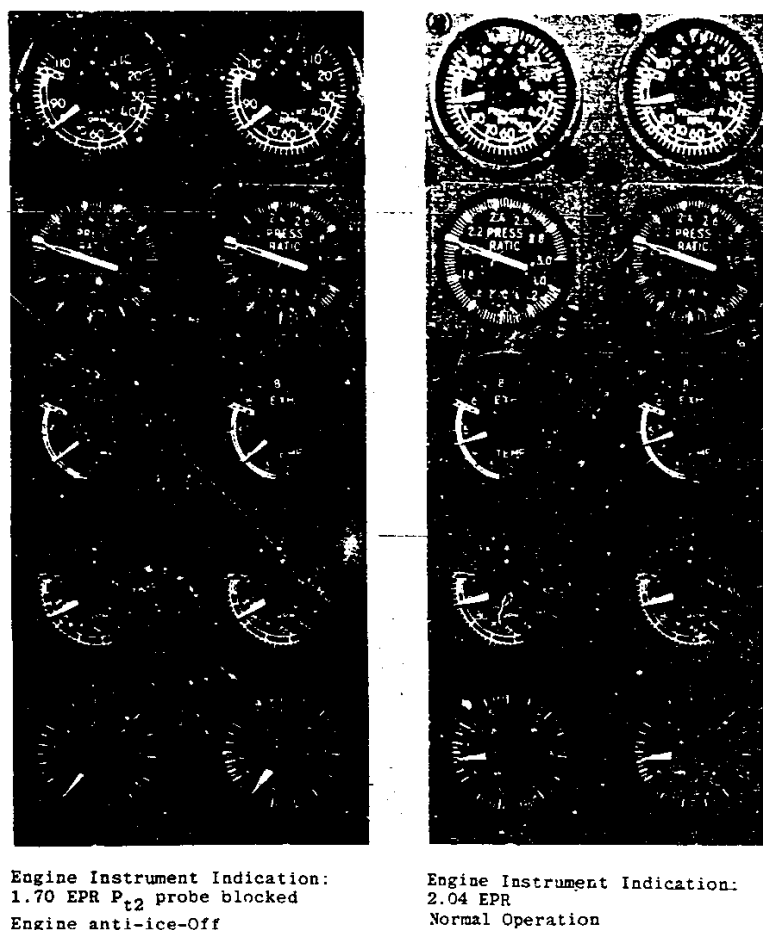
Figure 6.—Comparison of Instrument Readings -- 1.70 HPR vs. 2.04 EPR.

With the engine operating, a false indication of the actual EPR can be indicated in the cockpit when ice blocks the inlet probe. Under this condition, the P_{t_2} probe is vented to the nose cone pressure through a siphon-break hole in the sense line. The interior of the engine nose cone is vented to the engine inlet static pressure, which is lower than the engine inlet total pressure normally sensed by the P_{t_2} system. Under severe icing conditions, if the engine inlet anti-icing air bleed system is shut off and the normal P_{t_2} sensing port is blocked with ice, the P_{t_2} sensor will sense the lower pressure at the vent port in the nose cone. The cockpit indication may become slightly erratic as icing begins to block the probe and will indicate a significantly higher reading when ice fully blocks the probe. Tests have demonstrated that with a blocked probe at takeoff, engine power can indicate an EPR of about 2.04 with the engine actually operating at an EPR ratio of 1.70. Under these circumstances, a pilot would unknowingly attempt takeoff at a considerably lower thrust than desired. However, the pilot has available other indications of engine operation displayed in the cockpit, such as a lower N_1 , N_2 , EGT, and F/F consistent with the reduced engine thrust. [\(See figure 6.\)](#)

Should the pilot activate the engine inlet anti-icing system with a blocked probe, he would immediately notice a substantial drop in the indicated EPR, incorrectly indicating a low engine thrust as long as the normal P_{t_2} sensing port remains blocked. This results from the introduction of engine anti-icing air flow into the nose cone and resultant increase in the pressure in the interior of the nose cone. This pressure is higher than that which would be sensed at the normal P_{t_2} port. Falsely low indicated EPR's have been detected by pilots when they found that they were unable to set takeoff power without exceeding redline N_1 , N_2 , and EGT.
