09/11/91 Britt Airways, Inc., d/b/a Continental Express

Official Accident Report Index Page

BRITT AIRWAYS, INC., d/b/a CONTINENTAL
EXPRESS FLIGHT 2574 IN-FLIGHT STRUCTURAL
BREAKUP EMB-120RT, N33701 EAGLE LAKE,
TEXAS SEPTEMBER 11, 1991

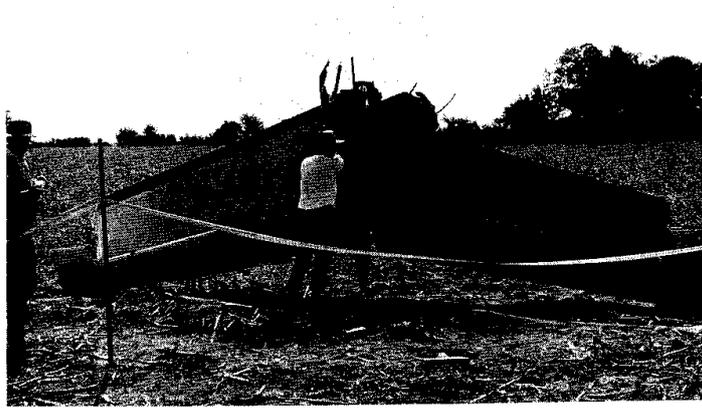
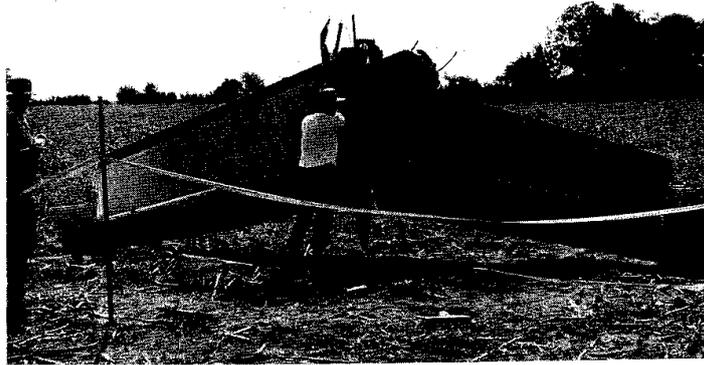
During the Safety Board's examination of the wreckage, none of the 47 screws that would have attached the upper surface of the leading edge assembly for the left side of the horizontal stabilizer was found. There was no evidence of distress in the upper attachment holes for the left side leading edge assembly or indication that the attaching screws were installed when the left side leading edge assembly separated from the horizontal stabilizer. In addition, a "lip" was formed on the forwardmost frame on the left lower side of the horizontal stabilizer spar cap. That frame (spar cap), with receptor holes for the lower attaching screws, was the area into which the screws mounted the underside of the left side leading edge assembly to the stabilizer. This lower frame area showed signs of distress. [Figure 1a](#), [figure 1b](#), [figure 1c](#), [figure 1d](#) show the condition of the left horizontal stabilizer leading edge.

Figure 1a.--View of horizontal stabilizer from underside.

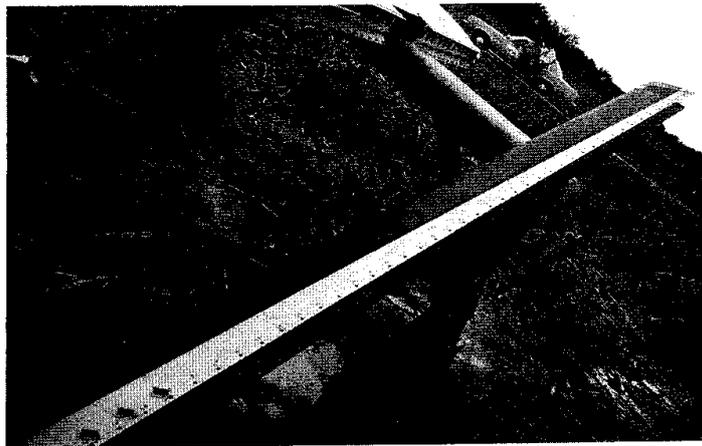
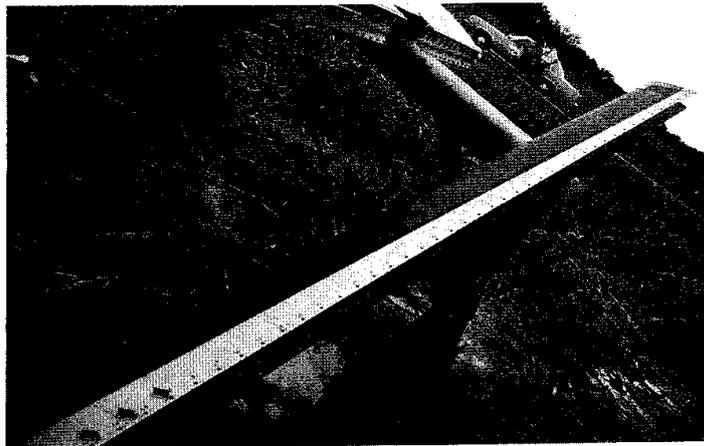
The lower attachment screws remained installed, but the leading edge assembly had separated from the stabilizer, with the exception of a small portion of composite structure remaining below the two farthest inboard screw heads. The spar cap on the lower left side of the horizontal stabilizer showed evidence of being pulled down so that it would project into the wind stream along with the leading edge. This pulling damage is consistent with the left side leading edge assembly having been ripped down and away from the lower attaching screws as it separated from the horizontal stabilizer. This evidence was consistent with screws missing on the top side of the left leading edge assembly, and the lower attaching screws holding fast, pulling down the frame (spar cap) on the lower side of the stabilizer, and thereby forming the lip.

Figure 1b.--Leading edge assembly and outboard portion of left side of horizontal stabilizer.

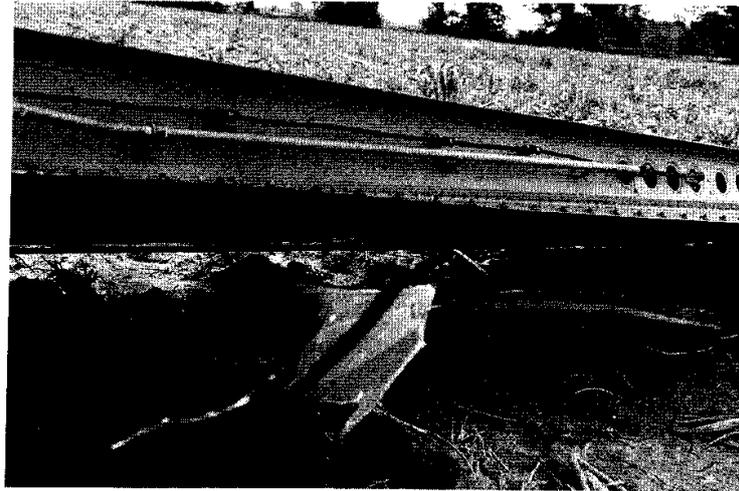
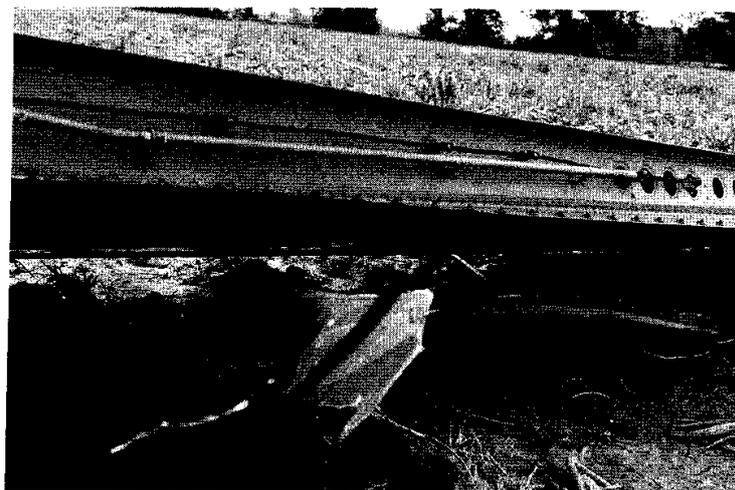
Figure 1c.--Front frame of left side of horizontal stabilizer with lower screw attaching area angled downward.

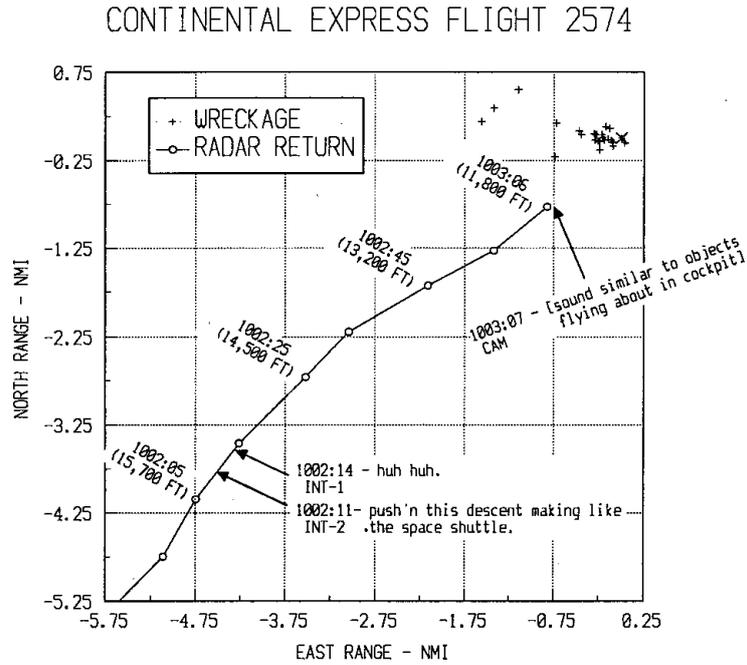
The airplane was flying to the northeast on a 44-degree heading at the time radar contact was lost at 1003:06 CDT. [Figure 2](#) shows the radar-derived ground track of flight 2574, selected sounds from the CVR, and the wreckage distribution.

Figure 2.--Radar-derived ground track, CVR sounds, and wreckage distribution.

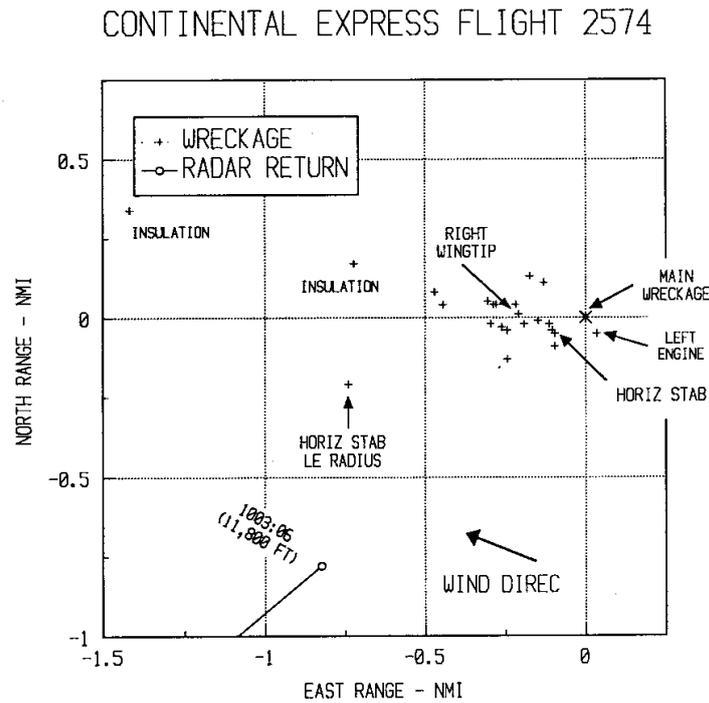
[Figure 3](#) provides a closeup view of part of the ground track and wreckage distribution. The piece of airplane structure farthest from the main wreckage was the left side leading edge (LE) of the horizontal stabilizer. The LE was the first piece of structure along the flight's northeasterly ground track, preceding the next piece by roughly 1/2 of a nautical mile.

Figure 3.--Closeup view of part of ground track and wreckage distribution.

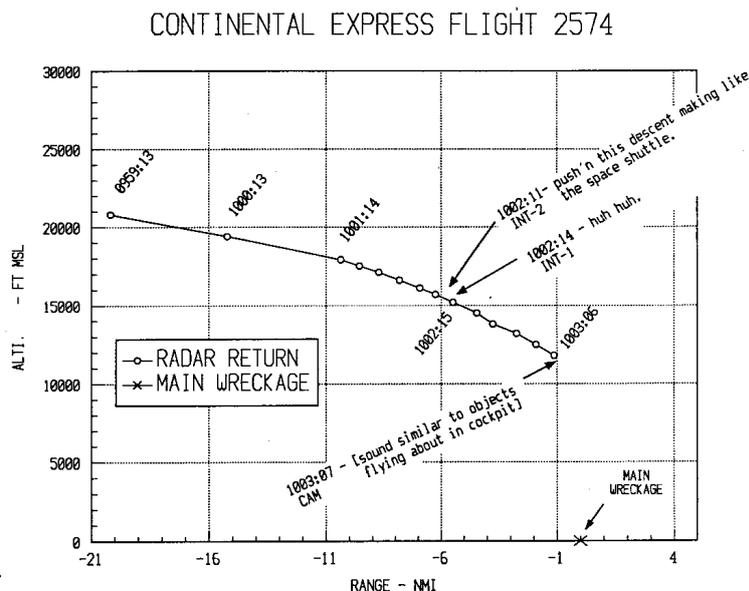
Figure 4 shows the radar-derived descent profile. The last radar contact occurred as flight 2574 was descending through 11,800 feet. The radar-derived rate of descent during the final minute was approximately 4,000 feet-per-minute, which is consistent with FDR data from the airplane.

Figure 4.--Radar-derived descent profile.
