02/28/84 Scandinavian Airlines System

Official Accident Report Index Page

Report Number	NTSB/AAR-84/15
Access Number	PB84-910415
Report Title	Scandinavian Airlines System Flight 901 McDonnell Douglas CD-10-30 Norwegian Registry LN-RKB John F. Kennedy International Airport Jamaica, New York, February 28, 1984
Report Date	November 15, 1984
Organization Name	National Transportation Safety Board Bureau of Accident Investigation Washington, D.C. 20594
WUN	3894-A
Sponsor Name	NATIONAL TRANSPORTATION SAFETY BOARD Washington, D. C. 20594
Report Type	Aircraft Accident Report February 28, 1984
Distribution Status	This document is available to the public through the National Technical Information Service Springfield, Virginia 22161
Report Class	UNCLASSIFIED
Pg Class	UNCLASSIFIED
Pages	85
Keywords	Landing accident, autothrottle speed control system, crew overreliance, crew procedures, wind shear.

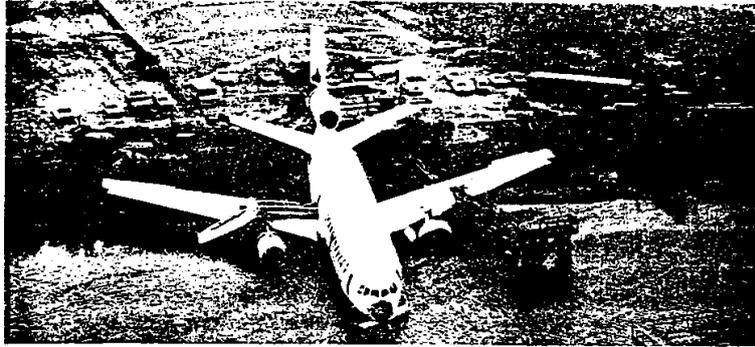
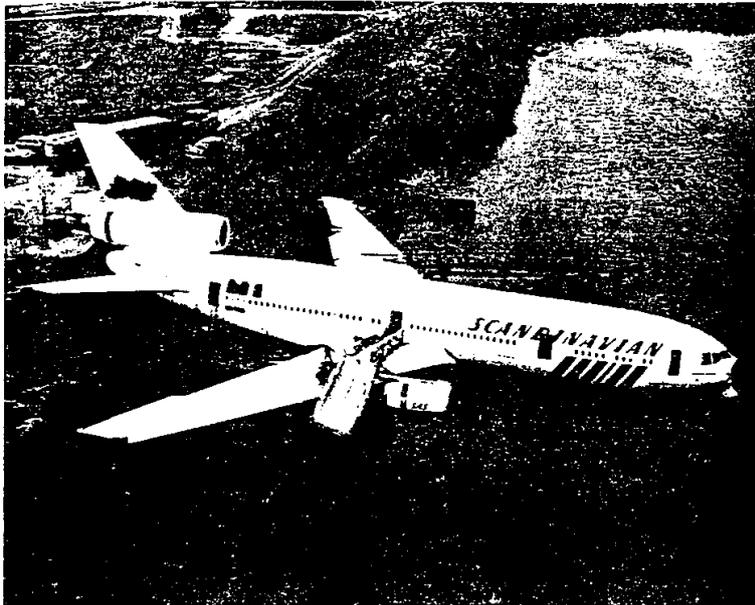
Figure 2.--Flight 901 gt rest in Thurston Basin.

The forward section of the airplane fuselage came to rest in Thurston Basin, a tidal waterway about 600 ft (182.88 meters) from the runway 4R departure end. The airplane was damaged substantially.[\(See figure 2.\)](#) The captain immediately began to execute the memory items of the "On-Ground Emergency Check List." However, neither he nor the systems operator could move the engine fire selectors or fuel cutoff levers to their full off positions.

The approach light structure for runway 22R was damaged substantially from contact with the left wing.

The aft portion of the fuselage remained generally intact. There was major damage at the lower nose area, to the radome, and to the forward pressure bulkhead at fuselage station (FS) 275. The nose landing gear structure had collapsed under the fuselage. The drag braces were fractured and had separated from their attachment fittings. The interior of the forward fuselage area was deformed and exhibited fractures at the flight deck and galley floor locations. Several floor beams below the galley floor were fractured and twisted.

The wings, leading edge slats, and flaps sustained moderate damage from impact with the wooden pier structure. The leading edge slats were extended fully and the trailing edge flaps were extended to the 40° position.
