09/20/81 World Airways, Inc.

Official Accident Report Index Page

Report Number	NTSB-AAR-82-1
Access Number	PB82-910401
Report Title	Airways Inc., Flight 32, McDonnell Douglas DC-10-30CF, N112WA, Over North Atlantic Ocean, September 20, 1981.
Report Date	January 12, 1982
Organization Name	National Transportation Safety Board Bureau of Accident Investigation Washington, D.C. 20594
WUN	3378A
Sponsor Name	NATIONAL TRANSPORTATION SAFETY BOARD Washington, D. C. 20594
Report Type	Aviation Accident Report
Sup Notes	The subject report was distributed to NTSB mailing lists: 1A, 8A and 8B.
Distribution Status	This document is available to the public through the National Technical Information Service-Springfield, Virginia 22161 (Always refer to number listed-in item 2)
Report Class	UNCLASSIFIED
Pg Class	UNCLASSIFIED
Pages	54
Keywords	DC-10, galley lift system, design deficiencies, operations procedures.
Abstract	About 0245 G.m.t. on September 20, 1981, a flight attendant on board World Airways Flight 32, a DC-10-30CF, was fatally injured as a result of being trapped between a service cart in the galley personnel lift and the ceiling of the lower galley as the lift raised. There were 331 reve

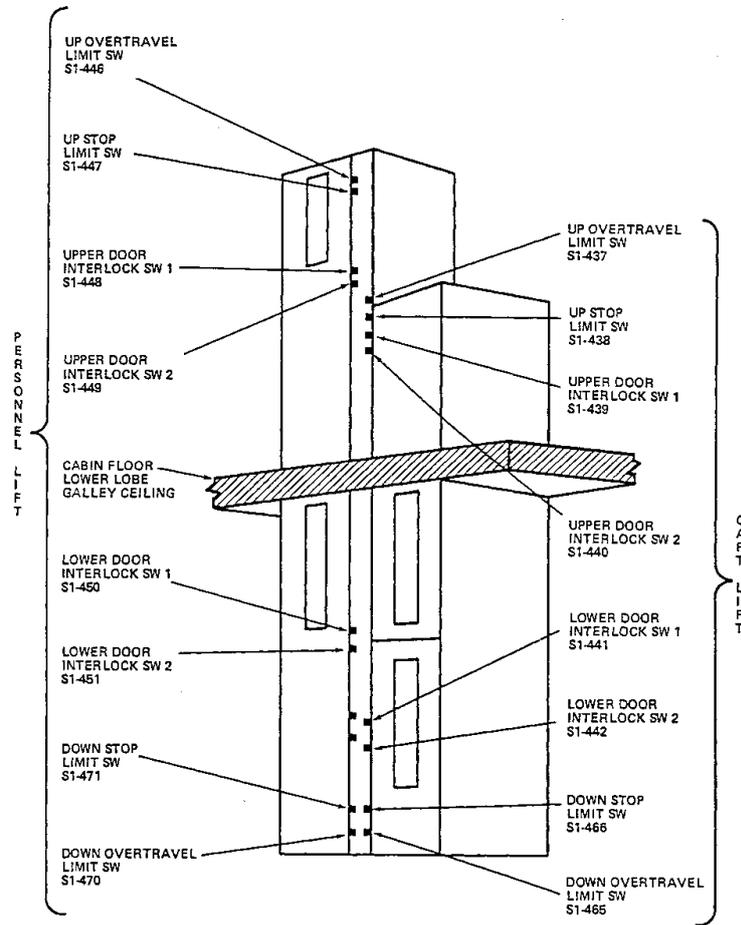
Figure 1.--Galley lift system with electrical switch locations.

Limit Switches - The range of travel of the lifts is controlled by limit switches installed within the wire duct attached to the forward side of one of the vertical lift tracks. There are two sets of two limit switches for each lift; one set located in the service center and one set in the lower galley. One switch is a normal stop switch and the other limit switch is for overtravel in the event the normal switch fails to operate. The limit switches are actuated by a cam plate mounted on the side of the lift. The cam plate has a machined offset to prevent actuation of the overtravel limit switch unless the normal switch fails to operate. In addition to the limit switches, mechanical stops are installed in the vertical lift tracks to stall and shut off the gear motors if both limit switches malfunction. (See figure 1.)

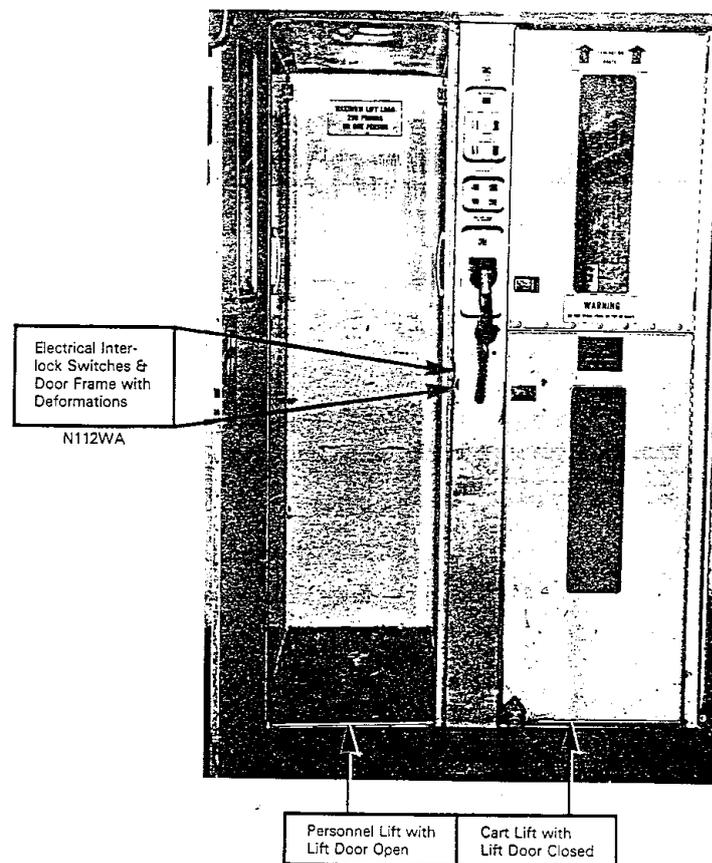
Figure 2.--Personnel and cart lifts.

The lower galley personnel lift door frame was deformed and battered in the area where the electrical interlock switches are mounted(see [figure 2](#)). The uppermost electrical interlock switch on the lower galley personnel lift door, S1-450(see [figure 1](#)), was found with the switch roller assembly twisted and the roller striker arm jammed in the depressed (switch closed) position. The damage to the lower galley lift door frames was the result of repeated bumping by food and liquor carts.

Require a redesign of the DC-10 aircraft galley personnel and food cart lift doors and door frames to relocate the interlock switches to a position where they will not be susceptible to damage by food service carts, to inadvertant contact by personnel attempting removal of food service carts, and to contamination by foreign substance. (Class I, Urgent Action) (A-81-126)

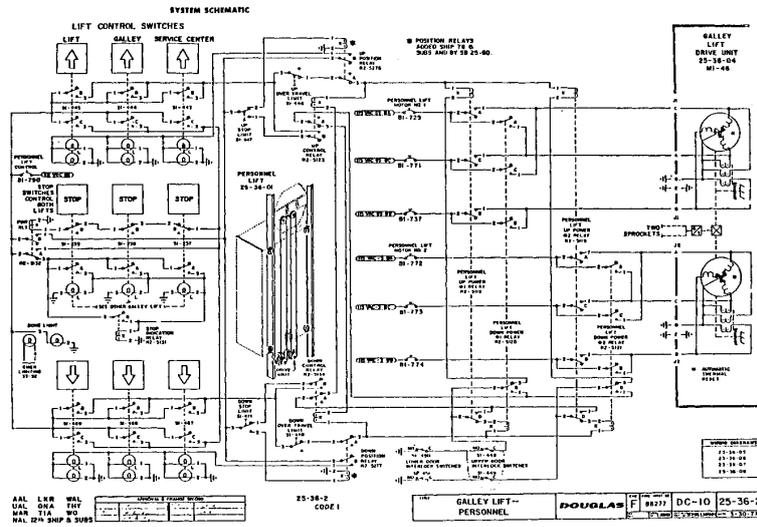
Figure 4.--Electrical diagram of galley personnel lift system.

Alternate Circuit - Each lift has two independent circuits to provide power to the system. Normally, both circuits operate; however, if an electrical malfunction occurs in one of the two circuits, the system should continue to operate at half (or partial) speed, thus allowing continuation of food service. Each system has its own set of upper and lower door interlock switches and its own up and down power relay. In addition, these components in each system are wired to up and down control relays common to both system. (See figure 4.)

Require the modification of the switch circuitry in the DC-10 aircraft galley lift system to accord the "Stop" switch function priority over all other control switch functions. (Class II, Priority Action) (A-82-2)

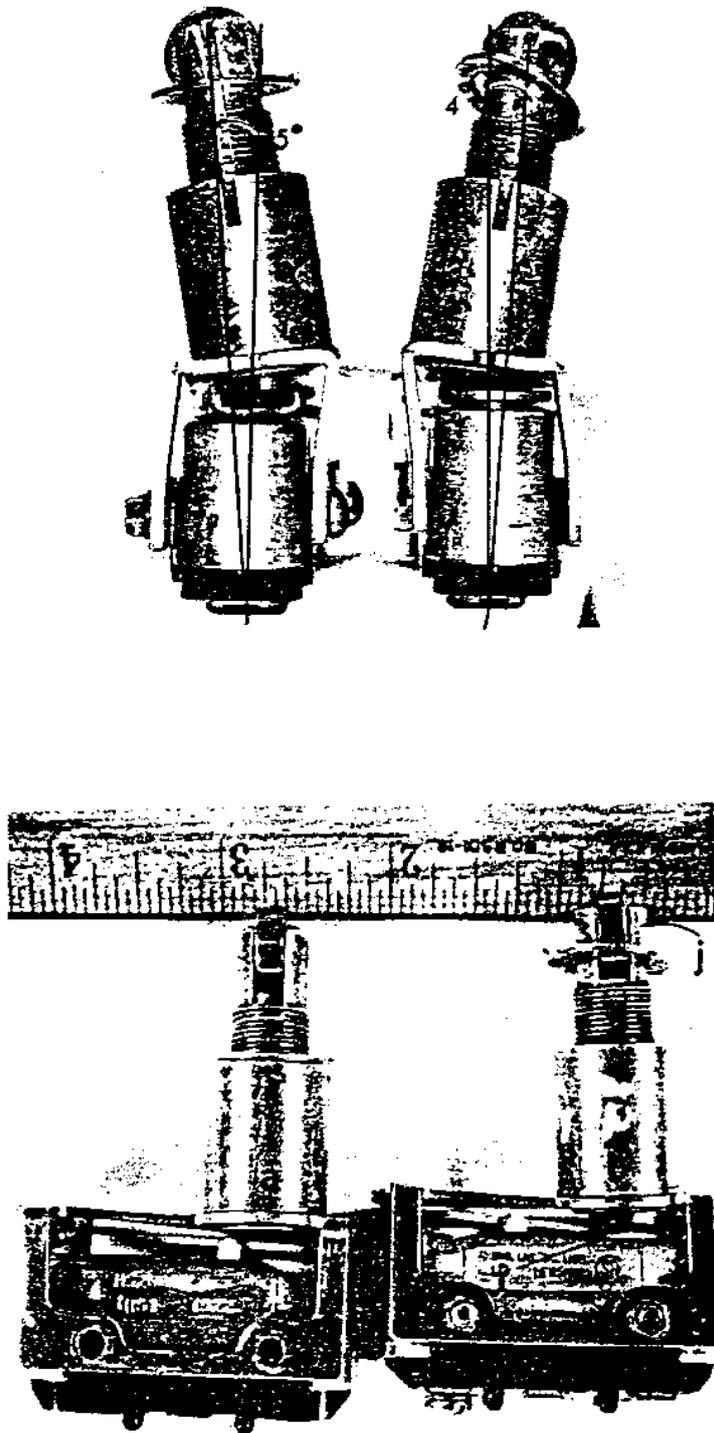
Figure 6.--Side view of S1450 (a) and S1-451 (b) switch assemblies, showing degree and directions of bending.

Examination of the two personnel lift door interlock switch assemblies in the lower galley disclosed that the support brackets were bent. The bends were in a rearward direction and were 5° from centerline for the upper switch (S1-450) and 4° from centerline for the lower switch (S1-451). (See [figure 5](#) and [figure 6](#).)

Other malfunctions of the interlock switches have been caused by mechanical damage. It was found that the door jamb and door frame structure on the lower level galley personnel lift is subject to repeated contacts by galley carts in the general area where the interlock switches are located. Examination of the galley lift door interlock switch assemblies revealed bending of the support brackets in a rearward direction.

In this accident, the Safety Board concludes that the deformation and subsequent jamming of the upper electric interlock switch (S1-450) on the lower galley personnel lift door was the direct result of damage to the door jamb area where the switches were mounted from recurrent contacts by galley carts. Although the deformation of the lower switch (S1-451) was of a lesser degree than that of the upper switch, the Board concludes that the damage to this switch was sustained under similar circumstances and caused intermittent jamming in the "closed" position. This conclusion is based on the results of the operational check at Gatwick after the accident, which disclosed lift operation at a normal speed with the lower galley personnel lift door open and the upper service center personnel lift door "closed." Electrical power to both personnel lift AC motors would have been necessary to cause the lift to operate at normal speed. This could only occur if both switches were closed. The results of the metallurgical examination of the switch assemblies further corroborate a probable malfunction of both switches at the time of the accident. The catering representative's statement that the lower galley lift door interlock switches had to be depressed in order to operate the lift cannot be reconciled with other evidence developed during the investigation.

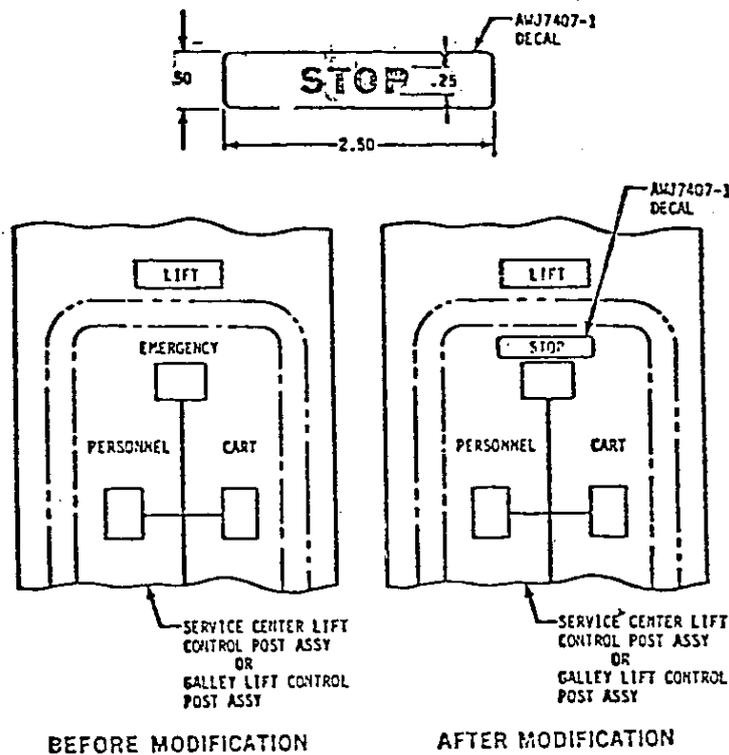
Analysis at DAC revealed the EMERGENCY terminology on the service center and lower galley lift stop switch placards is unsatisfactory. This condition exists due to the ability of the lift UP or DOWN switches to override the EMERGENCY stop switches. The word EMERGENCY is used to denote absolute priority over any normal operational modes. Present configuration permits the UP or DOWN operating switches to override the EMERGENCY switches, thereby invalidating the emergency mode. Installation of a STOP placard over the word EMERGENCY will provide the proper switch terminology and indicate the true function of the switches.

A. Fabricate two decals as shown, letters to be black on aluminum background.

B. Identify each decal as AWJ7407-1 per operator's shop practice.

C. Install AWJ7407-1 decals over engraved word EMERGENCY on service center lift control post assembly and galley lift control post assembly per operator's shop practice.
