04/28/88 Aloha Airlines

Official Accident Report Index Page

Report Number	NTSB/AAR-89/03
Access Number	PB89-91C404
Report Title	Aircraft Accident Report--Aloha Airlines, Flight 243, Boeing 737-200, N73711, near Maui, Hawaii, April 28, 1988
Report Date	June 14, 1989
Organization Name	National Transportation Safety Board Bureau of Accident Investigation Washington, D.C. 20594
WUN	4886A
Sponsor Name	NATIONAL TRANSPORTATION SAFETY BOARD Washington, D.C. 20594
Report Type	Aircraft Accident Report April 28, 1988
Distribution Status	This document is available to the public through the National Technical Information Service, Springfield, Virginia 22161
Report Class	UNCLASSIFIED
Pg Class	UNCLASSIFIED
Pages	262
Keywords	decompression; disbonding; fatigue cracking; corrosion; multiple site damage (MSD); FAA surveillance; maintenance program; nondestructive inspection
Abstract	<p>On April 28, 1988, at 1346, a Boeing 737-200, N73711, operated by Aloha Airlines Inc., as flight 243, experienced an explosive decompression and structural failure at 24,000 feet, while en route from Hilo, to Honolulu, Hawaii. Approximately 18 feet of the cabin skin and structure aft of the cabin entrance door and a

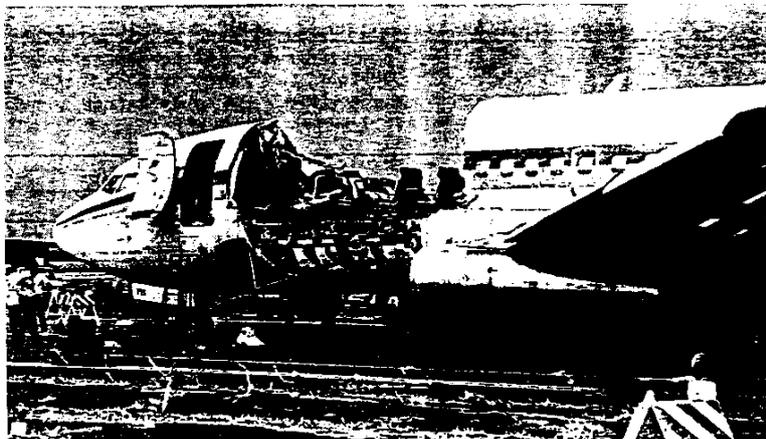
A major portion of the upper crown skin and structure of section 43 separated in flight causing an explosive decompression¹ of the cabin. (See [figure 1](#) and [figure 2](#).) The damaged area extended from slightly aft of the main cabin entrance door, rearward about 18 feet to the area just forward of the wings and from the left side of the cabin at the floor level to the right side window level.

Figure 2a.--General view, left side of forward fuselage, N73711

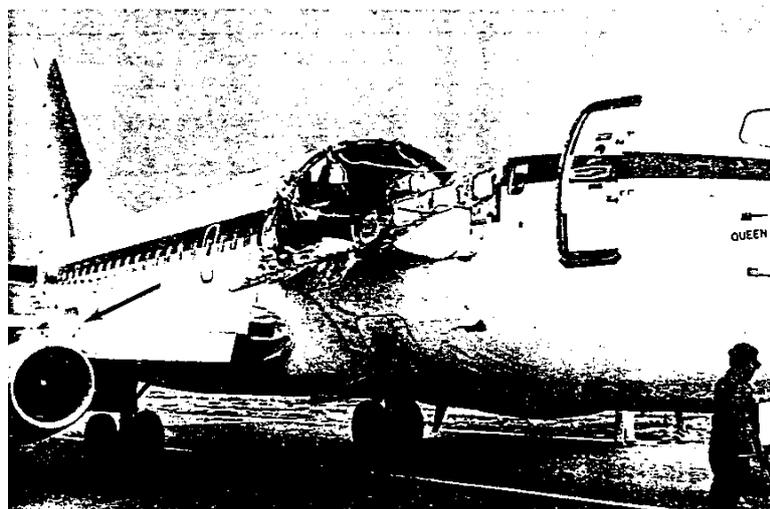
Figure 2b.--General view, right side of forward fuselage, N73711. Arrow marks fragments of S-4R lodged in the leading edge flap.

A fuselage section from BS 365 to BS 420 between S-4R and S-8R was trapped between the leading edge flap and inboard side of the right engine strut. This was the only significant piece of structure from the damaged area that was recovered. The recovered piece contained two skin repairs along S-4R. This section and several samples cut from the remaining fuselage skin were submitted to the Safety Board's Materials Laboratory for further analysis. (See 1.16.3 Materials Laboratory Analysis.)
