Report Number NTSB-AAR-79-17

Report Title American Airlines, Inc. DC-10-10, N110AA, Chicago-O'Hare International Airport Chicago, Illinois, May 25, 1979

Report Date December 21, 1979

Organization Name National Transportation Safety Board Bureau of Accident Investigation Washington, D.C. 20594

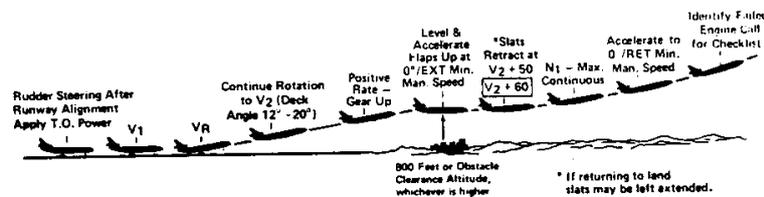
Figure 14. Diagram of AAL emergency procedure.

If an engine failure occurs when making a Standard Thrust take-off, Standard Thrust on the remaining engines will produce the required take-off performance. If deemed necessary, the remaining engines may be advanced to Maximum Take-Off Thrust.

On July 23, 1979, American Airlines issued Operations Bulletin No. DC-10-73 which amended the procedure. The bulletin states, in part:
