# 09/22/81 Eastern Airlines

**Report Number** NTSB-AAR-82-5

**Report Title** Eastern Airlines Flight 935, Lockheed L-1011-385, N309EA, Near Colts Neck, New Jersey, September 22, 1981.

**Report Type** Aircraft Accident Report September 22, 1981

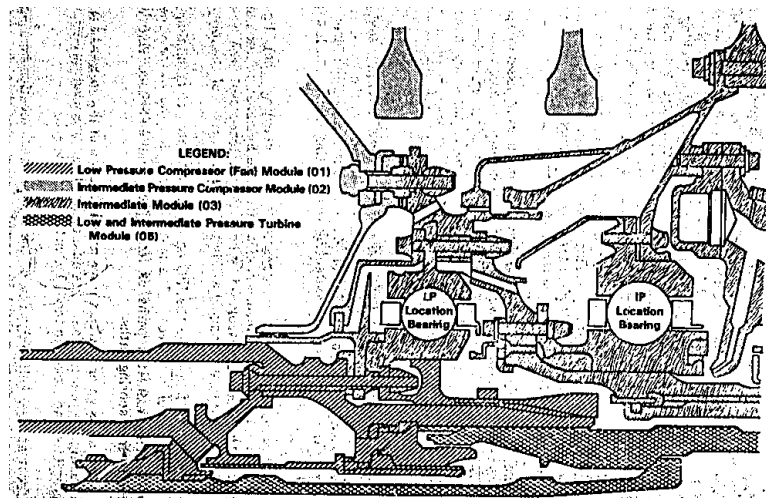
**Figure 4. -- RB-211-22B Module Arrangement.**

The compressor rotor shaft has five titanium discs in the forward section and two steel discs forming the rear section. Titanium rotor blades are used throughout. The rear stub shaft is splined and locked to the IPT shaft. (See figure 4.)

The front air seal knife edge fins of the low-pressure location bearing (LPLB) air and oil seal were rubbed down to about 50 percent of their normal height; the fins had rubbed against the IPC rear stubshaft coupling.

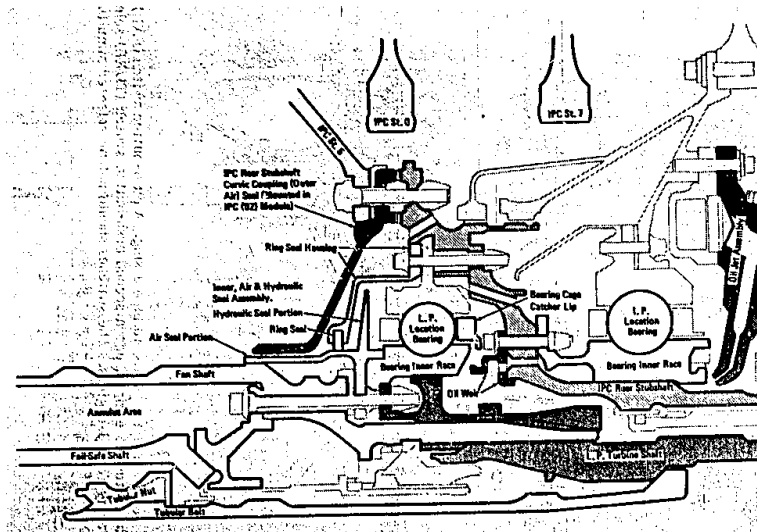
Figure 5. -- Installed Position of Components Associated with LPLB Failure.

The outer surface of the LPLB ring seal housing was heavily heat damaged and was dry. Heat produced by the rubbing had discolored the inner diameter of the ring seal housing. Heat discoloration was greatest at the housing's inner portion near the ring seal. The piston ring was seized in its seal locating groove. Evidence of oil leakage was observed between the abutment faces of the IPC rear stubshaft and the LPLB oil weir and between the abutment faces of the intermediate pressure location bearing (IPLB) inner race front flange and the IPC rear stubshaft.

The low-pressure location bearing had deteriorated from intermittent spalling of the bearing's outer race that encompassed 250° of its circumference. The area of apparent fatigue spalling was biased toward the rear side of the

bearing's race track. The profile of the LPLB's inner race track was worn heavily and was elongated axially to a width of 1.250 to 1.375 inches; the forward and rear lands of the inner race adjacent to the track profile were also heavily worn. The bearing cage was extensively overheated. The bearing location lands were worn and the bearing cross grooves were filled with debris. The front half of the bearing cage was heavily rubbed on its front face from contact with the base of the hydraulic seal fin. Molten material produced from the inner track/ball wear and breakup had been deposited onto the front half cage bore for 160° of its circumference. The edge ball pockets were heavily worn. The rear oil catcher lip was distorted rearward from rear and rearward movement of the inner race; it had come in contact with the retention bolt heads of the low pressure location bearing oil weir. The main surface areas of the location bearing balls showed minor primary skidding type damage with wear ranging between 0.007 to 0.012 inches on the diameter of the ball. The individual ball's wear pattern was uniform and the balls generally maintained their sphericity. None of the balls had any visual appearance of secondary fatigue. All of the balls had randomly located sliding flats, some of which were reoriented. The flats' approximate diameter ranged from .125 of an inch to .75 of an inch; these flats could be related to the inner race movement in the fore and aft thrust directions.

The oil scavenge cavity located in the intermediate pressure compressor rear stubshaft contained a mixture of metal and oil sludge in the scalloped area of the cavity, although none of the oil scavenge holes was clogged. The mating abutment faces of the rear stubshaft of the IPC and the inner race front locating flange of the intermediate pressure location bearing exhibited paths of leaking oil and embedded fine metallic particles which had formed scoring paths.

The mating abutment faces of the LPLB oil weir and the IPC rear stubshaft also contained embedded fine metallic particles, particle scoring paths, and oil-stained leakage paths. Oil passages were not clogged.

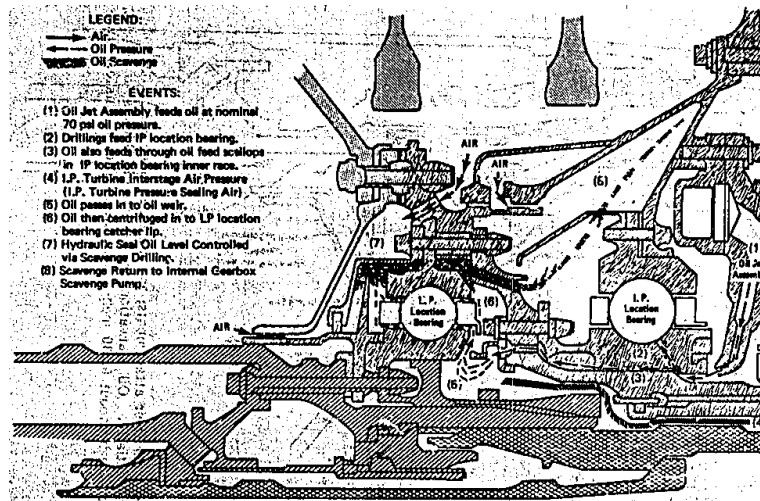
Figure 6. -- LPLB Normal Oil Supply and Scavenge.

Oil leaving the LPLB collects in a centrifugal sump in the area of the LPLB outer race. Oil leaves this sump through overspill holes in the IPC stubshaft arranged to maintain a constant sump depth. In addition, these holes are angled to form a hydraulic trap air seal between the LPLB chamber and the remainder of the gearbox. Oil leaving the sump through the overspill holes joins other scavenge flows in the gearbox and is returned to the tank by one of the four scavenge pumps through a magnetic chip detector and strainer, and the fine scavenge filter.

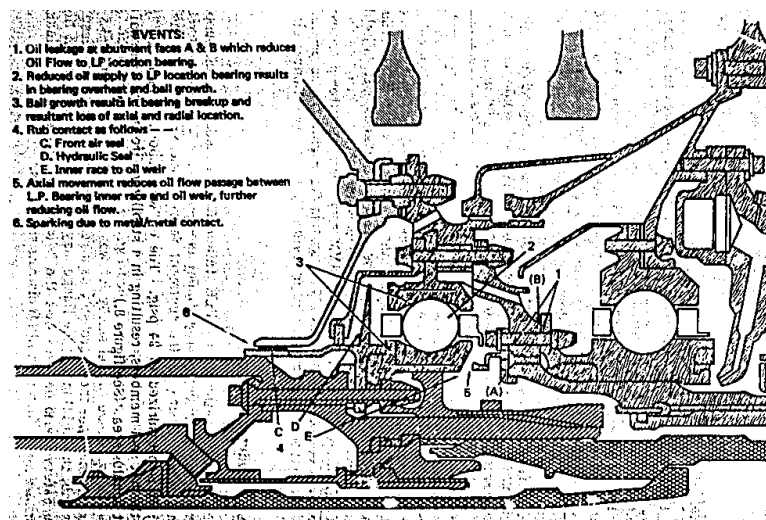
Figure 7. -- Initial Failure Sequence.

The initiating event in the LPLB failure was an inadequate oil supply to the bearing because of oil leaks between abutment faces of the IPC rear stubshaft and the LPLB oil weir and leaks between the abutment faces of the LPLB inner race locating flange and the IPC rear stubshaft. Each of these interfaces had evidence of oil leakage path stains and foreign debris entrapment. (See figure 7.) The LPLB oil supply system does not provide a positive oil feed to the bearing, but rather a "slinger" type is used to lubricate the bearing. Since the oil supply jet was not positive and since leaks occurred across the flanged abutment faces, probably as a result of poor mating of these surfaces following overhaul, the LPLB inner race flange may have become distorted at high power settings. The Safety Board believes that the "slinger" oil supply and oil leaks at the abutment faces are major factors in LPLB distress situations.

The inadequate supply of oil allowed the LPLB assembly to overheat and provided a temperature high enough to induce bearing outer race fatigue spalling, which in turn would have induced ball tightening and rubbing in the bearing cage pockets. The bearing cage and the bearing inner race lands also would have rubbed together, causing the cage to expand. These factors, in addition to high centrifugal force loadings, would allow the balls to grind and skid. The condition of the bearing's inner race and balls indicated that the balls were skidding and grinding into the bearing's inner race track in both the fore and aft directions, as shown by the contour match of the balls relative to the bearing's inner race track.

The predominant wear and damage pattern occurred at the front of the bearing's inner race. This failure pattern indicated that gross ball sliding took place when the engine was operating at a relative low power setting.<sup>5</sup>

Examination revealed that the inner rear face of the LPLB inner race and the forward lip of the oil weir had come into contact; the contact was caused by rearward axial movement of the inner race. These contact marks indicated that the LP system was rotating when the LPLB was displaced rearward. This would have further reduced oil flow between the LPLB bearing's inner race and the oil weir and thereby reduced oil flow to the LPLB itself.

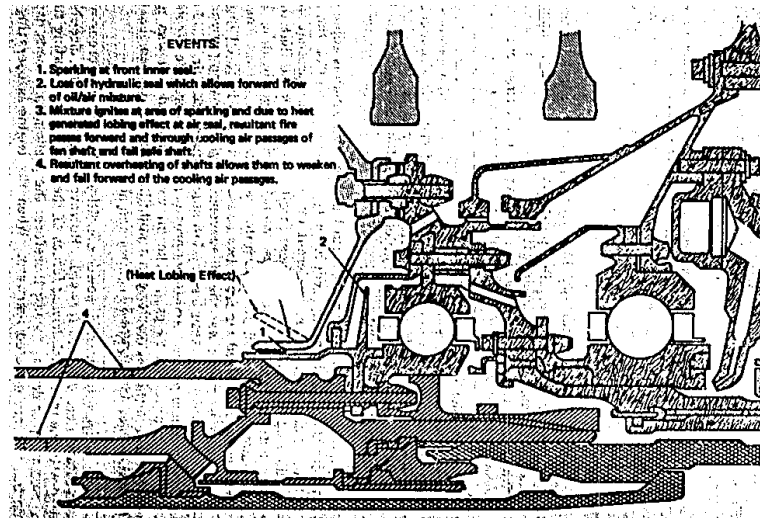
**Figure 8. -- Engine Fire Sequence.**

The ring (piston) seal housing and the ring (piston) seal which is adjacent to the hydraulic seal fin were also rubbed heavily. Oil level-type marks present on the rear face of the ring seal housing arm suggest that different levels of oil were present in the ring seal housing/hydraulic seal cavity. The differences in oil levels indicated that the normal capillary-type seal between the hydraulic seal and the ring seal housing had been compromised, thus allowing LPLB oil to eject into the fan shaft area. The oil that escaped was mixed with pressurized air from two sources and was injected into the fan shaft annulus area. The first source was the oil scavenge cavity, located between the LP and IP location

bearings, which is pressurized by 7th stage compressor air to 39 psig with the engine operating at climb power. Additional pressurized air is provided from the IPT pressure seal; it is pressurized to 24 psig. The oil was vaporized and was ignited by contact with the hot seal members, resulting in a stabilized fire in the fan shaft and the fail-safe shaft annulus area. (See figure 8.)

The stabilized fire degraded the material properties of the retained section of the fan shaft and caused the shaft to fail in a torsional and shearing mode. The degradation of material properties was evident by the discoloration patterns on the fan shaft fracture surface which indicated that the area adjacent to the fail-safe shaft fracture also reached a temperature probably in excess of 900° C. The recovered section of the fail-safe shaft exhibited rapid tensile/torsional overload fractures which also occurred as a result of exposure to these high temperatures.
