07/19/89 United Airlines

Report Number	NTSB/AAR-90/06
Access Number	PB90-910406
Report Title	United Airlines Flight 232, McDonnell Douglas DC-10-10, Sioux Gateway Airport, Sioux City, Iowa, July 19, 1989
Report Date	November 1, 1990
Organization Name	National Transportation Safety Board Office of Aviation Safety Washington, D.C. 20594
WUN	5158D
Sponsor Name	NATIONAL TRANSPORTATION SAFETY BOARD Washington, D.C. 20594
Report Type	Aircraft Accident Report July 19, 1989
Distribution Status	This document is available to the public through the National Technical Information Service, Springfield, Virginia 22161
Report Class	UNCLASSIFIED
Pg Class	UNCLASSIFIED
Pages	126
Abstract	This report explains the crash of a United Airlines McDonnell Douglas DC-10-10 in Sioux City, Iowa, on July 19, 1989. The safety issues discussed in the report are engine fan rotor assembly design, certification, manufacturing, and inspection; maintenance and inspection of engine fan rotor assemblies; hydraulic flight control system design, certification, and protection from uncontained engine debris; cabin safety, including infant restraint systems; and aircraft rescue and firefighting facilities. Safety recommend

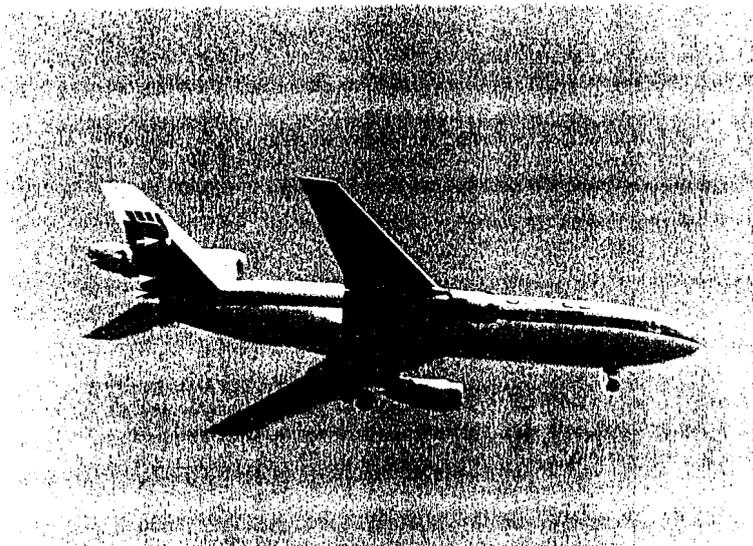
Figure 3.--Photo (C. Zellmer) taken while flight 232 was approaching Sioux Gateway Airport.

Photographs of the airplane were taken by observers on the ground during its final approach to Sioux Gateway Airport. They showed that the No. 2 engine fan cowling and the fuselage tail cone were missing. The remainder of the No. 2 engine appeared intact. Postcrash examination of the wreckage revealed that the No. 2 engine fan rotor components forward of the fan forward shaft, as well as part of the shaft, had separated from the engine in flight. (See [figure 3](#), [figure 4](#), [figure 5](#)).

Arrows indicate damage to the right horizontal stabilizer. It is also evident that the No. 2 engine fan cowl door and the tail cone are missing.

There were three large holes found in the right stabilizer. One hole, located at the outboard leading edge and oriented generally spanwise, extended aft to the front spar; this hole was one of the damaged areas visible in the in-flight photograph taken during the airplane's approach to the airport. Considerable effort was expended to identify the source of this damage; the damage has dimensions similar to the size of the large piece of the fan disk and blades. However, no positive match could be made. A second hole seen in the in-flight photograph was forward of the inboard elevator. Flight control hydraulic components are in this area. The exact size and shape of the hole could not be determined because of damage from the ground impact and the breakaway of the stabilizer section outboard of the inboard elevator actuator. A third hole was in the inboard elevator; there are no critical components within this structure.

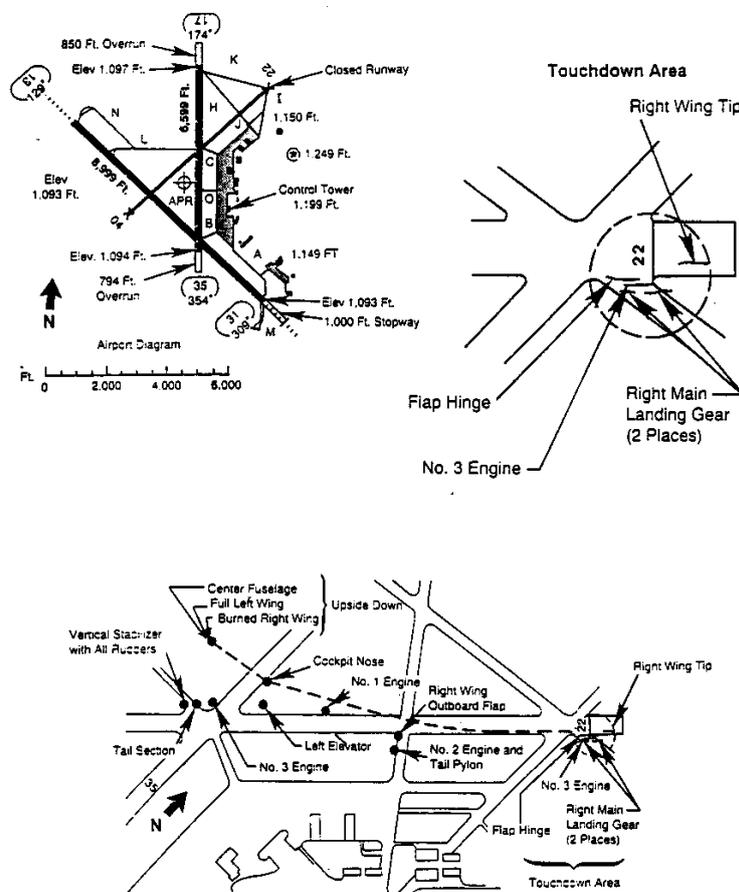
Figure 6.--Sioux Gateway Airport and wreckage path of UA flight 232.

The cockpit separated early in the sequence and came to rest at the edge of runway 17/35. The largely intact tail section continued down runway 22 and came to rest on taxiway "L." The engines separated during the breakup. The No. 1 and No. 3 engines came to rest near taxiway "L" and the intersection of runway 17/35, between 3,000 and 3,500 feet from the point of first impact. (See [figure 6](#).)

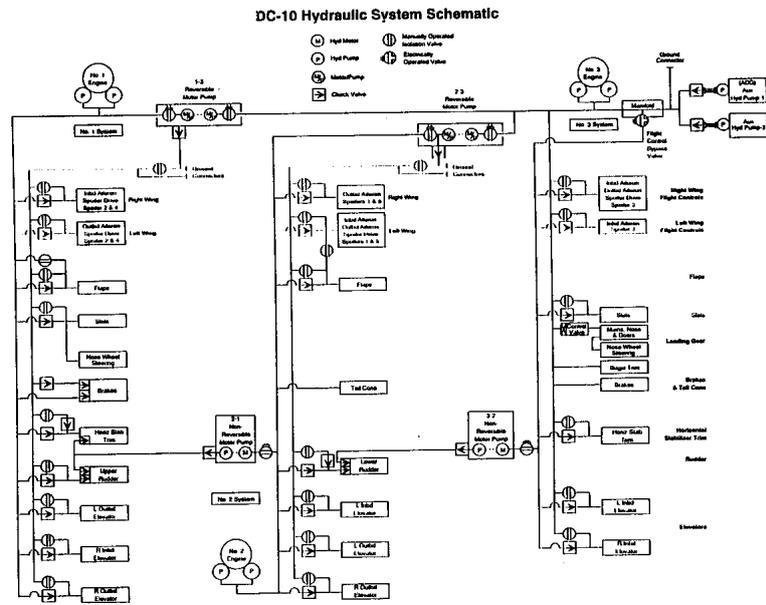
Figure 10.--DC-10 hydraulic system schematic.

The No. 1 hydraulic system provides power to the right inboard aileron and the left outboard aileron, the right inboard and outboard elevators, the left outboard elevator, the upper rudder, the horizontal stabilizer trim, and the captain's brake system. The No. 2 hydraulic system provides power to the right outboard aileron and the left inboard aileron, the inboard and outboard elevators on the left side, the outboard elevator on the right side, and the lower rudder. It also provides power to the isolated closed-loop system that operates the upper rudder. The No. 3 hydraulic system provides power to the right inboard and outboard aileron and the left inboard aileron, the inboard elevators on the right and left side, horizontal stabilizer trim, and the first officer's brake system. It also drives an isolated closed-loop system that powers the lower rudder actuator. These closed-loop arrangements allow for operation of the remaining parts of hydraulic systems No. 2 and No. 3 in the event of damage to the rudder hydraulic system. (See figure 10).

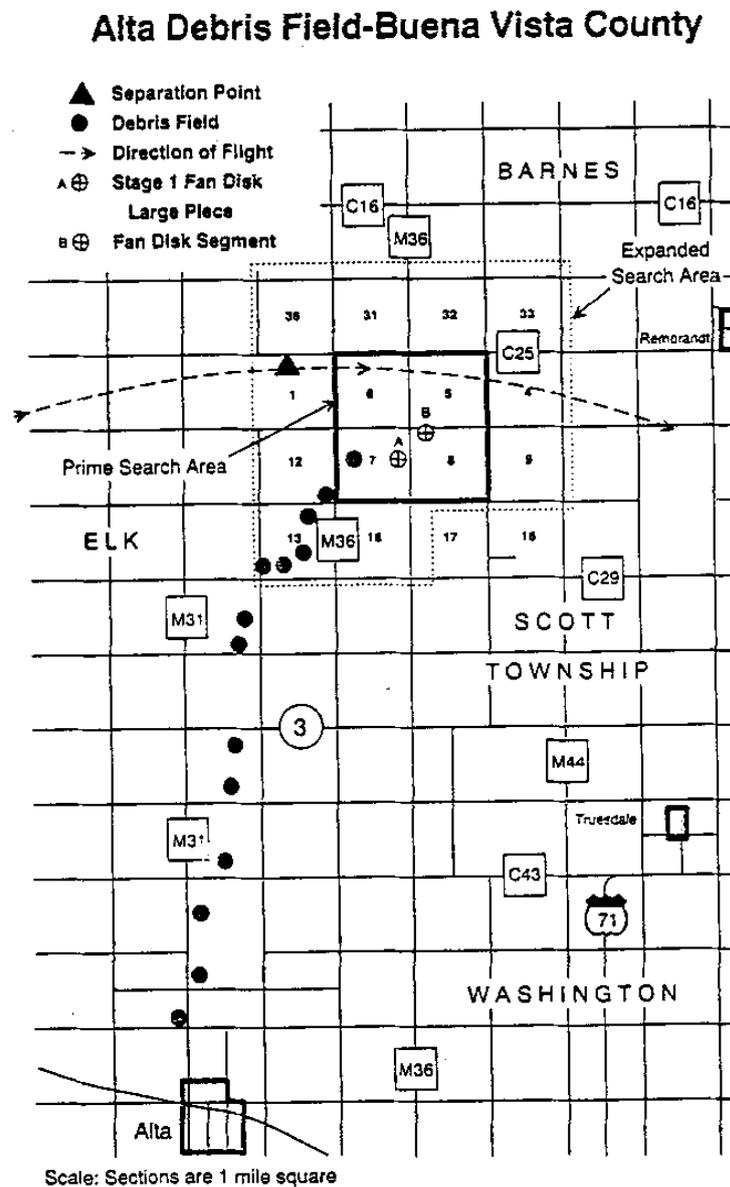
Figure 11. --Trajectory information/Alta debris field.

Also found near Alta soon after the accident were parts of the tail engine adapter assembly, consisting of adapter ring and bellmouth assemblies, an anti-ice pneumatic tube, a starter air tube, three cowl hold-open rods, two hydraulic system accumulators from the No. 2 engine-driven hydraulic pumps, fan blade fragments, two pieces of insulated metal braid-covered hydraulic hose clamped together, and a segment of aluminum material broken out of the large structural "banjo" forging from the airplane inlet duct structure.
