**THE FORTY-SIXTH MEETING OF THE
INFORMAL PACIFIC ATC CO-ORDINATING GROUP (IPACG/46)**

**THE THIRTY-THIRD MEETING OF THE
IPACG FANS INTEROPERABILITY TEAM (IPACG FIT/33)**

Agenda Item 2: PROBLEM REPORT ACTIVITY (Central Reporting Agency)

**Federal Aviation Administration (FAA) Central Reporting Agency (CRA)
Problem Report (PR) Briefing**

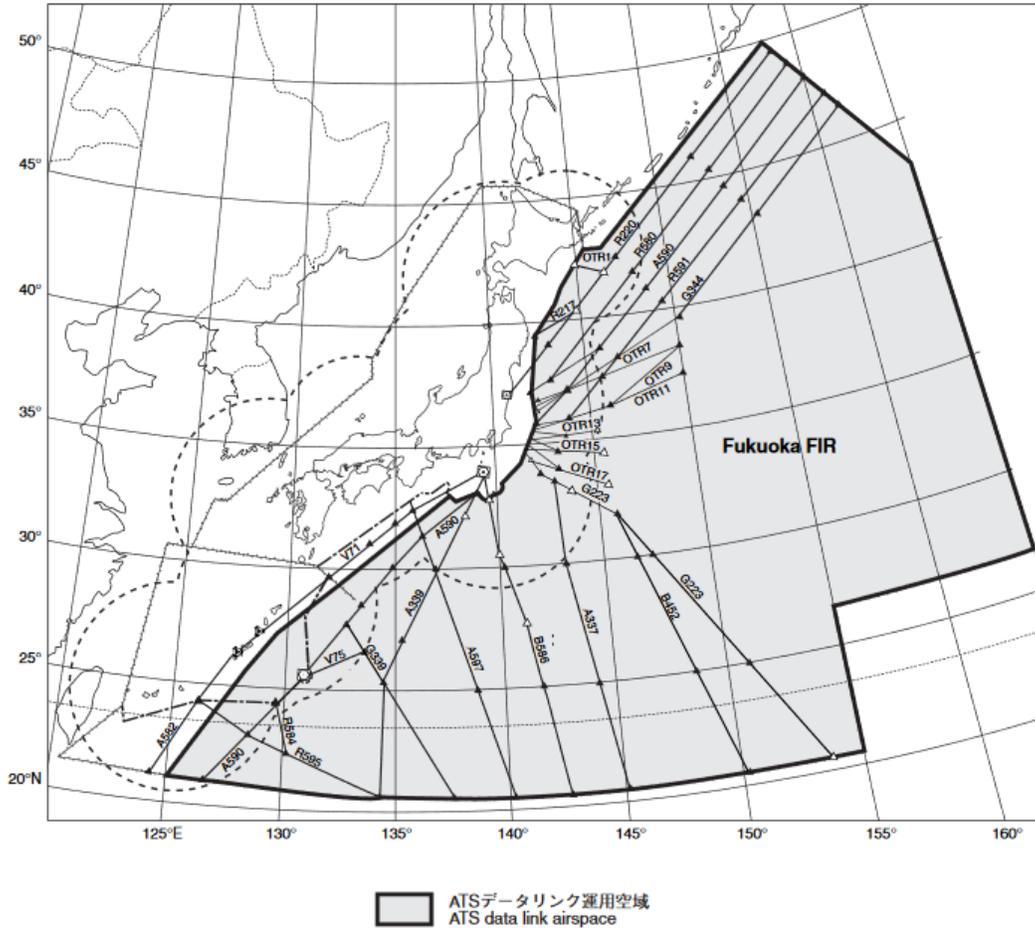
Figure 2 ATS Data Link Airspace in the Fukuoka FIR

2.1.3. 2939-KS, Closed / Air – Procedural. A 787 flight crew reported that they were unable to establish a CPDLC connection with Fukuoka. The CRA found that Fukuoka responded to the AFN contact messages from the airplane with negative AFN acknowledgement messages because although the airplane's route entered the Fukuoka FIR the route did not enter ATS data link airspace. Figure 2 illustrates this airspace.
