**Federal Aviation
Administration**

**MU-2B SERIES AIRPLANE
SAFETY EVALUATION REPORT
APPENDICES DOCUMENT
DECEMBER 2005**

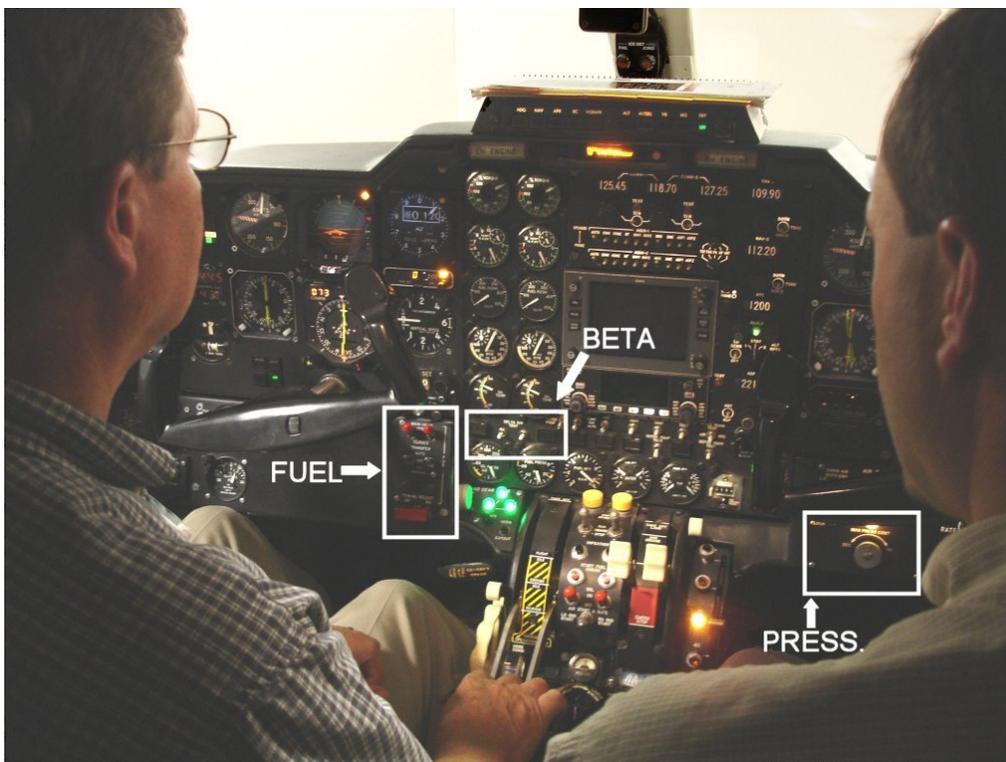
Cockpit layout was examined for placement of caution/warning indicators and system controls. These included: (1) beta lights, (2) fuel cut-off switches, (3) pressurization controls, and (4) oxygen system controls (for cockpit). An overview image of the instrument panel is shown in Figure 1 of this appendix with three of these four items labeled.

Figure 1. Overview of instrument panel showing location of fuel switches, beta lights and pressurization control.

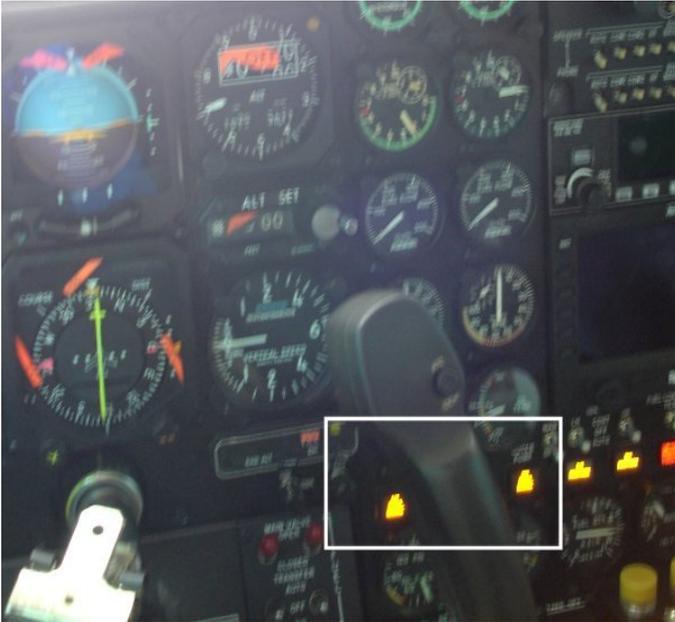
Beta lights. Comment was made that the beta lights could be obscured from the pilot's view by the control yoke during some phases of operation. Examination of the indicators from the approximate pilot's eye position indicated that they could be obscured by the right side of the yoke under some circumstances (see Figure 2 of this appendix; photograph taken from approximately pilot's eye position). A repositioning would allow both lights to be seen at all times without requiring any head movement. However, as these lights are generally considered to be a confirmation of conditions, that would cause a significant aircraft performance change. It was determined that their positioning was not such that it would prevent them from being used to confirm that observed aircraft performance changes were or were not attributable to beta. The operational significance of this positioning needs to be discussed with AFS-820 and ACE-111. Figure 2. Beta lights from approximately pilot's eye position.

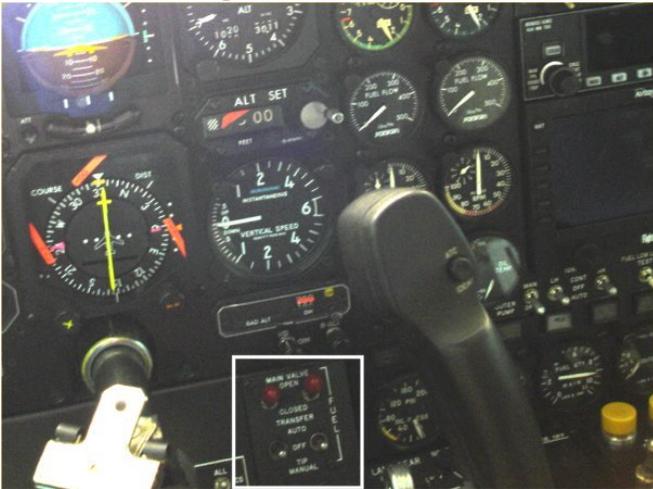
Figure 3

Fuel cut-off switches. The question had been raised as to whether it might be possible to accidentally activate the fuel cut-off switches (Figure 3). Examination of these switches showed that this was highly unlikely as the switches have detents and must be pulled out to be moved from one position to another.

Figure 3. Fuel cut-off switches as seen from approximately pilot's eye position.

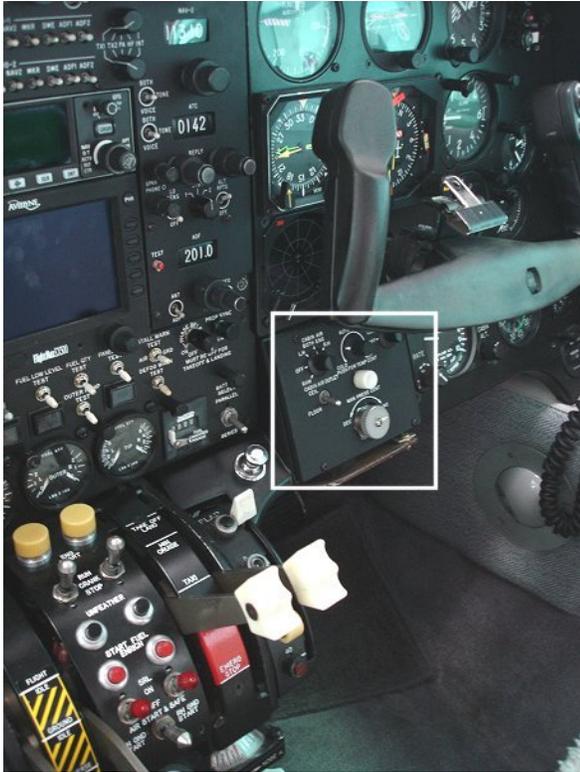
Figure 4

Pressurization controls. The question was raised concerning accessibility of the pressurization controls. This was examined using a pilot of moderate stature (5'7") with the seat positioned at arm's length (normal position for this pilot) from the instrument panel with the seat belt/harness on. The pressurization controls (Figure 4) were easily reached and manipulated from this seating position.

Figure 4. Pressurization controls as seen from approximately pilot's eye position.

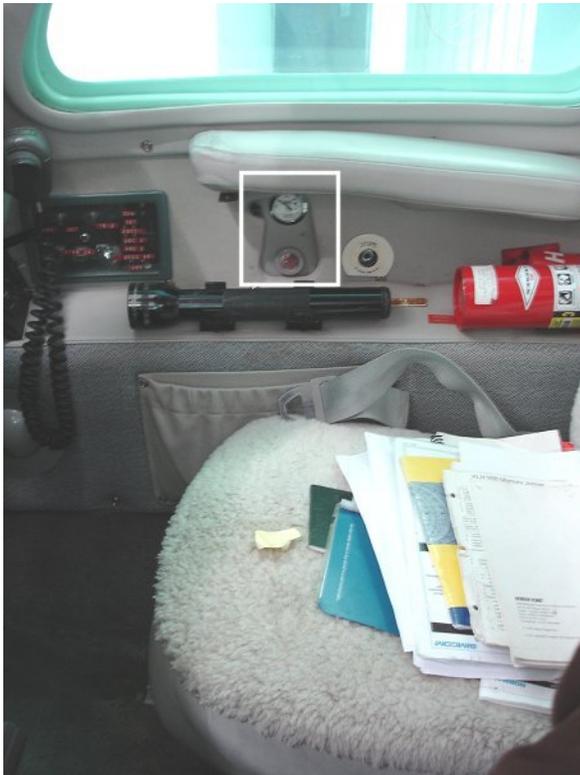
Figure 5

Oxygen system controls, cockpit. The oxygen system control (Figure 5) was examined and determined to be at the extreme limit of reach for a pilot of this stature when wearing the belt and harness. However, the normal procedure calls for turning this valve on prior to departure, and it thus should not be necessary to access the control during flight.

Figure 5. Cockpit oxygen controls as seen from approximately pilot's eye position.
