Federal Aviation Administration
Aircraft Certification Service
Small Airplane Directorate

**MITSUBISHI HEAVY INDUSTRIES
MU-2B SERIES AIRPLANE
FFFSR REPORT**

JUNE 27, 1997

**FAA/JCAB FACT FINDING FOCUSED SPECIAL
CERTIFICATION REVIEW TEAM**

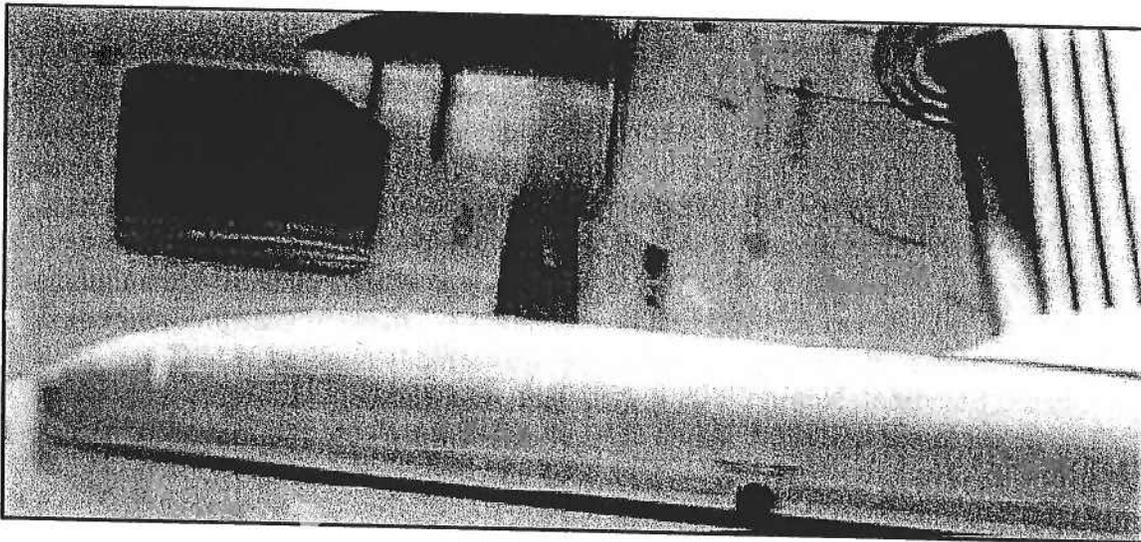
Figure I-1

Appendix C conditions were simulated on the long fuselage model MU-2B-60 in icing tanker flights conducted on April 26 and 27, 1996, at the AFFTC. Testing confirmed that Appendix C ice on the upper wing surface collected on the protected portion of the boots. Cycling of the boots removed all of the upper wing surface ice. Impingement on the lower surface was approximately 6 to 8 inches aft of the boot. Typical ice collection on the

Ice impingement on MU-2B wing upper surface in icing tanker testing. The icing cloud contained droplets larger than Appendix C. The yellow color of the ice is from dye added to the tanker water to aid visual detection of the ice.

During the icing tanker tests, ice was observed to accrete on the protected areas of the outer wing upper surface within Appendix C conditions (see figure I-1). The outer wing was selected for this test because the impingement analysis conducted by the current de-icing

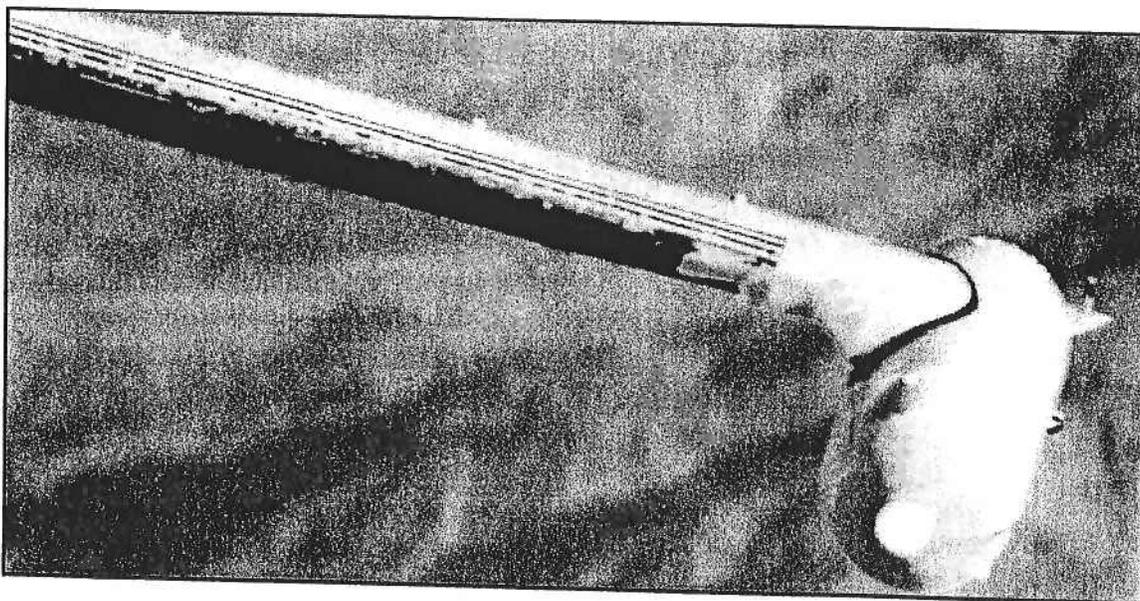
In SLD test conditions, the wing upper surface did collect some ice aft of the last active de-ice tube in a ridge with a ragged profile and sharp edges. After 20 minutes and several boot cycles, the ice ridge was observed from the chase plane to be stabilized with dimensions of approximately one inch wide and a maximum height of approximately $\frac{3}{4}$ inch (see figure I-3). The ridge was observed to build to approximately $\frac{3}{4}$ inch in height and then some spanwise portions would self-shed in the air stream. The growth and self-shedding process stabilized at a spanwise fraction coverage estimated at 40 percent. The artificial shape configuration shown in figure I-4 was developed to represent the SLD ice ridge aft of 7 percent chord on the upper surface of the wing. Ice buildup was not totally removed from the boots with every cycle of the boots. Some residual ice was observed on the wings as shown in figure I-5 and the horizontal stabilizer as shown in figure I-6.

Figure I-3
MU-2B in SLD. Ice ridge is visible at aft upper edge of de-icing boots.

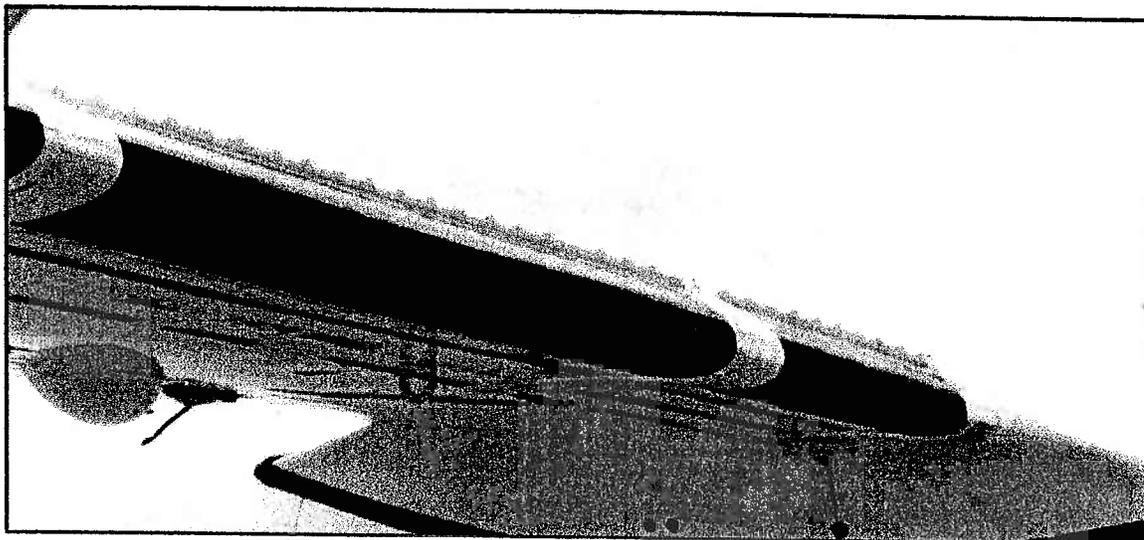
Figure I-4
MU-2B artificial ice shape viewed from the pilot's perspective.

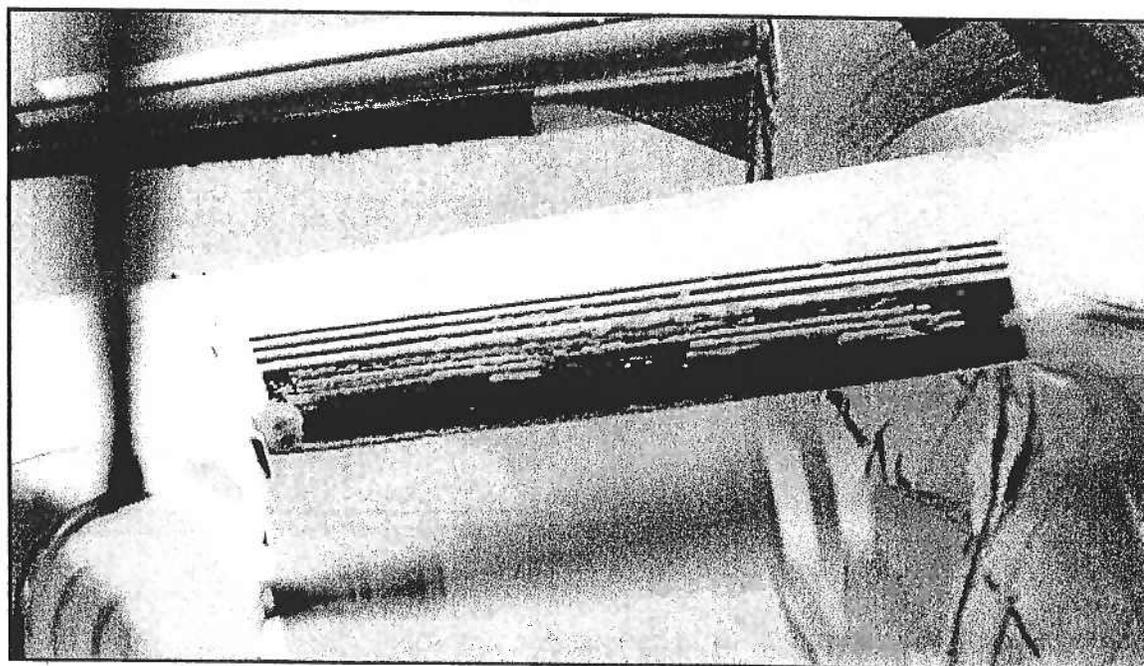
Figure I-5
MU-2B post-boot cycle residual ice on right inner wing in SLD. Note ragged edge of ice visible on lower surface of horizontal stabilizer.

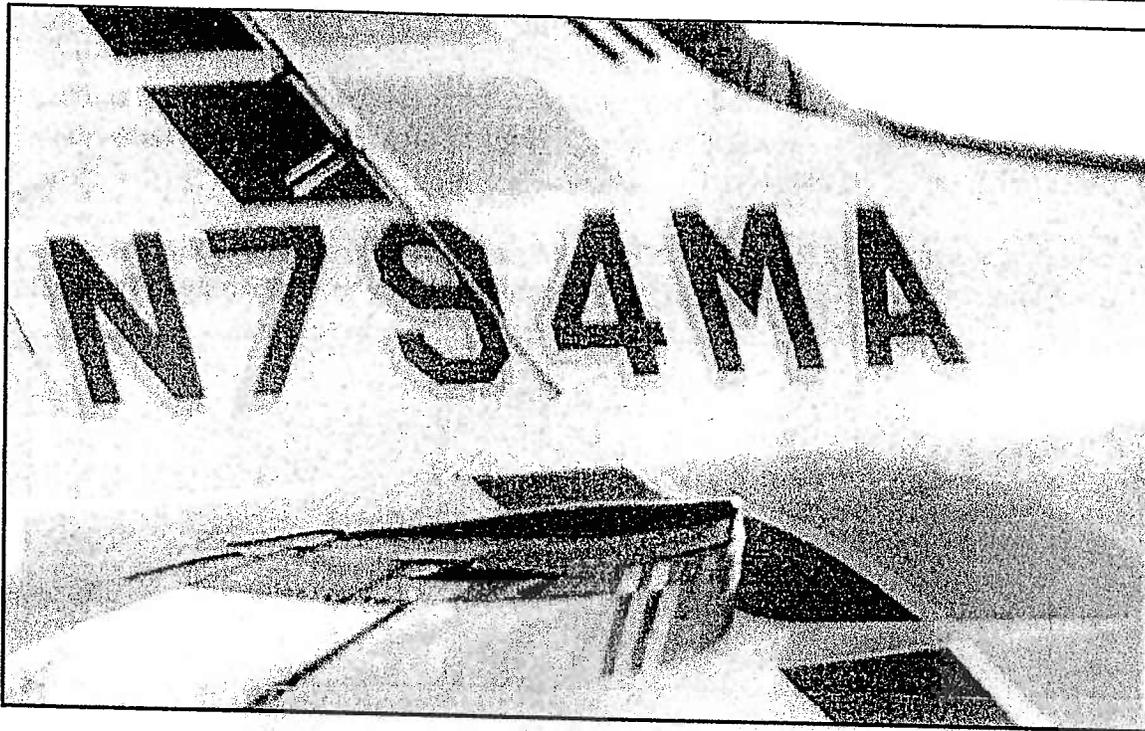
Figure I-6

SLD ice on MU-2B lower surface of the right stabilizer with some ice visible aft to leading edge joint. Ice is visible on the vertical stabilizer.

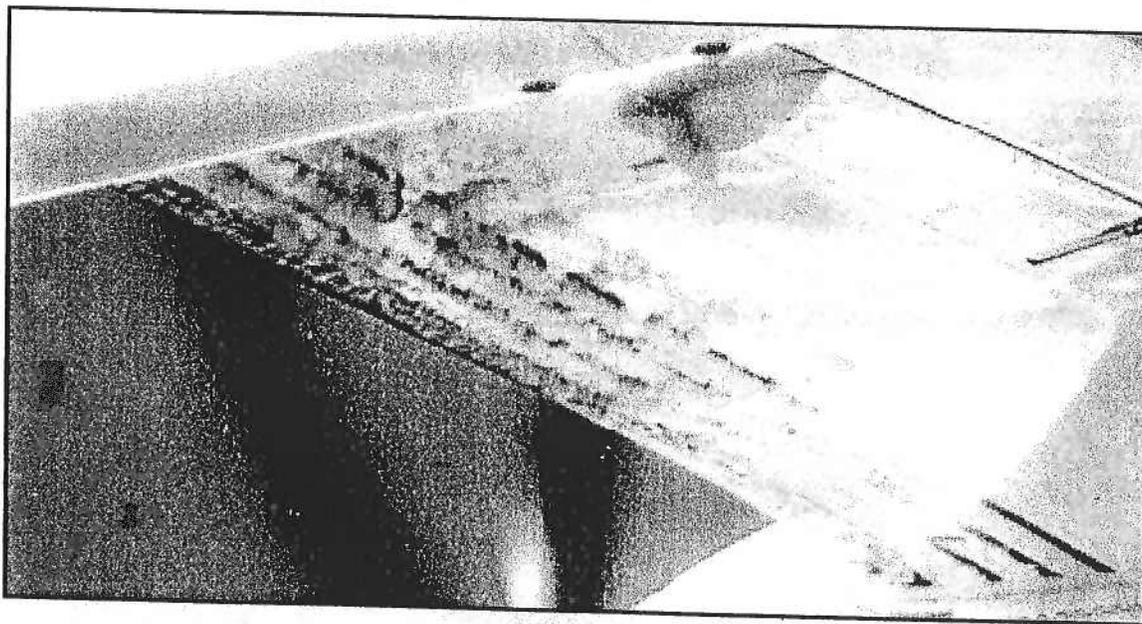
Figure I-7

The lower wing surfaces collected ice asymmetrically, best defined as distributed ice elements to approximately 30 to 40 percent chord as shown in figure I-7; and aft of the up-going propeller blade, a sharp lip of ice immediately aft of the active portion of the de-icing boots that extended with smaller, more distributed ice elements, to approximately 30 to 40 percent chord as shown in figure I-8. Post-flight documentation of the lower wing surface

SLD ice on the MU-2B left wing lower surface.

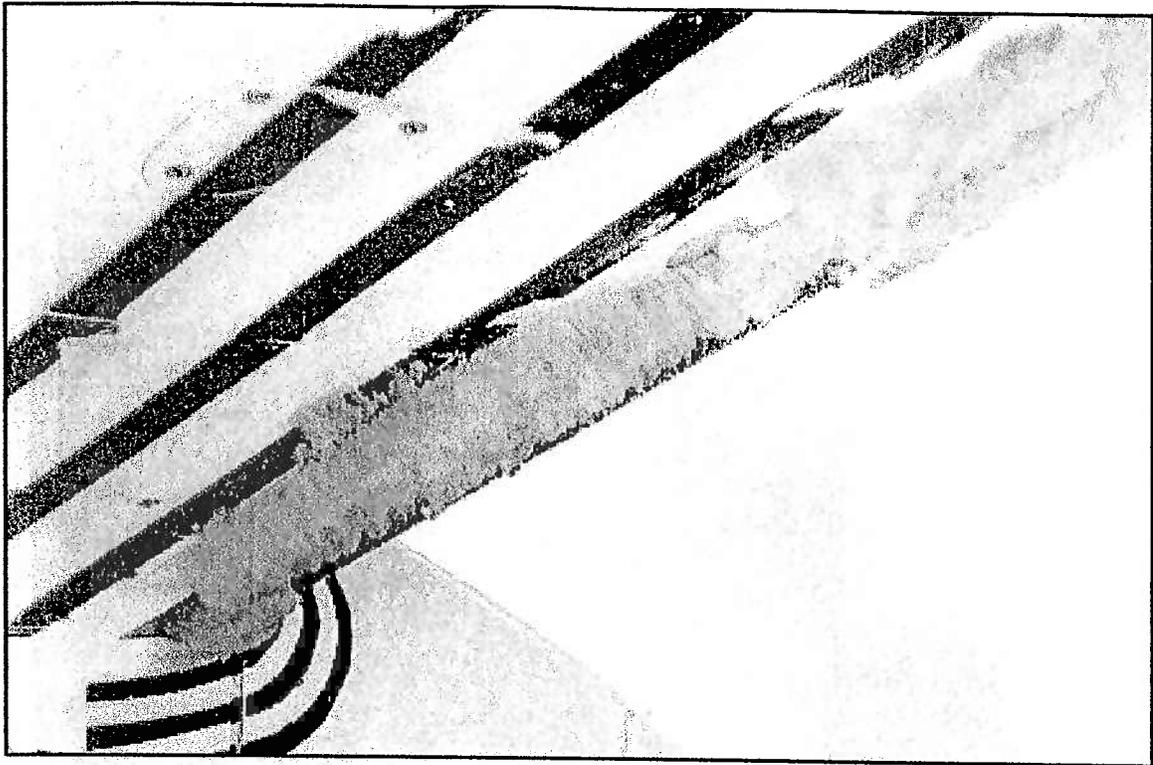
Figure I-8
SLD ice on the MU-2B left inner wing lower surface.

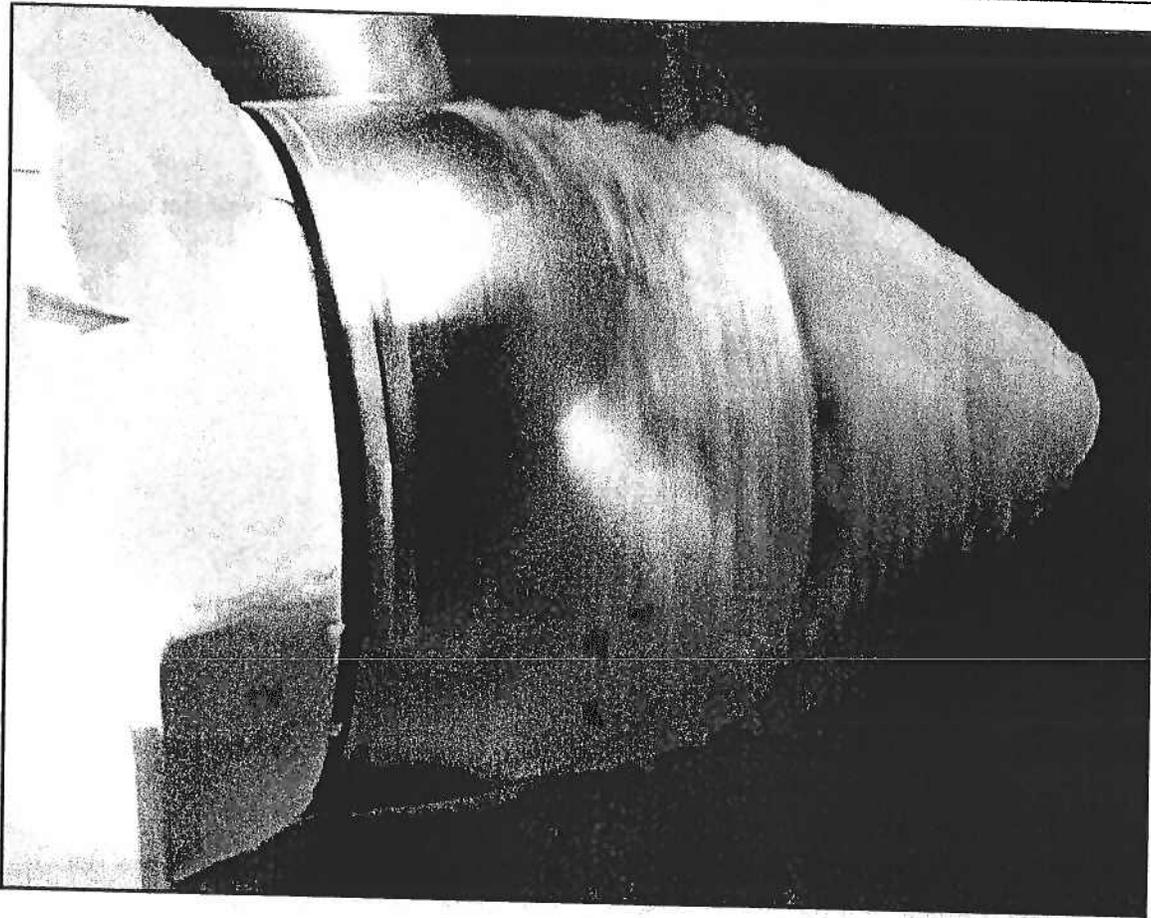
Figure I-9
MU-2B left propeller spinner in SLD. Ice extends aft to propeller blade roots. Appendix C ice covers approximately the forward half of the spinner. Ice is visible on the unheated upper inlet surface.

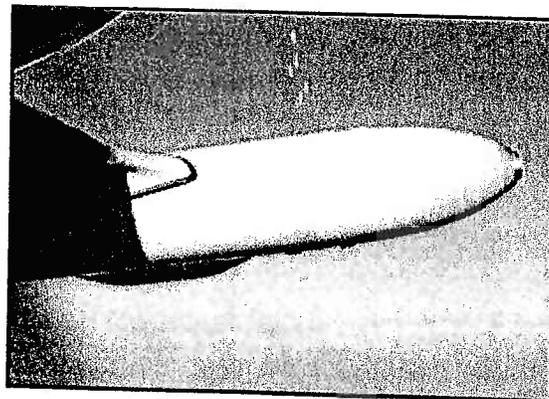
Figure I-11
MU-2B tip-tank ice visual cue in SLD.

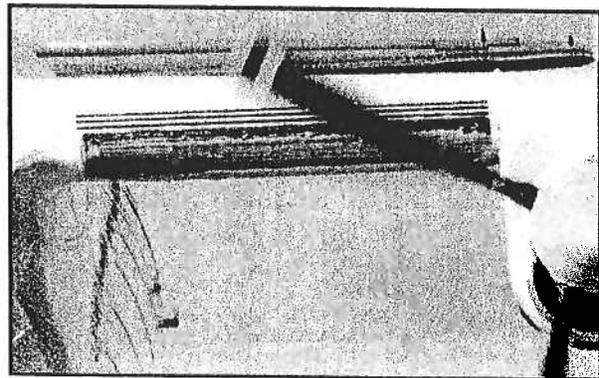
MU-2B in SLD. Assymetry of ice accretion results from propeller wash effects with co-rotating propellers. Above left: Down-going blade decreases AOA resulting in more aft-wise impingement on upper surface. Above right: Up-going blade increases AOA aft resulting in less aft-wise impingement on upper surface. The light green color (seen in both figures above) at the stagnation line is liquid water.

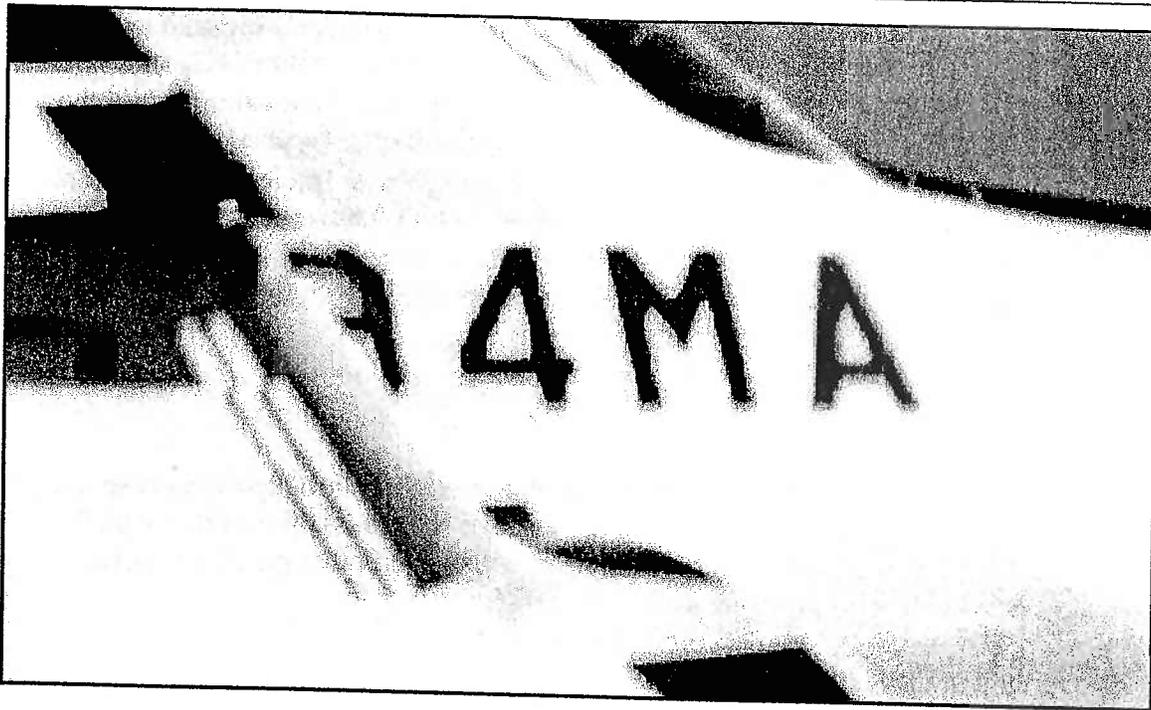
Figure I-14

MU-2B right stabilizer in SLD. Ice can be seen extending approximately 10 inches further outboard than the left stabilizer (figure I-15 below). Observe ice on the leading edge of the vertical stabilizer.

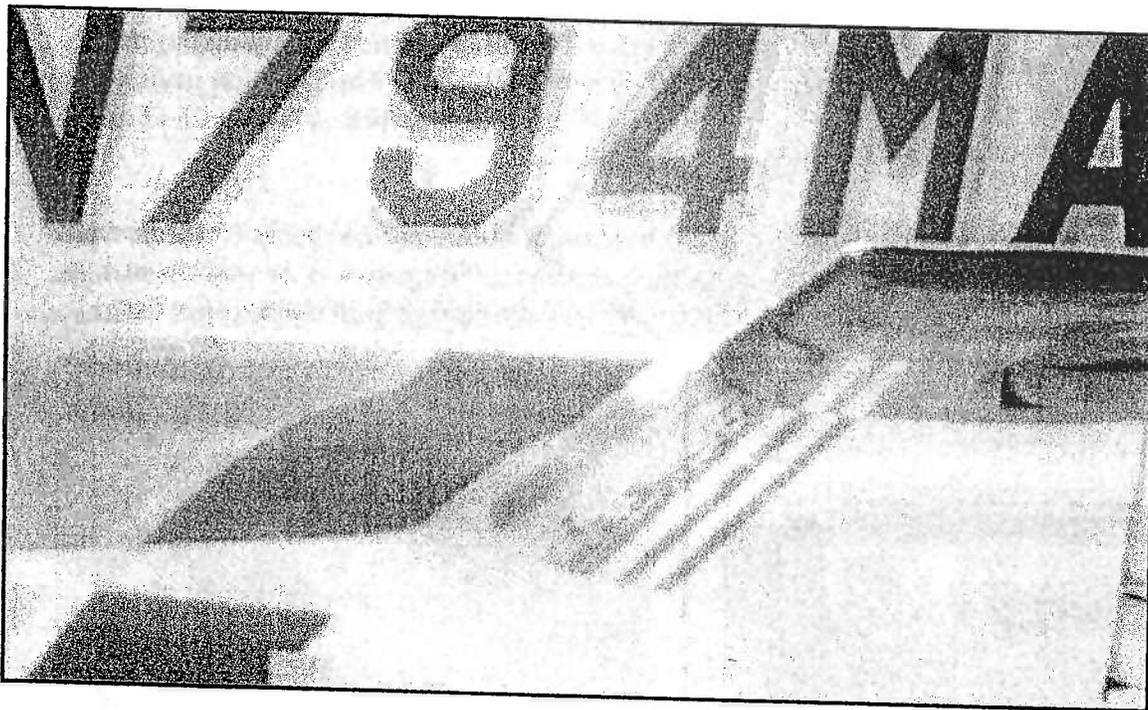
Figure I-15

MU-2B left stabilizer in SLD. Ice does not extend as far outboard as the right stabilizer. Distributed roughness elements are visible aft of the boots but to lesser extent than the right stabilizer.

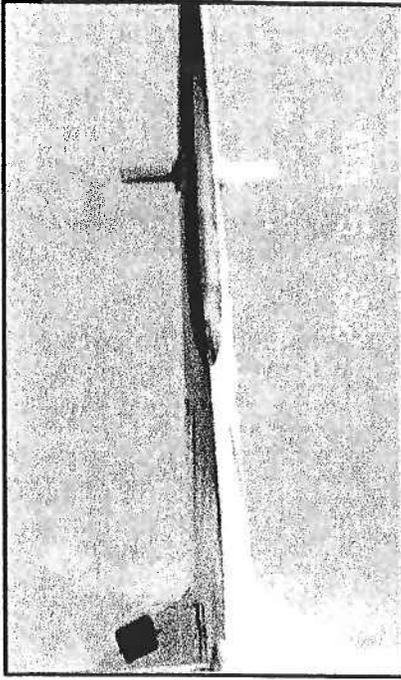
*Figure I-16
Ice on the vertical stabilizer is not symmetric due to propeller wash effects.*

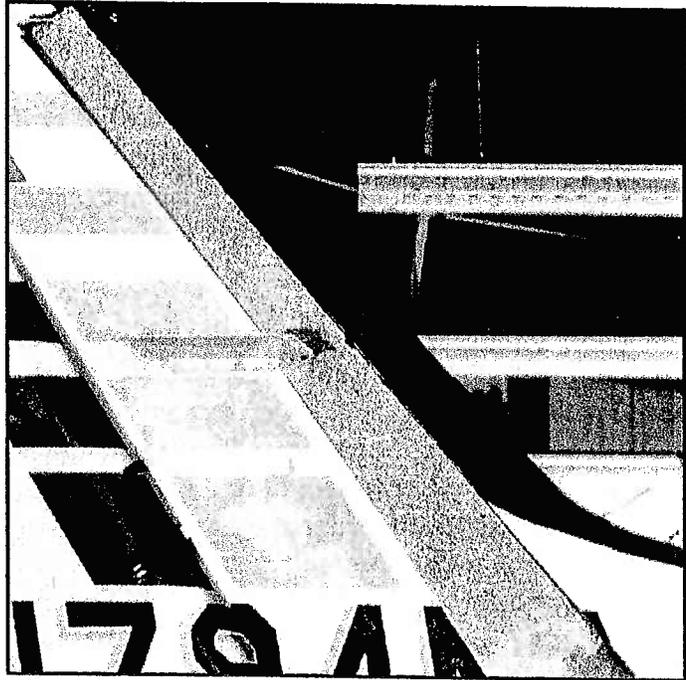
*Figure I-17
Asymmetry on the vertical stabilizer is represented by roughness elements.*

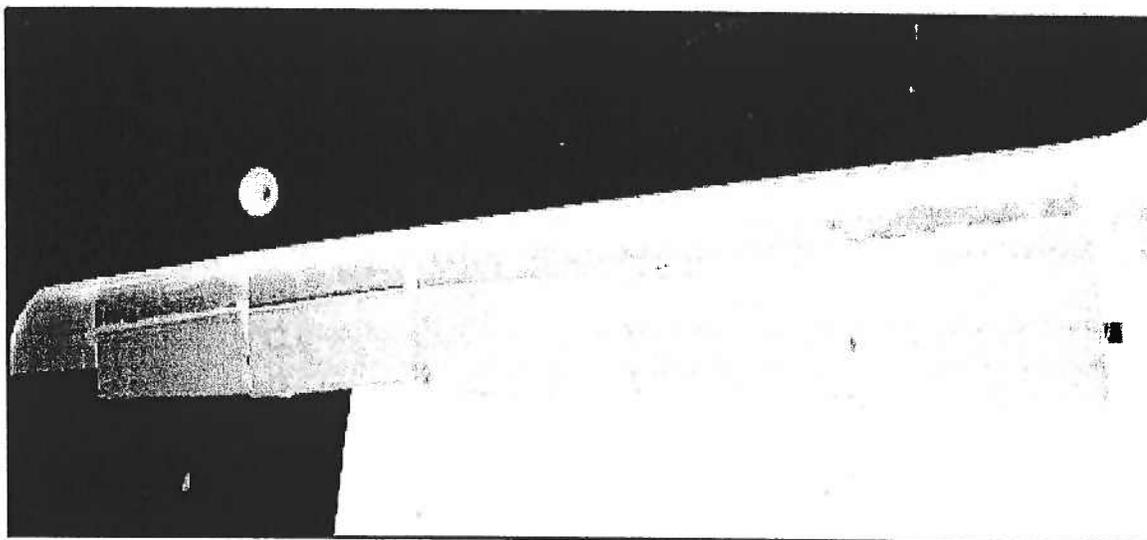
The Team and MHI conducted flight tests using sandpaper to simulate an inadvertent icing encounter, and conducted a pushover maneuver to evaluate the tail stall margin. The configuration tested is shown in figure I-24. The ice shape comprised 60 grit sandpaper wrapped around the leading edge de-ice boot on the upper and lower surface back to the front spar. The airplane was then flown through various maneuvers including push-overs from coordinated flight and in sideslips. The FAA evaluation was limited to flap settings of 20° and 40° at low speeds in coordinated flight, and in sideslips. There was no perceptible longitudinal control force lightening or force reversals throughout the maneuvers. The flight complied with the aspects of the FAA policy set forth in the Small Airplane Directorate memorandum, "Recommended Method of Identification, Susceptibility to Ice Contaminated Tailplane Stall," dated July 12, 1994, with two exceptions. The most critical speed for the

Figure I-24
60 grit sandpaper on lower surface of right horizontal stabilizer of MU-2B.

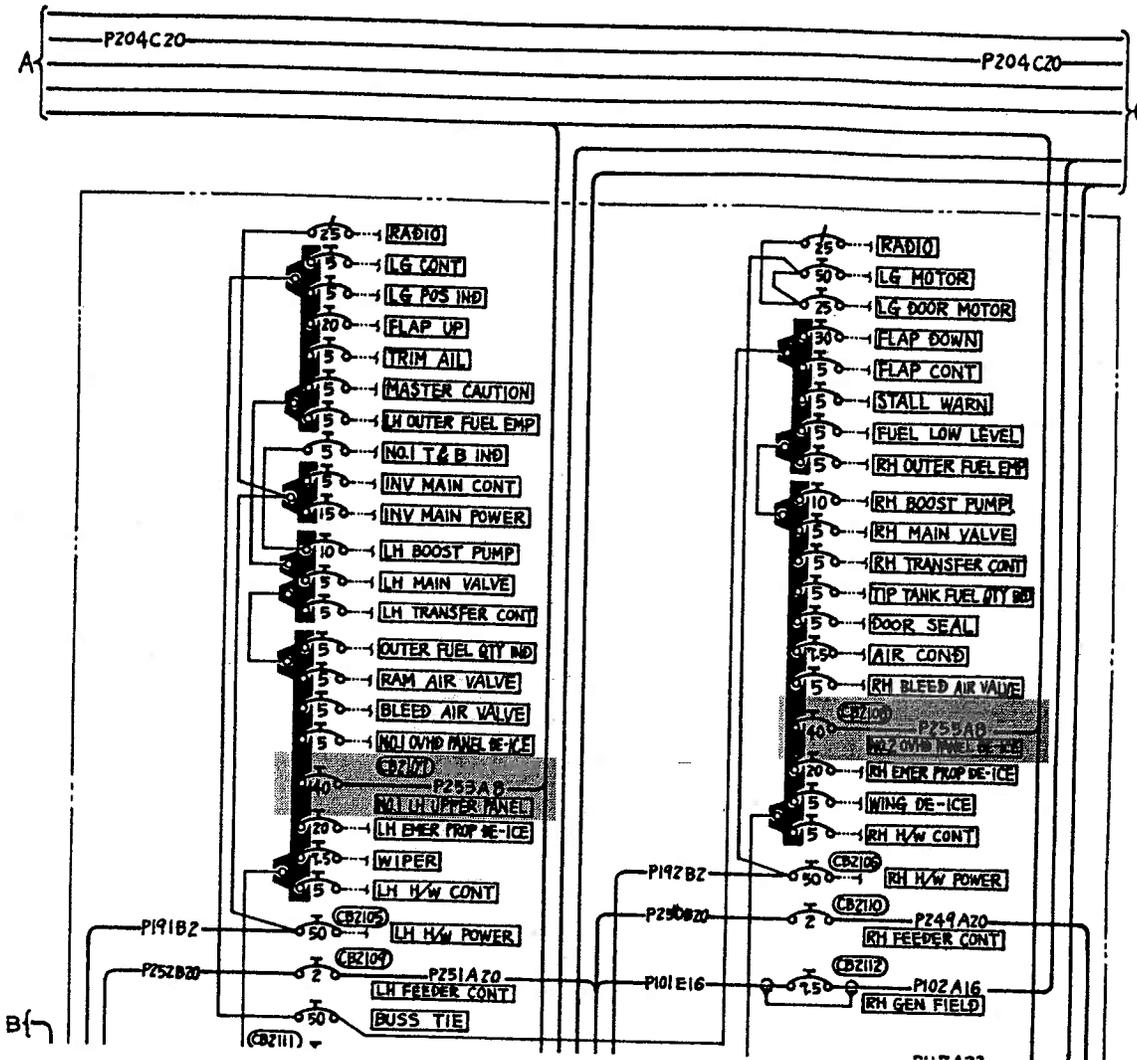
found acceptable previously, they have agreed to modify the anti/de-ice system circuit protection by eliminating CB2107 and CB2108.

Figure III-2
Circuit breaker panel.

1. Recommend a service bulletin be issued by MHI to require the installation of a water trap/drain valve in the tail de-ice manifold pressure line, and require that the system be drained during each 100 hour inspection. If the line accumulates water through condensation or flight through rain, the line may freeze and render the tail boots inoperative.
2. An open failure of a single circuit breaker for icing systems results in loss of capability of four essential anti/de-ice systems and should be corrected. Issue an AD to remove Circuit Breakers CB2107 and CB2108 for the essential systems that are protected by combination switch/circuit breakers.
