MITSUBISHI MU-2 AIRPLANES; Availability of Special Certification Review

Subject: ACTION: Mitsubishi MU-2 Special Certification
Review (SCR) Program

SPECIAL CERTIFICATION REVIEW OF MITSUBISHI MU-2

FINAL REPORT

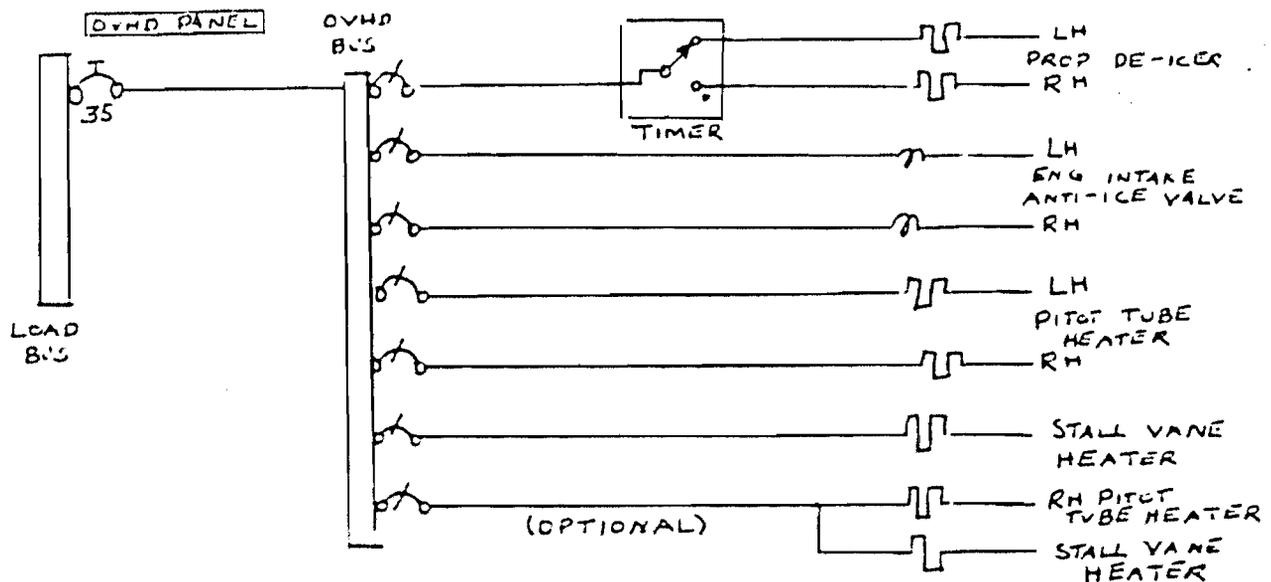
1. LH/RH propeller deicer heaters.
2. LH/RH engine intake anti-ice valves.
3. LH/RH pitot tube heaters.
4. Stall warning vane heater.

The following schematic diagram describes this specific installation:

B. A failure mode and effects analysis of the circuit follows:

C. A single failure (a fault of the OVHD circuit breaker can cause a loss of all of the previously reviewed Deice loads. MIL HDBK 217D lists the Mean Time Before Failure of a circuit breaker as 5×10^5 operating hours.

The combination of circuit breaker reliability, circuit protection for each switch/circuit breaker controlled load and the power monitoring capability provided by the PROP DEICE current meter and ENG INTAKE heat lights were and are considered adequate in meeting the CAR 3.681, 3.690, and 3.691 requirements. In addition there is no adverse service history showing this installation to be unsafe. The power monitoring capability of this system is designated in the following photograph of the OVERHEAD PANEL.

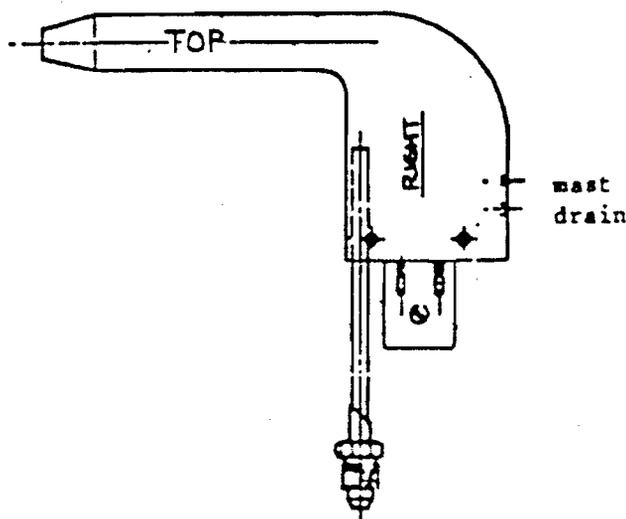
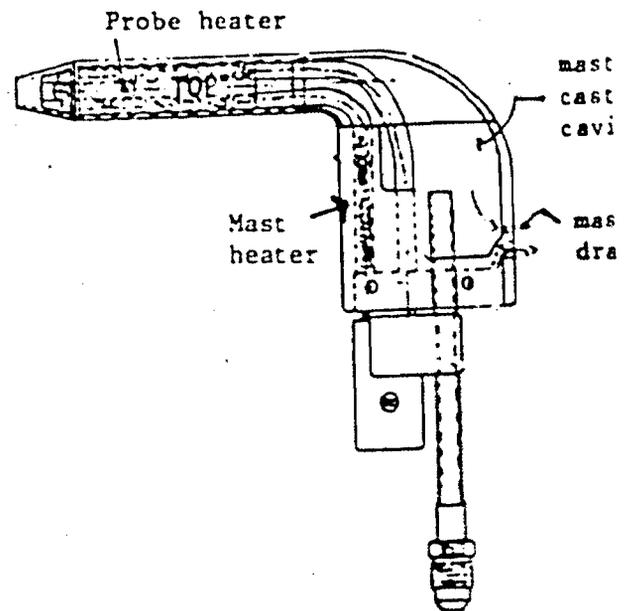
Subsequent investigation has revealed it is possible for moisture to collect and freeze within the pitot mast casting and not properly drain out of the mast drain.

PE 506 Pitot head

PH 1100 Pitot head

This is caused in part by the horizontal mounting of the pitot tube assembly. In addition, the lower heat (PH 506 L or R) pitot tubes do not incorporate a heater in the mast as does the higher heat pitot tube (PH 1100 R or L). Since the higher heat pitot tube utilizes a mast heater, the collected moisture does not have an opportunity to freeze and obstruct the pitot pressure.

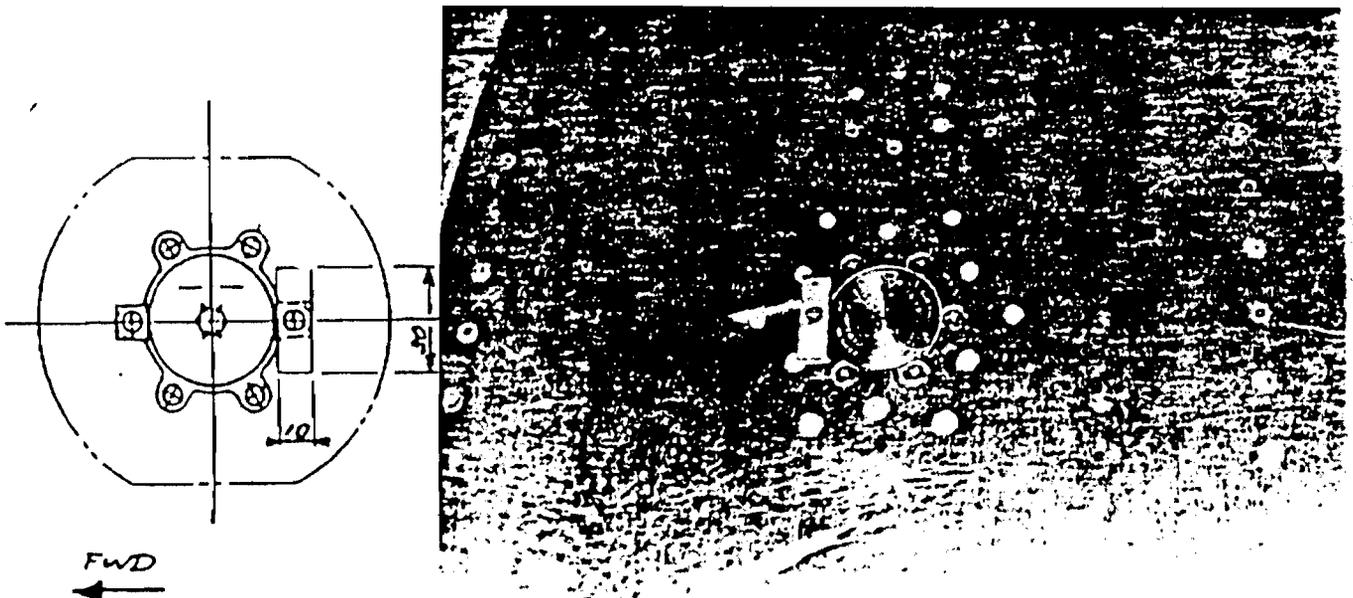
A photo and sketch of the calibration ramp is shown below:

We know of no service difficulty reports due to static port calibration ramp installations or of ice accretions on the ramps. The MU-2 mounted ramp is attached with a screw that is connected directly to the heated port, and it is reasonable to believe that there is a level of thermal conductivity between the static port and the calibration ramp. In addition, the calibration ramp is within the boundary layer of the fuselage and, therefore, should be considered ice accretion free.

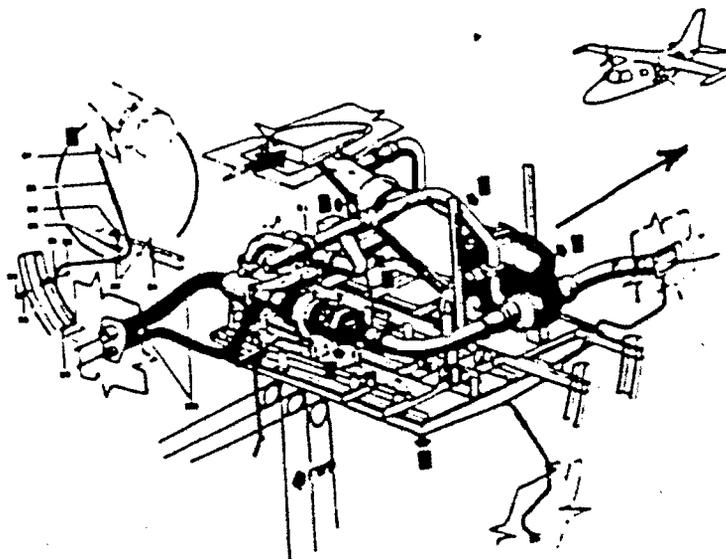
AiResearch Cooling Turbine Installation

Three of the four failures resulted in pieces of the turbine damaging the aircraft skin, the fourth failure did no damage to the airplane. In all failures, damage to the airplane occurred quite some distance and in a direction opposite from components critical to safety of flight. Components critical to safety of flight are considered to be simultaneous failures of the elevator cable and elevator trim cable. Since the cables are well separated from each other and all previous failures have occurred in the direction opposite from the cables, there is little likelihood of a simultaneous failure due to uncontained rotor failure.

Direction of
Failures
