Federal Aviation
Administration

ZODIAC CH 601 XL AIRPLANE SPECIAL REVIEW TEAM REPORT JANUARY 2010

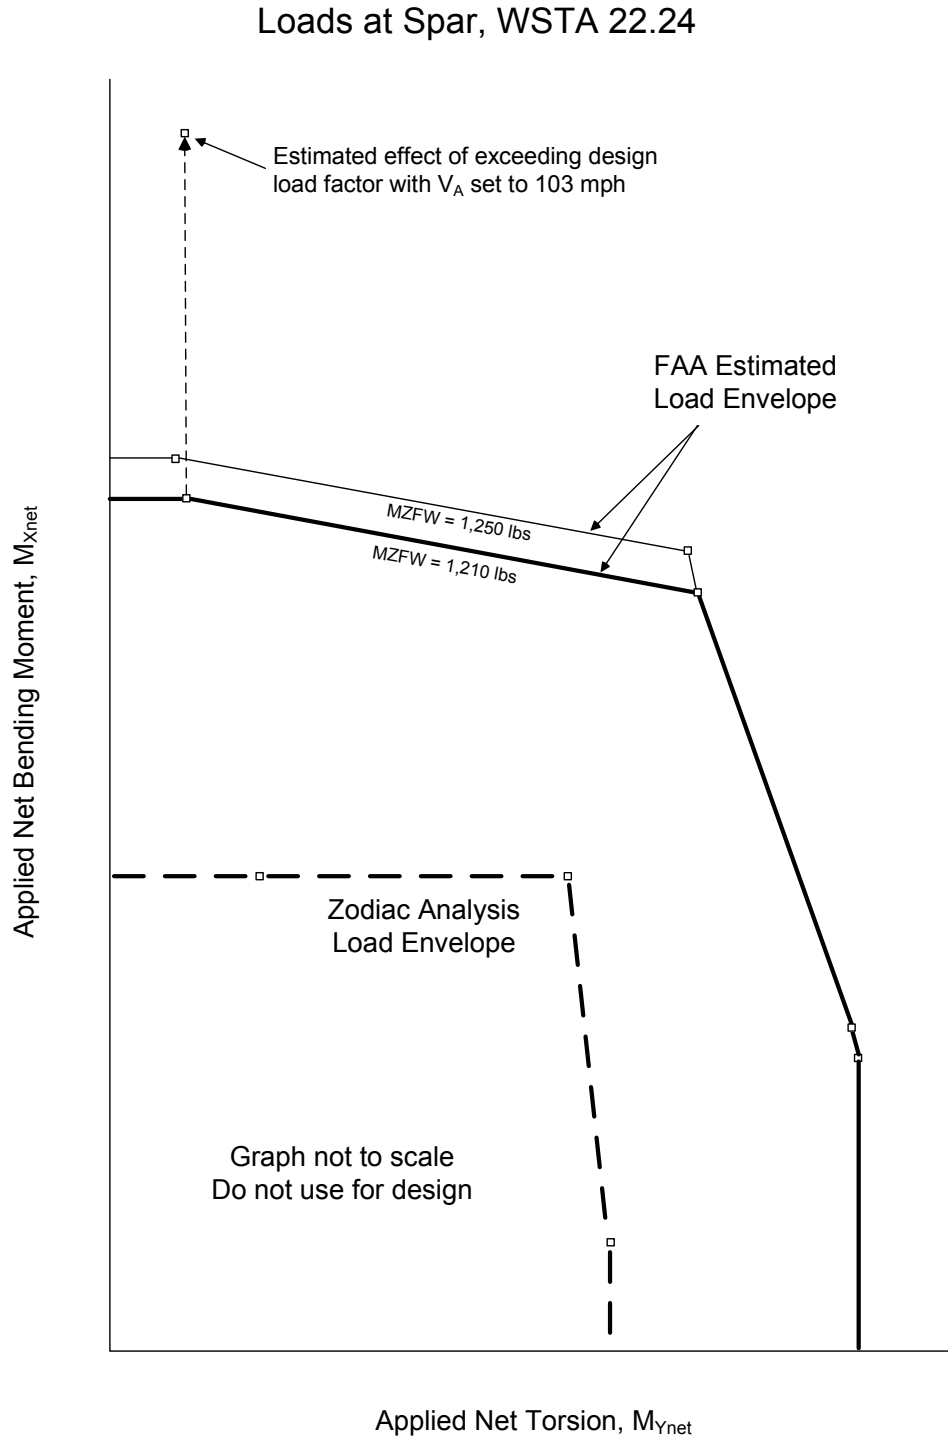
Figure 1: Comparison of FAA Estimated Loads with 'Zodiac CH 601 XL Stress Analysis and Tests'

- The amount of lift produced by the portion of the wing planform covered by the fuselage. The manufacturer’s analysis assumes the wing planform covered by the fuselage is as effective in producing lift as an adjacent portion of exposed wing planform. This assumption may not be conservative and may be noncompliant with the ASTM F 2245 § 5.1.1.2 requirement that ‘...these loads must be distributed to conservatively approximate or closely represent actual conditions.’

- The correct definition of the maximum zero fuel weight (MZFW). The manufacturer’s analysis defines the MZFW as the maximum takeoff weight (MTOW) minus full fuel. This definition is incorrect. The intent of the MZFW is to design the wing for the condition where airplane weight is at a maximum but the wing fuel tanks are only partially full. Because the fuel load is alleviating for wing bending loads, using the proper fuel load to determine MZFW is important.

For the CH 601 XL, the MZFW case is the condition where two occupants (190 lbs each, according the ASTM standard) are added to the empty weight of the airplane (830 lbs). Then sufficient fuel is added to the wing tanks to reach MTOW. For the CH 601 XL, the MZFW is 1,210 lbs (830 + 380 lbs) and the MTOW is reached with 110 lbs of fuel, instead of the zero fuel weight used in the manufacturer's calculations. This could lead to the structure being designed to a lower capacity than needed.

- The correct value for the maneuvering speed, V_A . The manufacturer determined V_A to be 90 knots (103) mph based on a stall speed, V_S , of 44 knots (51 mph). However, the manufacturer's flight test report documents a measured stall speed of 43 knots (49 mph). In addition, the flight test report did not appear to contain proper temperature corrections to convert the measured data to standard atmospheric conditions. Using data in the manufacturer's CH 601 XL flight test report and correcting to standard conditions reduces the stall speed to 41 knots (47 mph), resulting in a V_A of only 82 knots (94 mph). Using a V_A of 90 knots (103 mph) instead of 82 knots (94 mph), a pilot could inadvertently reach 4.8g instead of the intended 4.0g at V_A . The critical importance and intent of V_A is stated in FAA publication FAA-H-8083-3A Airplane Flying Handbook. The handbook defines the design maneuvering speed as the "...maximum speed at which the airplane can be stalled or full available aerodynamic control will not exceed the airplane's limit load factor. At or below this speed, the airplane will usually stall before the limit load factor can be exceeded." Operating below V_A can prevent overstressing the structure from purposeful pitch control inputs, and from vertical gusts from all but the most extreme turbulence. Pilots expect not to be able to exceed the design limit load factor at or below V_A . Unknowingly operating at speeds above the proper maneuvering speed may cause pilots to inadvertently exceed the design limit load factor, particularly at aft center of gravity where stick forces are known to be light and stick force gradients flatten out.

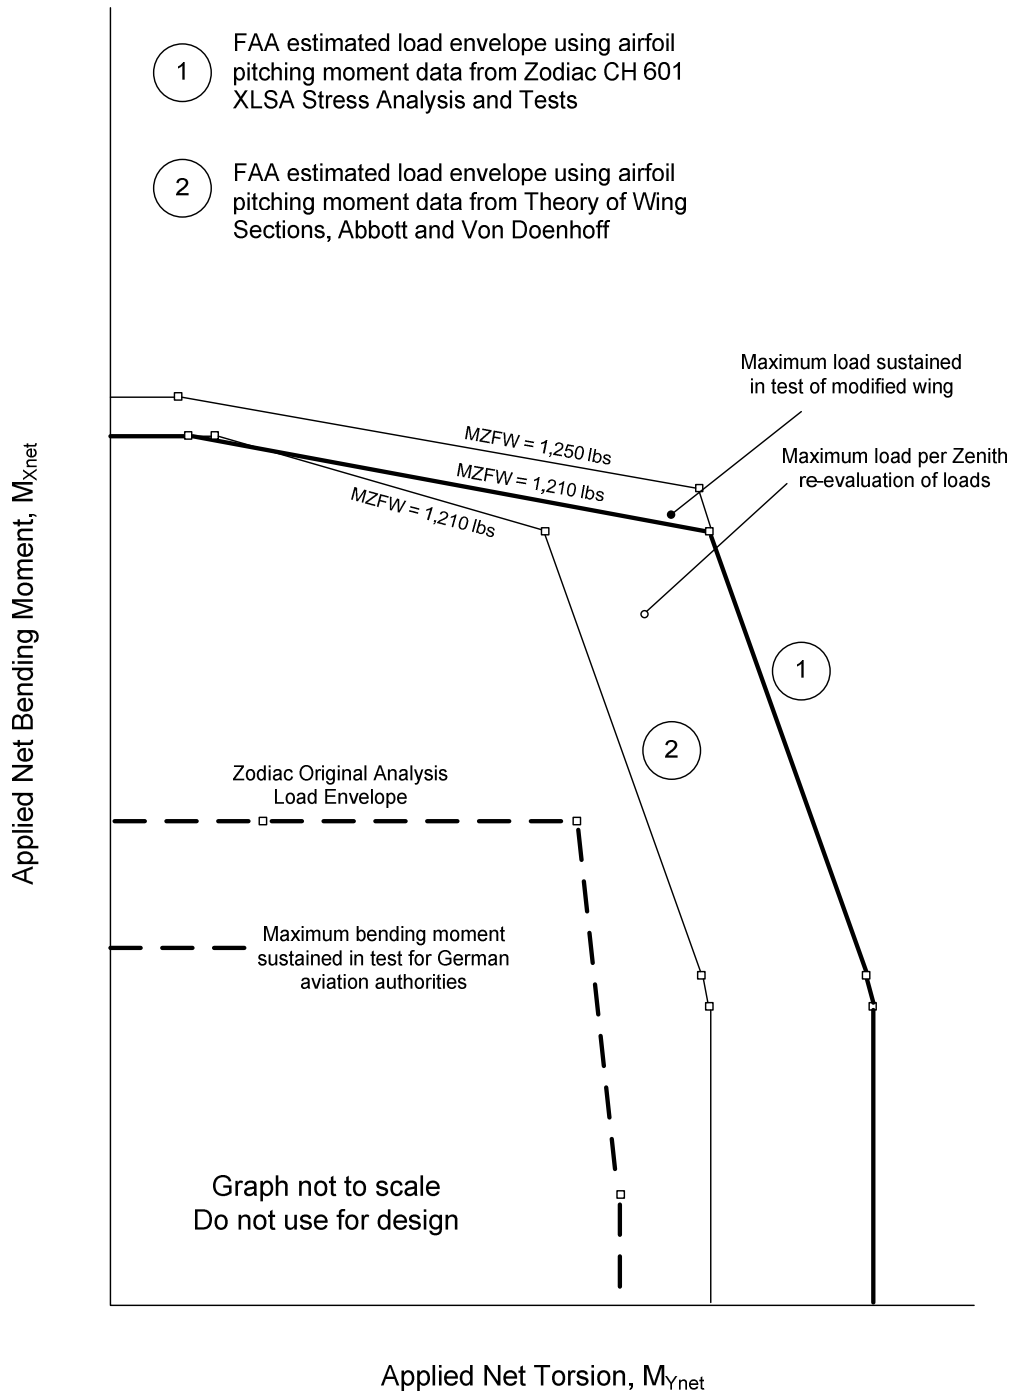
Figure 3: Revised Zodiac Analysis and Static Test Wing Design Loads

The manufacturer successfully tested the modified wing structure to loads higher than determined in their revised analysis. The wing structure did not fail at the ultimate test loads. However, the wing attachment bolts were bent and the attachment bolt holes were elongated, indicating there was permanent damage to the structure at these loads. We have depicted the loads from the manufacturer's revised analysis and static test in figure 3.

Despite disagreeing with our position on several significant issues, the maximum bending moment achieved in the static test is only a few percent below our estimated maximum required bending moment. The maximum torsion load achieved in the test may only be a few percent below our estimated maximum torsion provided the manufacturer can justify the airfoil pitching moment data with applicable test data. It is possible that if the manufacturer had continued the static test to structural failure, the ultimate test load could have equaled or exceeded FAA estimates of the required load envelope.

- The manufacturer stopped the static test of the modified structure approximately five percent below the FAA’s load estimates required for ASTM compliance. At the time of this report, the manufacturer was continuing to make modifications to the wing structure and the drawings referenced by the safety directive to provide further improvements. The manufacturer should consider additional structural testing and analysis once a final design is reached to demonstrate the new wing meets the ASTM standards.

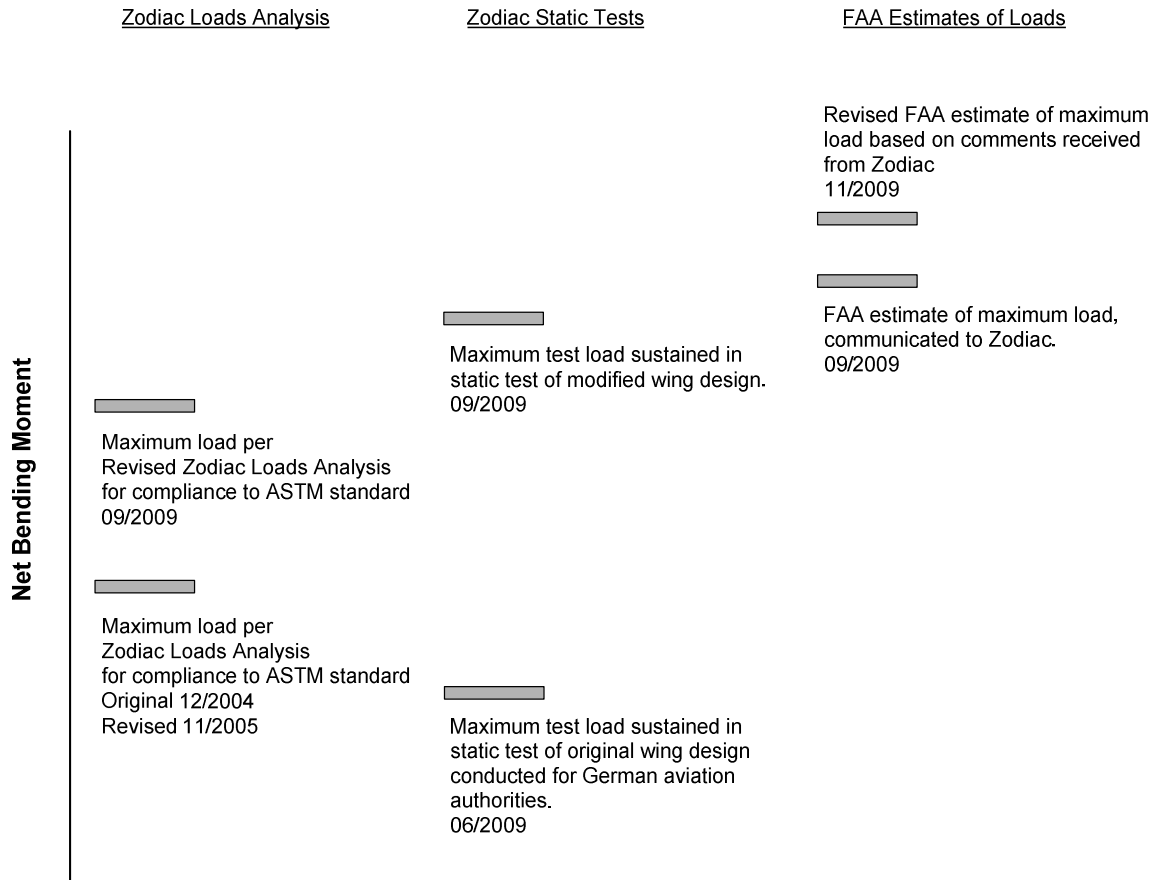
Figure 4: History of Zodiac Wing Structural Loads Analysis and Tests

Figure 4 presents a history of the manufacturer's loads analysis and static testing. We provide this information to provide a time line of the manufacturer's structural analysis and testing.

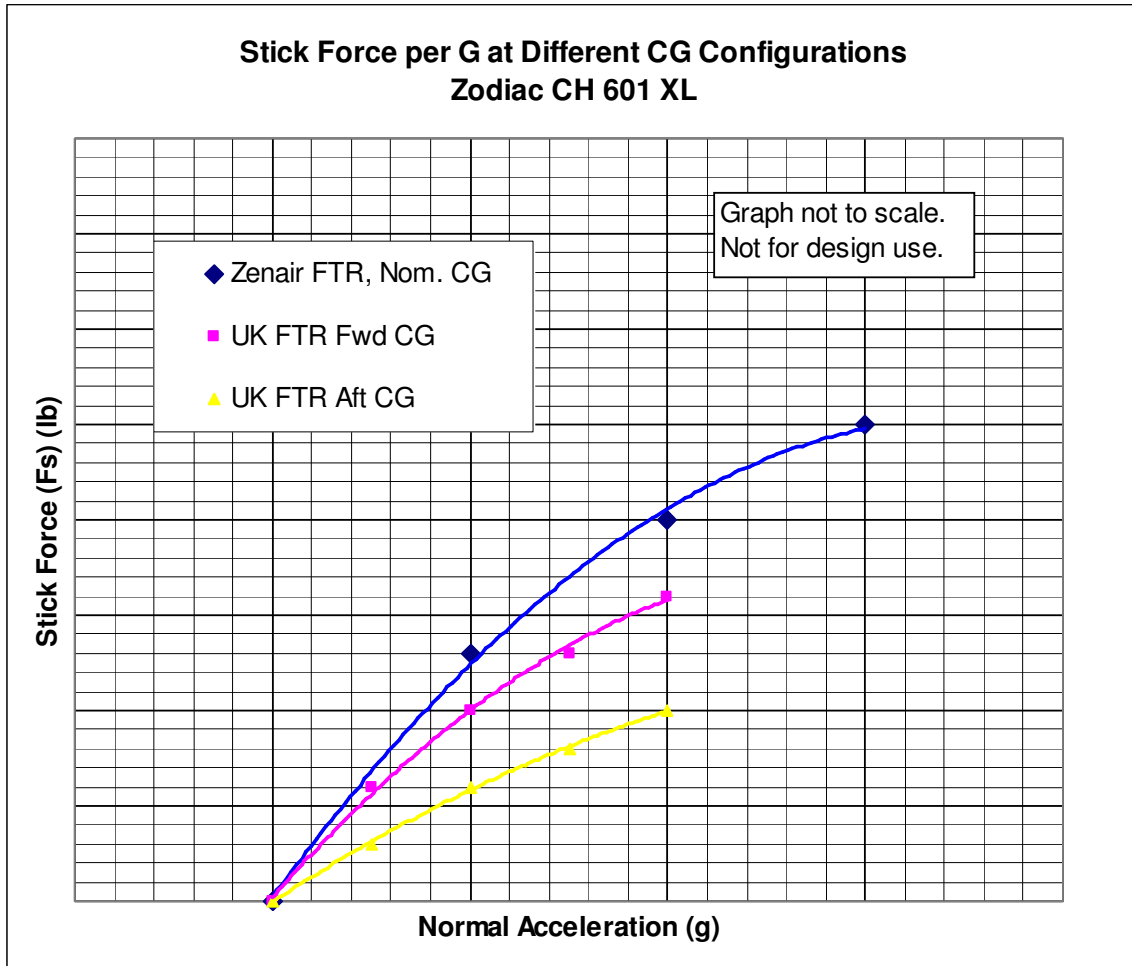
Figure 5: CH 601 XL Stick Force per g Evaluation

The NTSB recommended testing the aircraft stick force per g at maximum aft center of gravity. However, there is no regulatory requirement for testing in this configuration in either the ASTM standard or in 14 CFR Part 23 § 23.155. For reference, the FAA's applicable guidance in AC 23-8B recommend testing at aft heavy and light center of gravity configurations to verify proper control forces.

Though not required to do so, it appears their tests followed the guidance provided by AC 23-8B. However, when applying this guidance to aft center of gravity data to match compliance with 14 CFR Part 23 § 23.155(a), Figure 5 shows the stick force at limit load appears to extrapolate to a value slightly less than the 15 pound minimum requirement at limit load. Though the CH 601 XL does not have to comply with 14 CFR Part 23, the data does indicate that stick force gradients may not be acceptable for aircraft that are intentionally or unintentionally flown outside the POH center of gravity limits. This is simply presented for regulatory comparison, as 14 CFR Part 23 § 23.155(a) is not currently reflected in the ASTM standards at any center of gravity configuration.

- The current ASTM Standard F2245, 4.5.2.2 is actually more stringent than its 14 CFR Part 23 § 23.155(c) counterpart and may remain unchanged.
- The ASTM standard does not currently require a minimum control force at the limit load factor. ASTM International should amend their standards to require a minimum control force at limit load factor, similar to concepts defined in 14 CFR Part 23 § 23.155(a).

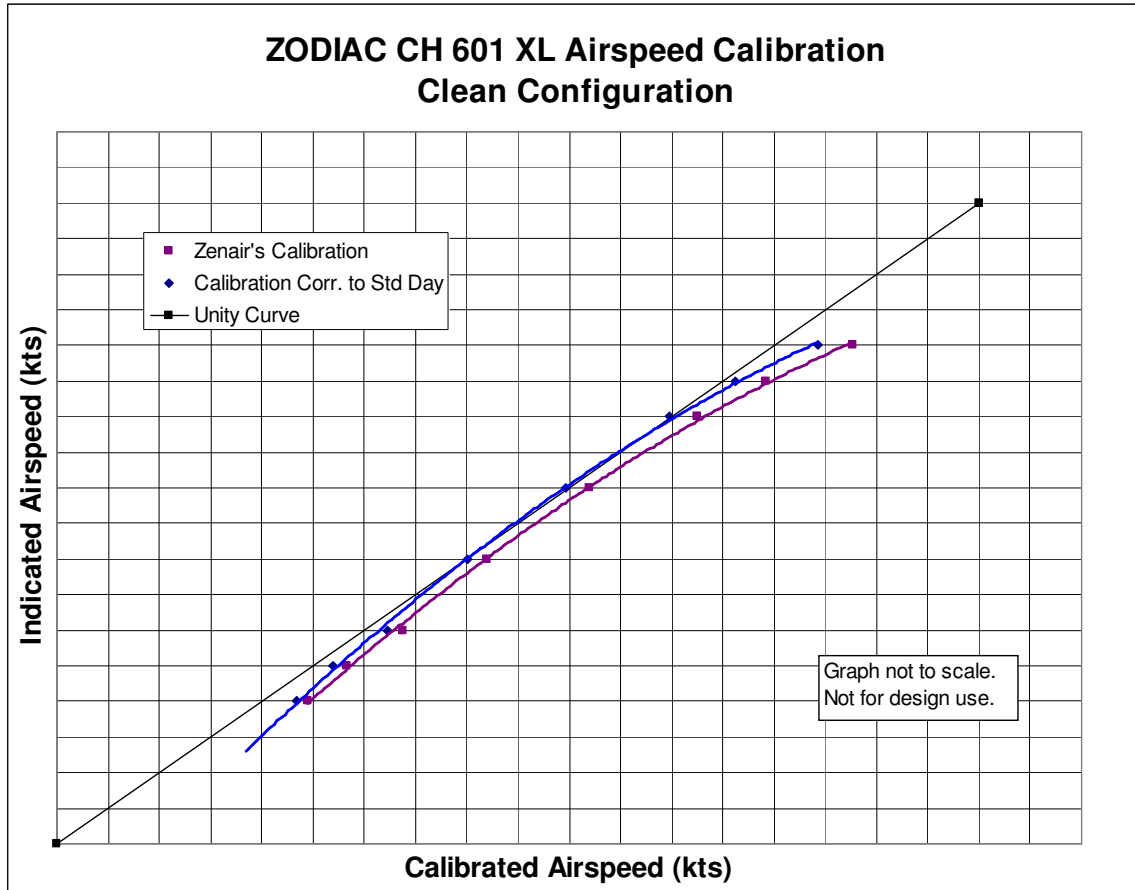
Figure 6: Standard Day Correction Effects on CH 601 XL Airspeed Calibration

Regarding stall speed, the manufacturer's flight test report determined the flaps up stall speed to be 35 knots indicated airspeed (KIAS) (40 mph) which was reported as 43 knots calibrated airspeed (KCAS) (50 mph). In reality, it was 43 knots true airspeed (KTAS) (49 mph), which after correcting to standard day conditions; the stall speed is calculated to be 41 KCAS (47 mph). The manufacturer's Airplane Flight Manual (AFM) reported a 43 knot (49 mph) flaps up stall speed indicating that standard day corrections were not applied to the flight test data.

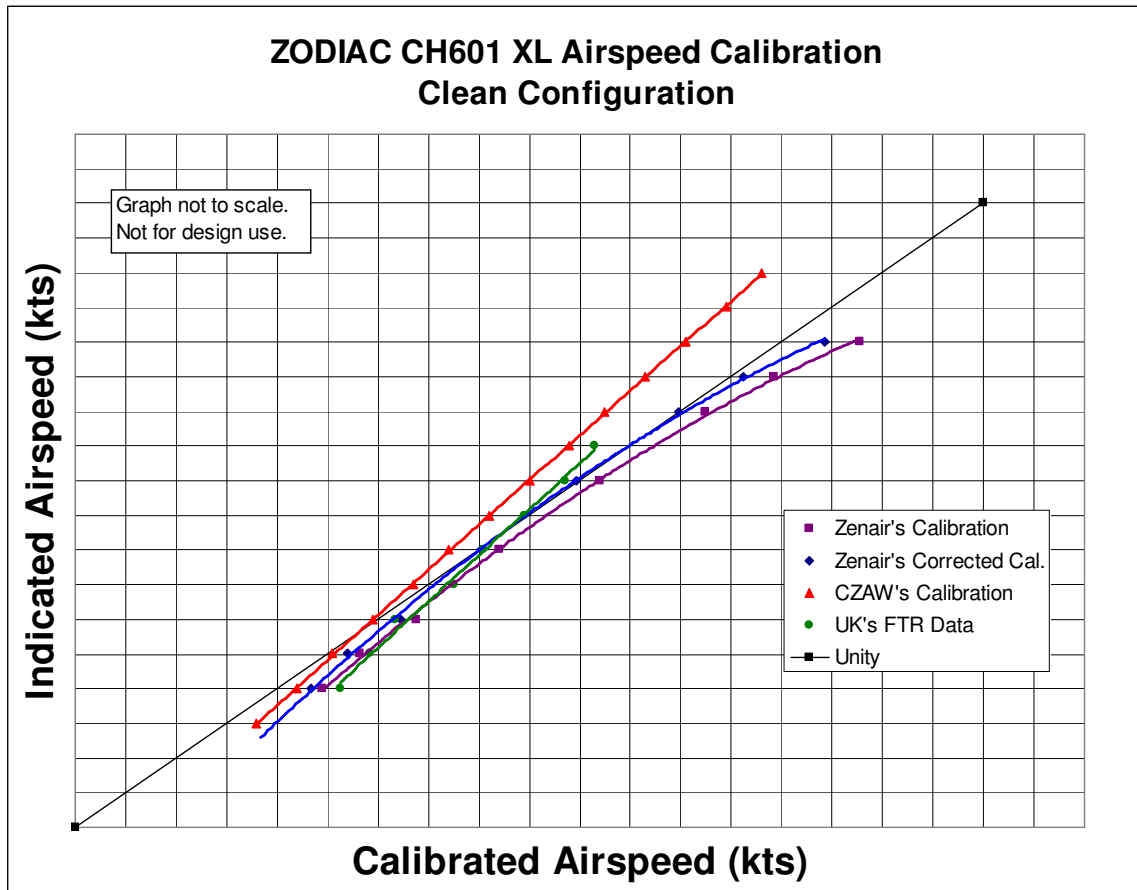
Figure 7: Zodiac CH 601 XL Airspeed Calibration Comparison

A comparison was made between CZAW and the manufacturer's airspeed calibrations. The calibrations were substantially different in both shape and magnitude. Without the flight test report, it is impossible to say which calibration is correct assuming that both designs are identical. Therefore, the potential to overspeed the aircraft exists. However, as part of the UK LAA flutter mitigation flight test program, an airspeed calibration was conducted and the results were overlaid with those from the manufacturer and CZAW, as seen in Figure 7. (Note: We have removed the actual airspeed values from figures 6 through 8 to protect the manufacturer's proprietary information and data.)

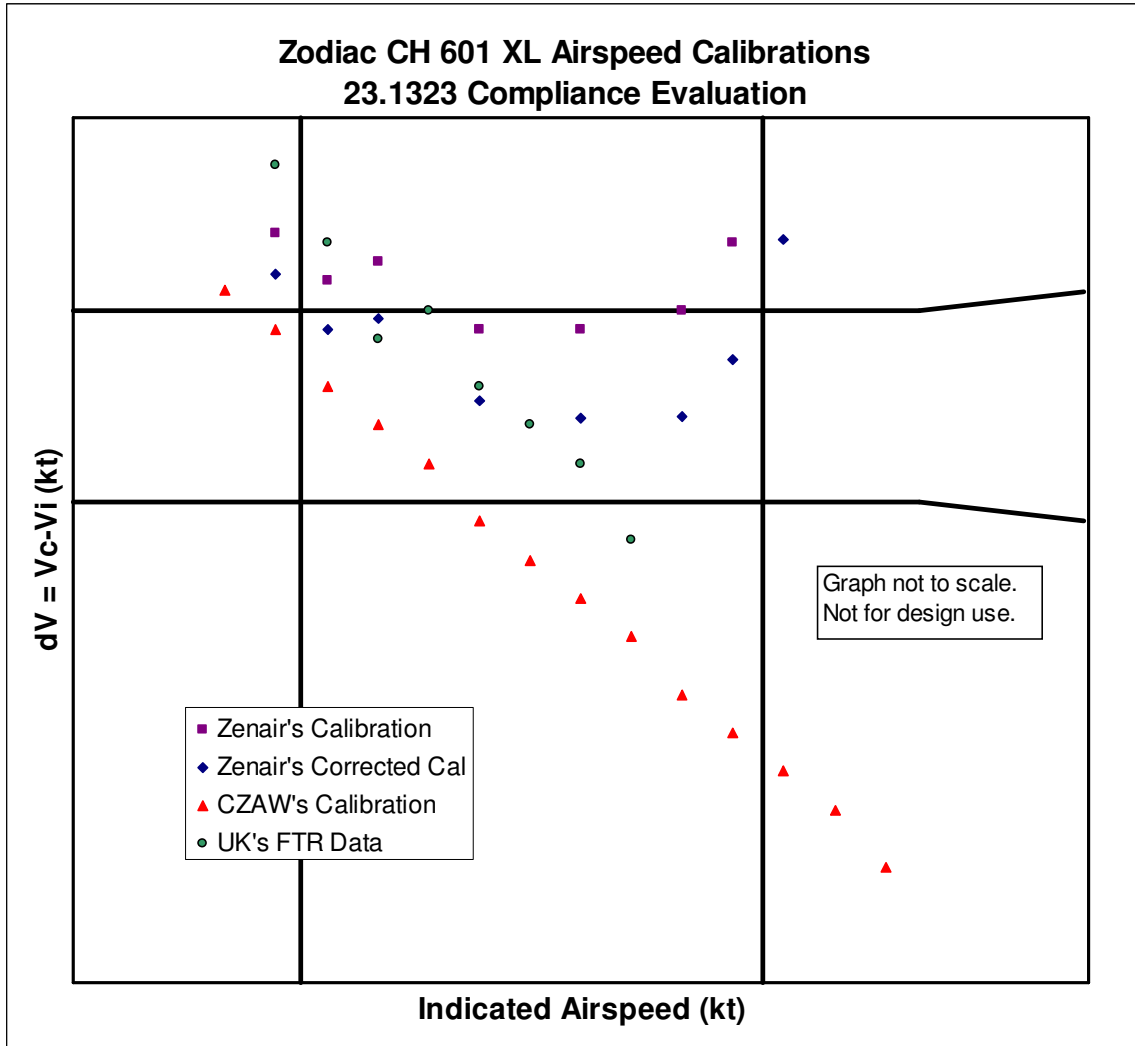
Figure 8: Zodiac Airspeed Calibration Evaluation per 14 CFR Part 23 § 23.1323(b)

The UK LAA's flight test results are similar in magnitude to the manufacturer's data, but trend with CZAW's data making the comparison inconclusive. Using a different approach to determine the validity of the calibration data, a 14 CFR Part 23 § 23.1323(b) analysis was performed on these data sets and shown graphically in Figure 8. It should be

To evaluate the airspeed error per 14 CFR Part 23 § 23.1323(b), the error dV , must be less than ± 5 knots or 3% bounded by a lower airspeed of $1.3V_{S1}$ to a maximum airspeed of V_{NE} . Using the manufacturer's values, this means that to meet 14 CFR Part 23 § 23.1323(b), all the applicable data needs to fall in the enclosed ± 5 knot rectangle.

With these criteria in mind, the manufacturer's original calibration did not meet 14 CFR Part 23 § 23.1323 until after correcting for standard day temperature conditions. For comparison, neither CZAW nor the UK LAA's data meets 14 CFR Part 23 § 23.1323, though they are not required to do so. However it is unusual for a low speed aircraft like the CH 601 XL to need a -24 knot static source error correction, indicating a potential error in the calibration methods used. If corrected improperly, this large airspeed error could translate into approximately a 2.8g load difference at maneuver speed for the CH 601 XL and CH 650. This evaluation suggests the need for an ASTM standard similar to
