# **General Aviation Airworthiness Alerts**

**AC No. 43-16**

**ALERT NO. 230  
SEPTEMBER 1997**

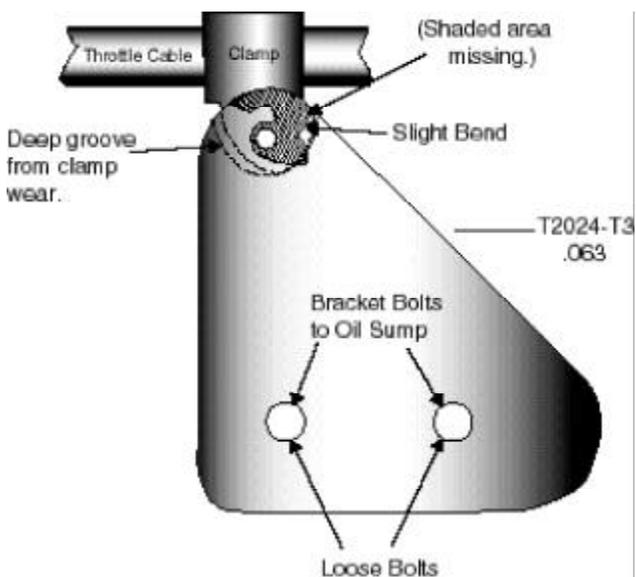
This aircraft was delivered to maintenance with a report of engine throttle failure.

An inspection disclosed that the throttle bracket support (P/N 169-910017-23) was severely damaged and broken. (Refer to the following illustration.) A section of the bracket was missing; therefore the throttle-cable clamp was no longer attached. The bracket had a deep groove where the clamp traveled, a slight bend, and the bolts used to attach the bracket to the oil sump were loose. Research of the manufacturer's parts manual revealed (P/N 169-910017-23) was the wrong throttle-support bracket. The correct bracket (P/N 169-910017-45) had been replaced by (P/N 169-910017-23).

When replacement parts are installed, maintenance personnel are urged to check that the specific part number matches the specific model of aircraft.

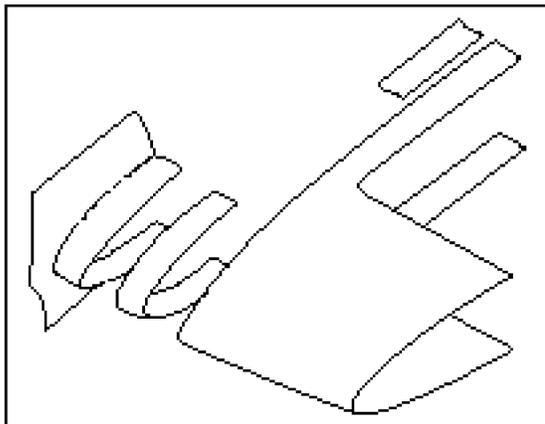
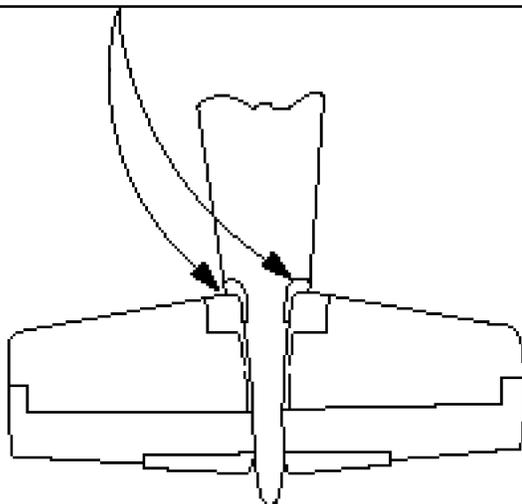
While complying with Airworthiness Directive (AD) 90-20-04, in conjunction with an annual inspection, the stabilator cuff fairing attachment fasteners were found improperly installed.

The left and right cuffs (P/N's 35-410504-15 and -16) were installed as part of a Beech Stabilizer Reinforcement Kit (P/N 35-4016-3). (Refer to the following illustration.) The "Cherry Max" rivets (P/N's CR3242-4-2 and CR3242-4-3) were of an inadequate grip length to penetrate the cuff, skin, and stringers. Further examination disclosed the cuffs had been installed upside down and on the wrong sides of the stabilator. (Left cuff was installed on the right side, and the right cuff was installed on the left side.) This was confirmed by the cuff part numbers when they were removed. When the cuffs were installed in this manner, there was a difference in the contour. This difference would not allow the rivet to penetrate and retain the intended structural members.

In the aircraft maintenance records, an entry was found for installation of the reinforcement kit. This entry was not in chronological order with other entries. It also had an improper date and there was no signature or certificate number. Other entries were found which did not comply with the requirements of Title 14 of the code of Federal Regulations (14 CFR) part 43, section 43.9.

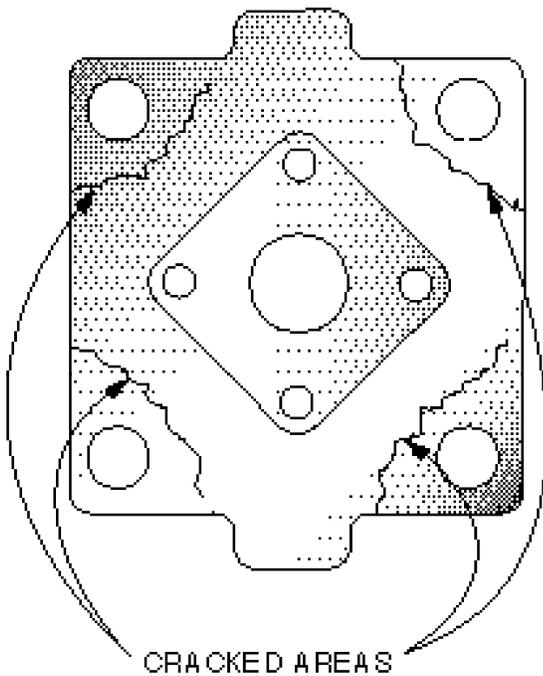
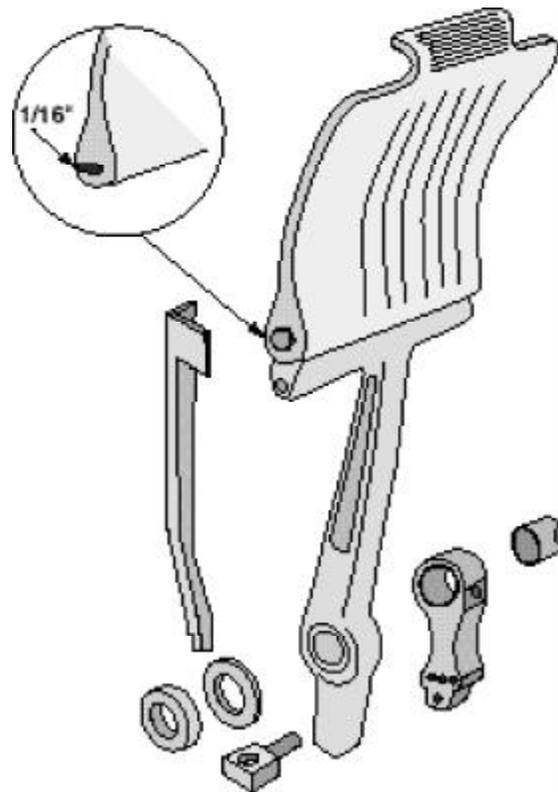
During a scheduled inspection, a hydraulic pump adapter was found broken.

The left engine hydraulic pump adapter (P/N 73303) was cracked or broken diagonally across each of the four corners. (Refer to the following illustration.) The adapter is used to attach the hydraulic pump to the engine accessory case. The submitter stated that many other failures of this type have been found. The cause of this failure was not given. This area deserves full attention during inspections and maintenance.

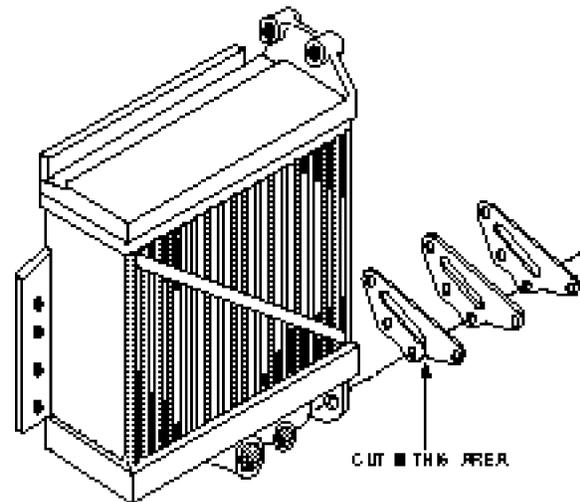
An investigation disclosed the source of the oil leak was between the oil cooler (P/N 641484) and the case. When the oil cooler was removed, the gasket (P/N 629116) was found cut. The spacer (P/N 634867, Fig 11, Index 2) was not required to be installed for this engine model (GTSIO520L0). (Refer to the following illustration.) While examining the gasket, uneven tear marks were found at random locations. The cause of this torn gasket could not be determined. It was suggested that gaskets be closely examined before installation and that care be taken to prevent damage during installation.

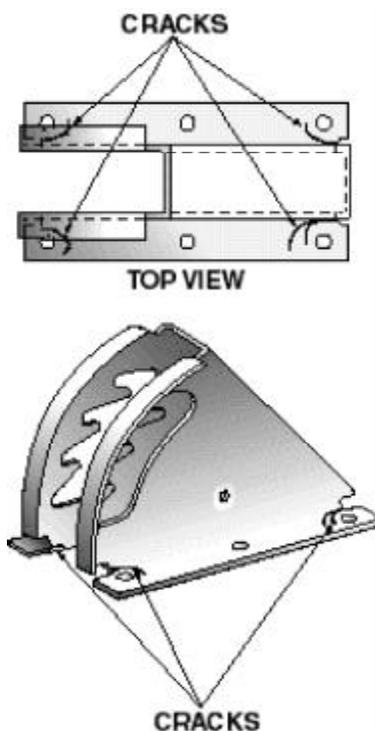
While complying with Piper Service Bulletin 965, the wing flap detent bracket was found cracked.

Several cracks were found, and each corner of the flap bracket (P/N 62706-00) had at least one crack. (Refer to the following illustration.) All of the cracks were adjacent to holes used to mount the bracket. This bracket deserves close attention during scheduled inspections and maintenance.
