General Aviation Airworthiness Alerts

AC No. 43-16

**ALERT NO. 235
FEBRUARY 1998**

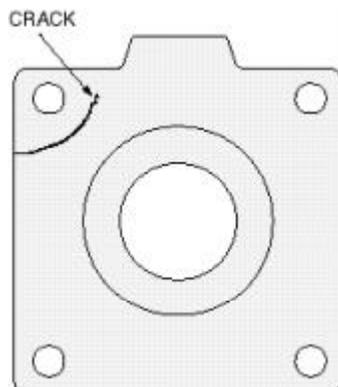
Beech Model 65 Queen Air	Hydraulic Pump Adapter Failure 2913
-----------------------------------------	----------------------------------------------------

During a scheduled inspection, the right engine hydraulic pump adapter was found cracked.

The crack was discovered while the source of an engine oil leak was being investigated. The adapter is secured to the engine accessory section by four bolts which pass through the adapter flange. The submitter's organization operates a fleet of 17 like aircraft. The submitter stated that this defect is common, and that approximately eight similar failures occur each year. The crack may occur at any of the four attachment points. (Refer to the following illustration.)

The submitter speculated the adapter flange should be "beefed up" to alleviate this problem.

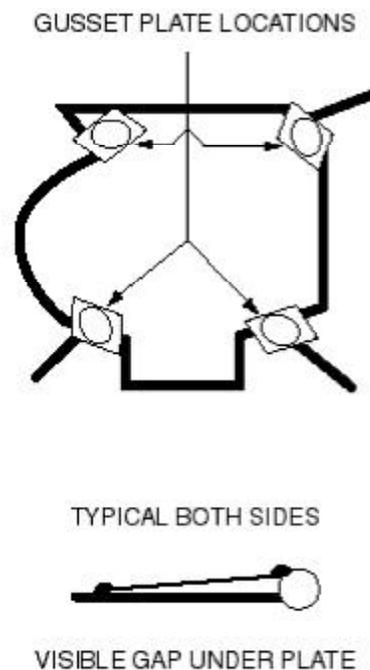
**Defective Engine
Mount
7120**

While a defective left engine mount was being replaced, the new mount (P/N 105-910010-77) was found defective.

The new mount was ordered from Kosola and Associates, Inc. Two of the weld joints were defective. The gusset plates on both upper brace arms were only tack welded to the brace arms. The submitter contacted the manufacturer. The manufacturer agreed the welds were not correct.

It is suggested that all owners of like aircraft, who have replaced engine mounts with parts from this manufacturer, should have the installation inspected for gaps under the gusset plates. (Refer to the following illustration.)

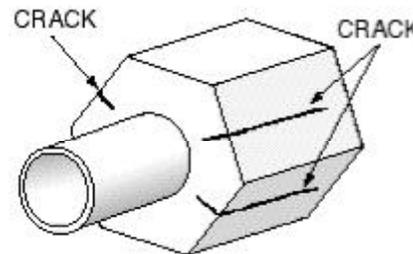
AFT BULKHEAD FITTING

A plumbing "B-nut" located at the aft bulkhead was found cracked in three places. Another "B-nut" at a "T-fitting" attachment was cracked in two places. (Refer to the following illustration.) These defective "B-nuts" were attached to an oxygen system tube (P/N 101-560140-1). Although the submitter did not offer a cause for these discrepancies, it is likely that overtorque and/or possible vibration played a key role in this failure.

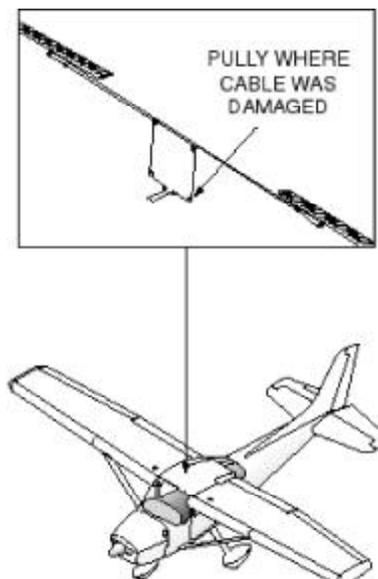
**Foreign Object
Damage (FOD)
2710**

During a scheduled inspection, the right aileron cable was found damaged.

The cable was frayed and mangled. It appeared that "something" came between the cable and the pulley. After further inspection, a round file was found around the cable area. The round file was approximately .1875 inch in diameter. The damaged cable and the pulley were located under the floor, just aft of the door, on the right side of the aircraft. (Refer to the following illustration.)

Once again, this case gives credence to the practice of conducting a "tool inventory" after completing every job!

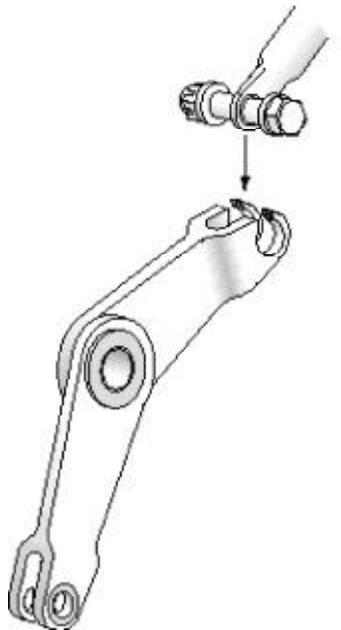
Schweizer Model 269C	Engine Control Linkage Failure 7603
---------------------------------	----------------------------------------------------

The engine throttle control failed; the engine went to idle RPM; the engine could not be controlled; a forced landing was required; and the aircraft sustained minor damage.

An inspection revealed that the interconnect rod, between the throttle servo bellcrank and the cable bellcrank (P/N 269A8418-21), had separated at the cable bellcrank pivot hole. (Refer to the following illustration.) Failure of this bellcrank occurred after 225 hours of operation, and the original bellcrank was replaced after 365 hours of operation. The manufacturer’s maintenance manual recommends inspection and lubrication of the bellcrank and linkage at 25-hour intervals.

The submitter recommended close adherence to the manufacturer’s published inspection and lubrication schedule.

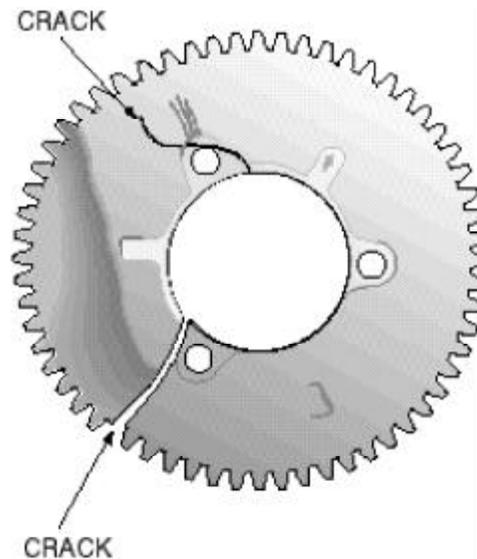
catastrophic failure during flight and deserves prompt attention.

It was recommended that all operators using the Model 532 or Model 582 engines should check the starter ring gear in accordance with SB 4UL90-E.
