# **General Aviation Airworthiness Alerts**

**AC No. 43-16**

**ALERT NO. 238  
MAY 1998**

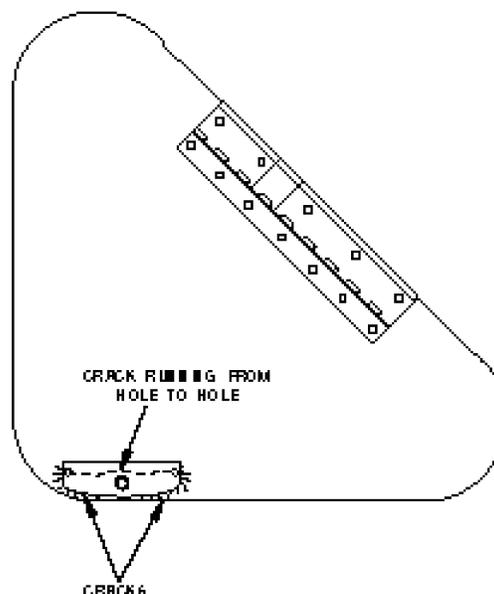
**Beech; Model 200; King Air; Defective Pilot's Storm Window; ATA 5610**

During a scheduled inspection, it was discovered that the pilot's storm window was cracked.

The storm window (P/N 101-420080-1) had numerous cracks emanating from the latch assembly. (Refer to the following illustration.) One of the cracks traveled between two screw holes used to attach the latch. The submitter did not offer a cause or cure for this defect. It would be wise to thoroughly inspect this area during scheduled inspections.

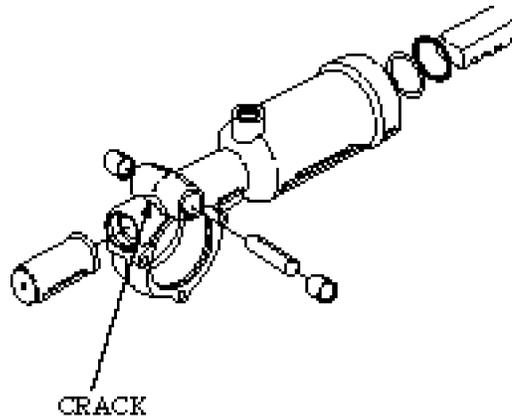
### **Cessna; Model 172RG; Cutlass RG; Main Landing Gear Actuator Housing Cracks; ATA 3233**

During a fleet inspection, it was discovered that twelve (12) main landing gear actuator housings (P/N 1281001-3) were cracked in the same area below the bearing cups (P/N S1997C7-8) on seven (7) different aircraft. All aircraft inspected had at least one actuator housing cracked in the same location. (Refer to the following illustration.)

Instances such as this should trigger the thought of a probable design flaw. Anyone coming in contact with this make and model aircraft should immediately look for similar indications of such cracking in this area. This report has been sent to the responsible FAA aircraft certification office for appropriate action.

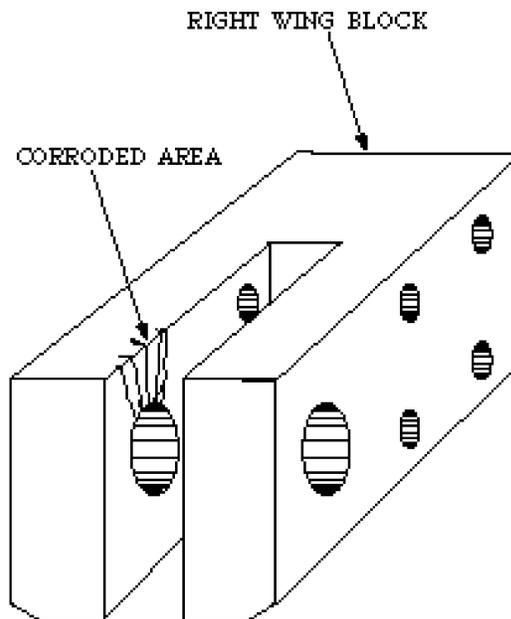
**Cessna; Model 182D; Skylane; Corroded Rear Spar Inboard Attach Blocks; ATA 5740**

During a routine fuel tank installation, the technician discovered a potentially dangerous area of corrosion at the wing attach points.

Upon removing the wings for fuel tank installation, the submitter discovered “intergranular corrosion” on both the left and right inboard rear wing spar attach blocks. The specific area of corrosion was located above the large bolt hole and inboard of the face of the slot. The corrosion

The submitter speculates this problem may have been due to the electrolysis process caused by dissimilar metals acting upon one another. The submitter further suggests, future incidents of such problems may be eliminated by treating the blocks with either zinc chromate paint or Alodine prior to installation.

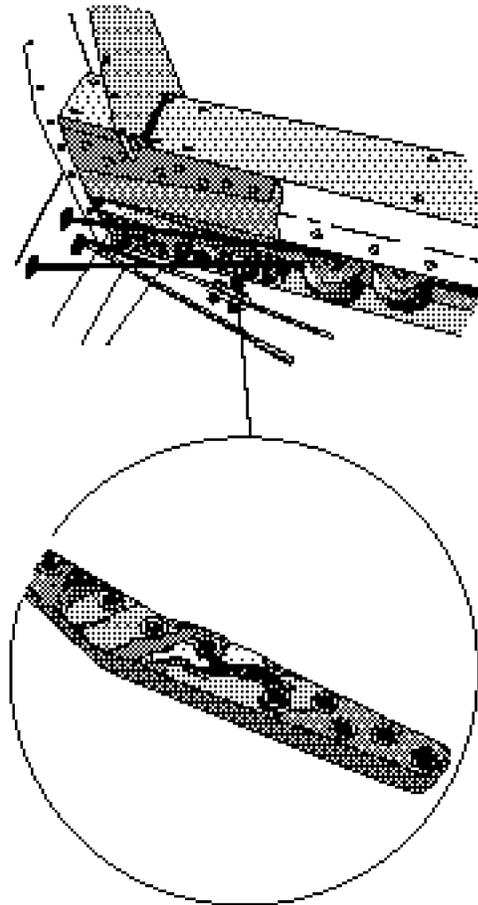
**Cessna; Model 320A; Skyknight; Cabin Bulkhead Damage; ATA 5312**

During an annual inspection, the rear cabin bulkhead support (P/N 0811075-10) was found buckled.

After disassembly and further inspection, a main structural fitting (P/N 0811276-3) was found severely corroded. The fitting was an integral part of the rear wing spar carry-through structure. The fitting surface had erupted due to intergranular corrosion and was structurally compromised. (Refer to the following illustration.)

This aircraft was manufactured over 30 years ago. The submitter speculated that the "fitting damage" was the result of "poor heat treatment" during the manufacturing process. This area deserves your full attention during scheduled inspections and maintenance.

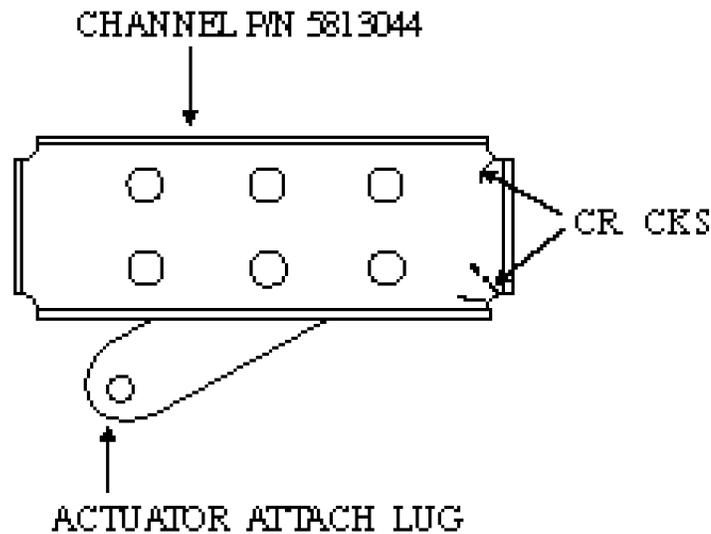
**Cessna; Model 404; Titan; Nose Gear Actuator Attach Bracket Cracks; ATA 3230**

During the installation of nose gear actuator attach lugs in compliance with a factory service bulletin, the technician noted structural cracks.

Both channels to which the lugs attach had cracks in the aft corner radii. (Refer to the following illustration.) The submitter speculates that one possibility for the cause could be incorrect rigging with insufficient preloading of the actuator against the drag brace which could have caused shock loads to be transmitted through the actuator to the attach structure.

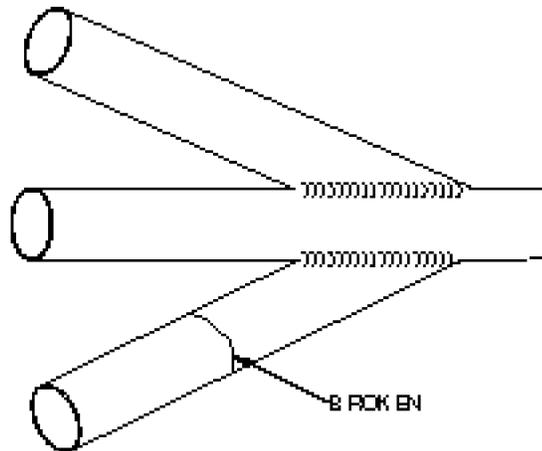
#### **Cessna; Model 441; Cracked Engine Mount; ATA 7120**

While performing an inspection to establish the cause of a rough-running engine, the submitter noticed a crack in the left engine mount tubing.

The specific location of the crack was on the lower tube of the upper inboard tubing cluster of the engine mount (P/N 5751006-1). (Refer to the following illustrations.)

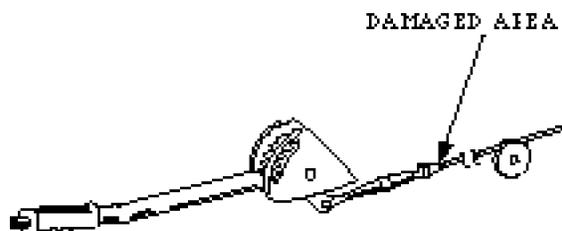
**Piper; Model PA 44-180; Seminole; Defective Wing Flap Control Cable; ATA 2750**

An inspection disclosed the wing flap cable (P/N 62701-101) was severely frayed. The cable was held together by only two cable strands. The frayed area was located just aft of the turnbuckle fitting attached to the flap control assembly. (Refer to the following illustration.) The location of the damaged area makes a thorough inspection very difficult. The submitter does not offer a cause for this defect; however, it seems likely that age and metal fatigue may have been contributing factors.

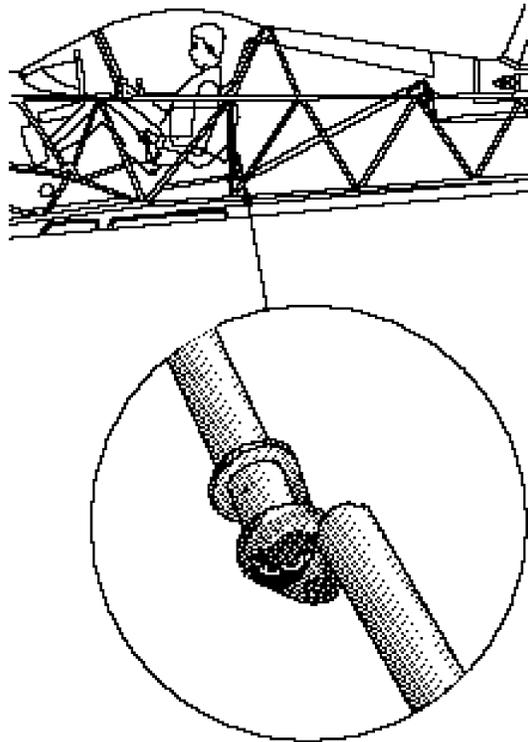
This aircraft is capable of unlimited aerobatics, and it is not uncommon to see plus or minus 10G indications. The submitter speculated this failure was caused by high "G loading" on the pilot's seat-back structure.
