# **General Aviation Airworthiness Alerts**

**AC No. 43-16**

**ALERT NO. 239  
JUNE 1998**

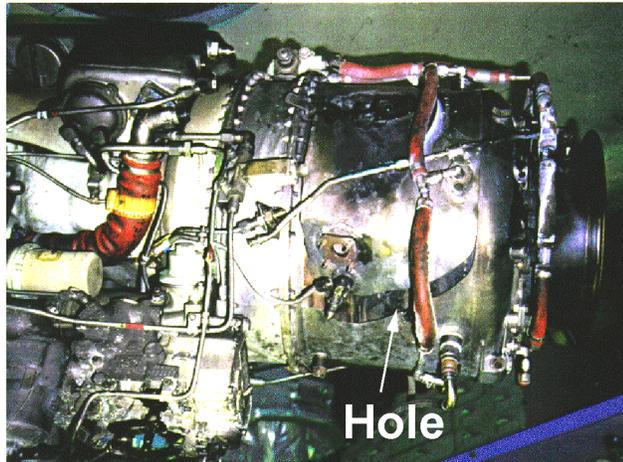
**Beech; Model B-100; King Air; Combustion Chamber Failure; ATA 7240**

Investigation of the aircraft determined that the left engine combustion case (plenum) had failed. The plenum (P/N 893973-5) had failed near the P-3 fitting boss and caused minor damage to the engine compartment's surrounding area. (Refer to the following illustration.)

The submitter recommends that the P-3 fitting boss/customer air-pad area of the combustion

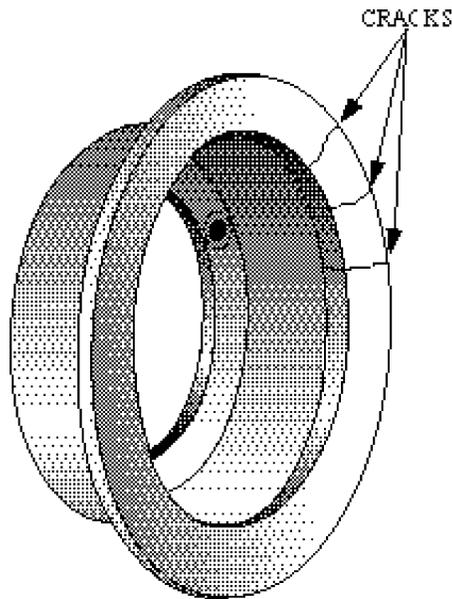
### Cessna; Model 172N; Skyhawk; Brake Disc Cracks; ATA 3242

Three cracks were discovered by visual inspection of the main landing gear brake disc (Cleveland Brakes, S/N not provided). The cracks radiated across the disc and extended completely through the disc. (Refer to the following illustration.)

The submitter stated that this is the third cracked disc that he has found this year.

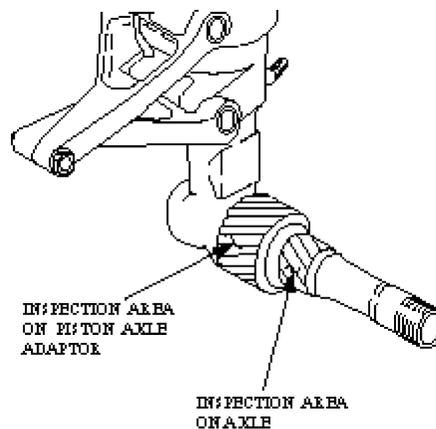
**Cessna; Model 560; Citation V; Main Gear Axle Corrosion; ATA 3213**

While performing Phase 1 and Phase 2 inspections on the aircraft, it was discovered that both main landing gear axles had corrosion. Item code number A324040 in the Phase 2 inspection requires the axle be inspected for presence of primer on the axle and axle adapter where the brake and brake adapter are located. (Refer to the following illustration.) The axle and axle

adapter did not have the required primer on them. As a result, light corrosion had already started forming. The corrosion was removed and corrosion-resistant epoxy primer was applied per the Citation Component Maintenance Manual.

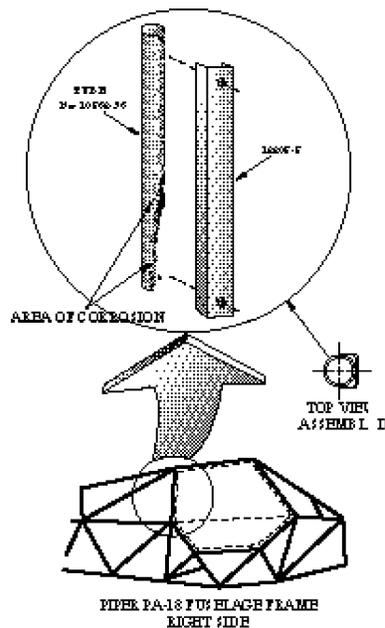
### **Piper; Model PA18; Super Cub; Frame Corrosion; ATA 5310**

An FAA-approved repair station, which rebuilds and repairs Piper PA-18 fuselage frames, has found severe corrosion on approximately 35 percent of the fuselages. One problem area is on the 5/8-inch vertical tube (P/N 10562-36) that extends from the top longeron, up to the rear wing attach fitting, on the right side at the aft upper door. (Refer to the following illustration.) The channel (P/N 12205-5) which is tack welded to this tube, is placed to provide proper clearance of the rear upper door. Apparently, trapped moisture behind the channel corrodes the 5/8-inch tube. This is a nearly impossible area to inspect unless the channel is removed. The area, not covered by the channel, generally remains relatively free of corrosion. The most prevalent area for corrosion is at the lower end; however, tubes are often corroded the entire length to the rear wing attach fitting.

The tube in question is the only vertical, load-carrying member to the right rear wing attach fitting. If indications of corrosion are found on this tube, the submitter recommends further inspection of tubes with like channel-covered surfaces for signs of corrosion.

Recommendation: The channel is a nonstructural part and at replacement of this, or other channels, proper breathing and ventilation should be provided. A channel replacement should include a 3/8-inch hole near the top and bottom. If these channels are to be covered with fabric, the fabric should be patterned and cut to provide ventilation.

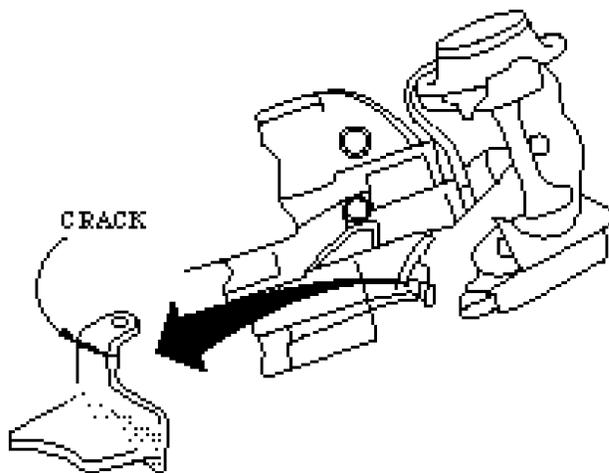
### McDonnell Douglas; Model MD 900; Main Rotor Droop Stop Support Bracket Failure; ATA 6220

During a scheduled inspection, all four of the main rotor head droop stop support brackets (P/N 900R2100001-103) were found broken.

It appeared that the droop stop support brackets cracked and ultimately failed. The brackets were broken at the bolt attachment point which secures the bracket to the main rotor head. (Refer to the following illustration.) This condition could cause the main rotor blades to contact the tail boom which could result in severe and possibly catastrophic damage.

The manufacturer was contacted and offered the following two possible reasons for failure of the droop stop support brackets: **1.** The pilot may have failed to center the cyclic stick prior to shutdown which can cause uneven loading of the main rotor system. **2.** The pilot may have made a hard landing.

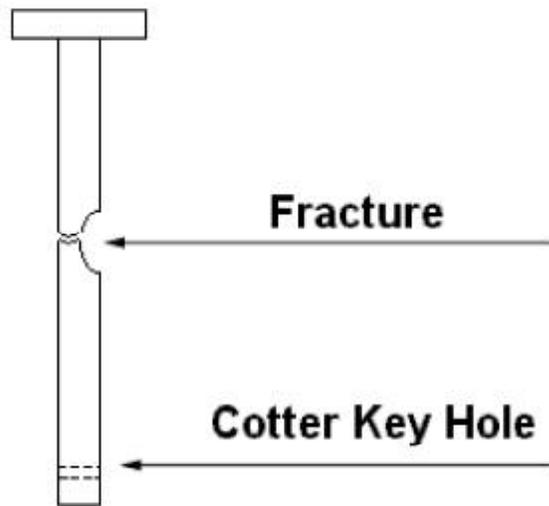
During postflight inspection, the lower hinge pin on the quick release cabin door assembly on a 1978 Aerobatic Bonanza F33C was noted to be out of normal alignment.

The submitter has ordered two new pins and will use less pressure in the future.
