Aviation Maintenance Alerts

AC No. 43-16A

**ALERT NO. 244
NOVEMBER 1998**

**Improve Reliability-
Interchange Service
Experience**

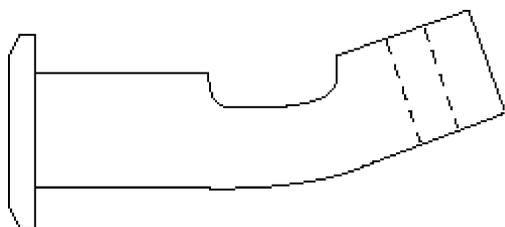
Beech; Model 300; King Air; Defective Entrance Door Latch; ATA 5210

An investigation revealed a bent and worn clevis pin in the forward upper door latch hook mechanism. (Refer to the following illustration.) The technician speculated that age and use contributed to failure of the clevis pin. During scheduled inspections and maintenance, pay close to the cabin door latching mechanism.

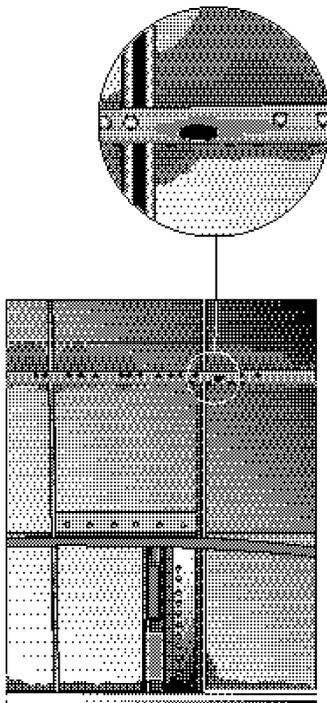
The pilot had to utilize a "G force" maneuver to get the gear loose and extended. The technician notified the manufacturer and an engineer from that company approved clearance modification to avoid further problems with similar aircraft in the future.

Boundary Layer issued Service Bulletin No. 103 to address this problem by providing a cut-out (see the following illustration) for additional clearance. The submitter also feels that the location and condition of the rubber bumper the gear is designed to rest against in the up-cycle process contribute to this problem.

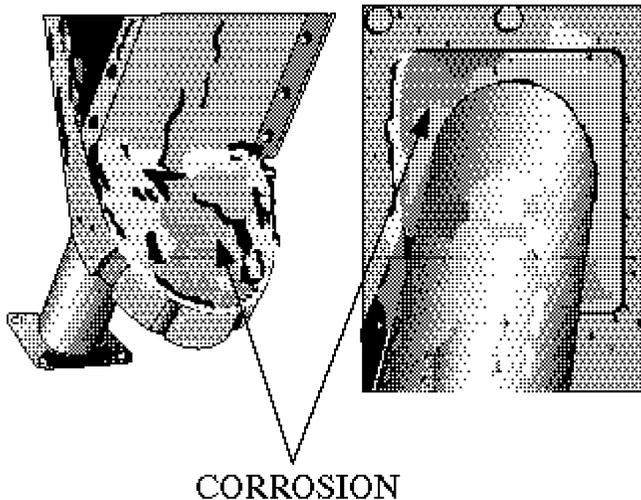
Piper; Model PA31T1; Cheyenne I A; Rudder Torque Tube Corrosion; ATA 2720

Closer inspection revealed heavy corrosion to the torque tube assembly (see the following illustration), and the technician determined that it was not fit for service. He also discovered that corrosion affected the bottom rib of the rudder.

The technician found residue of paint stripper when he removed the skin. Maintenance personnel painted the aircraft 5 years earlier according to the aircraft records.

fact that no drainage hole exists in the bottom of the rib added to the acceleration of the corrosion.

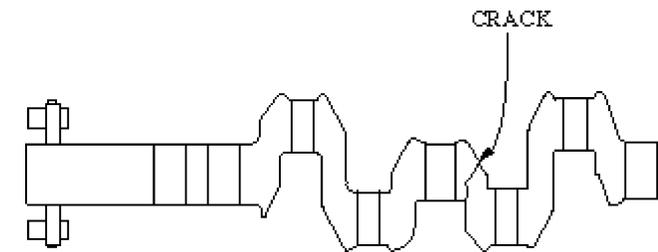
Piper; Model PA38-112; Tomahawk; Broken Crankshaft; ATA 8520

This aircraft was destroyed during a forced landing due to an engine crankshaft (S/ N L-21202-15) failure.

An investigation revealed a resulting fatigue crack adjacent to the center main bearing journal. (See the following illustration.)

The submitter recommends revising AD 91-14-22 requiring crankshaft inspection in accordance with Lycoming's Service Bulletin No. L163C, following any propeller strike.

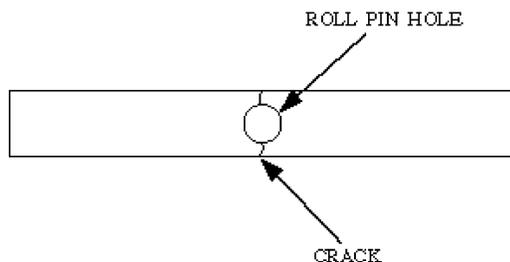
Piper; Models PA-28-140 and PA-28R-180; Cherokee and Arrow; Wing Flap Control Failure; ATA 2750

The Cherokee report stated the technician could not find the flap latching pin, and it appeared the pin fractured at the roll pin hole.

During an investigation, maintenance personnel discovered a broken flap handle latching pin. The latching pin broke at the .062-inch diameter roll pin hole. (Refer to the following illustration.) The roll pin retains the latching pin in the plug (P/N 62734-00). The area of the latching pin containing the roll pin is impossible to inspect. The technician cannot remove the roll pin for inspection without destroying the latching pin and plug.

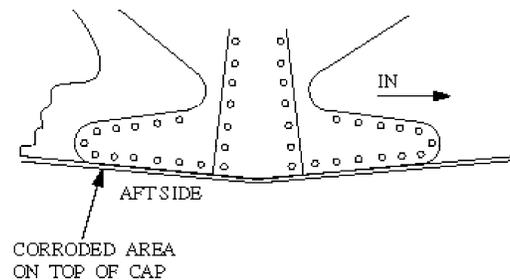
Piper; Model PA28-140; Cruiser; Inboard Main Spar Corrosion; ATA 5711

An inspection of the lower aft inboard section of the main spar cap (see the following illustration) revealed the presence of severe exfoliation corrosion.

The corrosion began approximately 1 inch under the outboard end of the wing attach doubler and extended to approximately 4 inches out from that point.

A crack resulted from the corrosion in the aft end of the spar cap which was approximately 1/8 inch in depth. Very mild surface corrosion

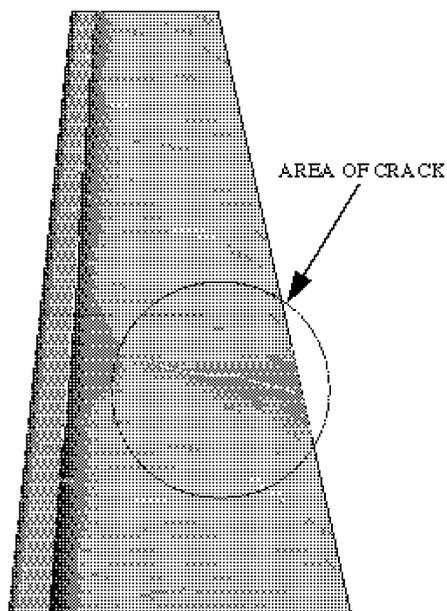
McDonnell Douglas; Model 369HS; Main Rotor Blade Defect; ATA 6210

This helicopter underwent a 100-hour inspection less than 6 hours before this incident. At that time, the helicopter did not display any damage or cracking. The technician recommended that all operators and technicians give full attention to the main rotor system during inspections and maintenance.

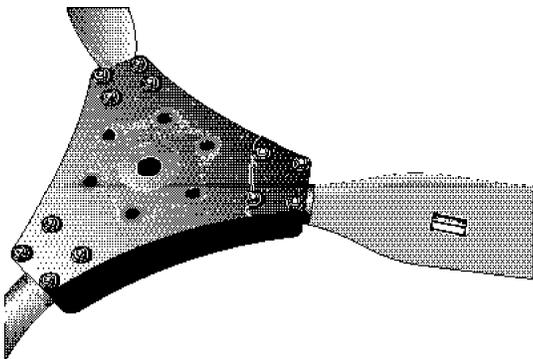
The submitter speculated "overtorquing" the mount bolts caused this damage. Before this occurrence, a technician loosened and tightened the blade mount bolts several times while adjusting the pitch for proper engine loading. The submitter suggested that the propeller manufacturer emphasize the importance of using a torque wrench to prevent overtorquing damage to the rear mounting plate.
