U.S. Department  
of Transportation  
**Federal Aviation  
Administration**

# **Aviation Maintenance Alerts**

**AC No. 43-16A**

**ALERT NO. 247  
FEBRUARY 1999**

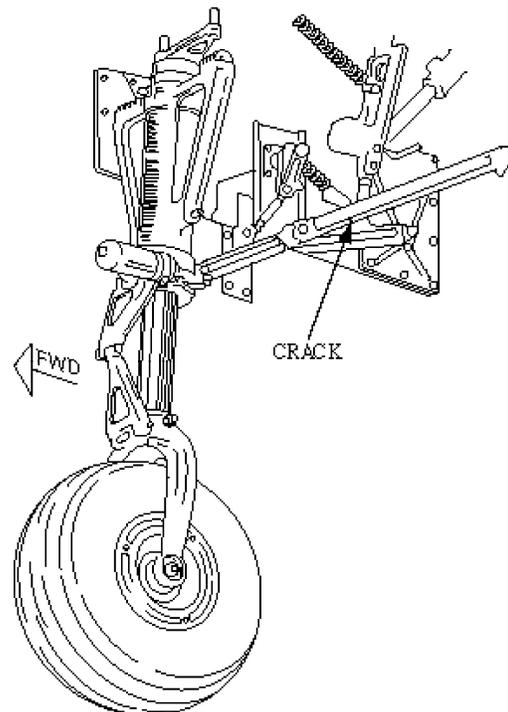
**Piper; Model PA 31-350; Chieftain; Nose Landing Gear Defect; ATA 3230**

While cleaning and inspecting the landing gear, a nose landing gear drag brace was found cracked.

The right upper drag brace link assembly (P/N 40336-00) was cracked where the actuator was attached. (Refer to the following illustration.) This was the second drag brace assembly the submitter found cracked.

Part total time-8,994 hours.

Maintenance personnel, owners, and operators should give this area special attention at every opportunity.

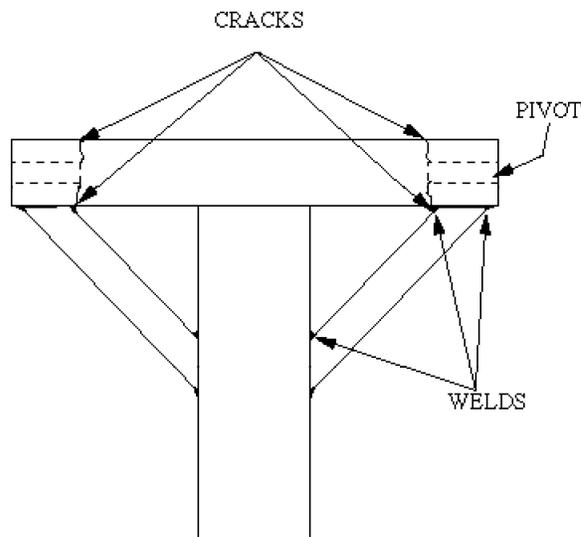
**Piper; Model PA 34-200; Seneca; Nose Landing Gear Trunnion Cracks; ATA 3221**

During a scheduled inspection, the maintenance technician discovered cracks in the nose landing gear trunnion.

The cracks were located at the trunnion (P/N 95713-04) pivot point attachments on each side. (Refer to the following illustration.) The cracks were approximately .5 inch long and were adjacent to the brace weld area.

The submitter stated this was the fourth like defect found on Seneca aircraft with similar time in service. It is recommended this area be inspected at every opportunity.

Part total time-8,800 hours.

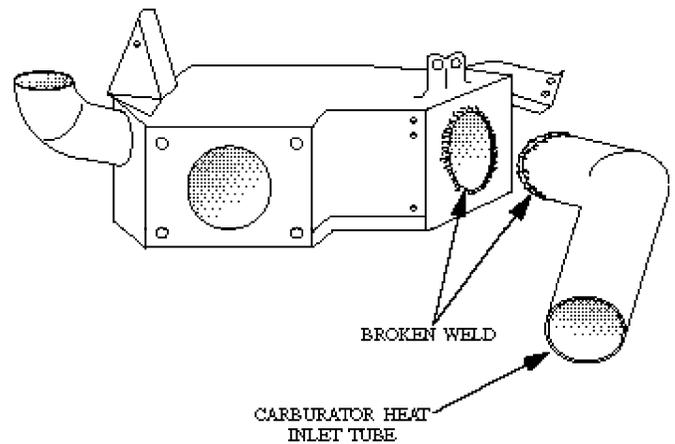
**Piper; Model PA 44-180; Seminole; Broken Carburetor Intake Air Box; ATA 7160**

During a scheduled inspection, the technician found the right engine carburetor intake air box was broken.

The air intake box assembly (P/N 86245-34) was broken where the carburetor heat inlet tube is attached by a weld. (Refer to the following illustration.) The submitter

speculated this failure was due to a "poor welding" technique. During the first 100-hour inspection, at 99.6 hours total aircraft time, the left engine air intake box was found in the same condition.

Aircraft total time-195 hours.

This area should be closely checked at every opportunity.

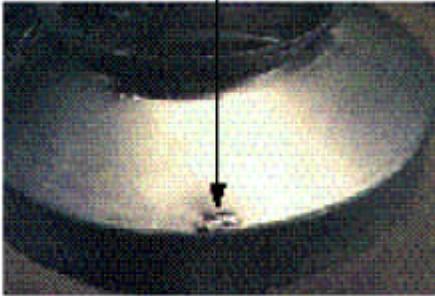
DAMAGED AREA AFTER REPAIR

**Raytheon; Model BAE 125-800A; Oil Leak; ATA 4990**

Evidence indicated the leak source was in the auxiliary power unit (APU) bay. An investigation disclosed that the APU oil sump tank had a hole chafed in the top section, and the oil tank had chafed against the engine mount beam sheet metal. (Refer to the following illustration.)

The oil tank was repaired, and the sheet metal was trimmed to provide adequate clearance.

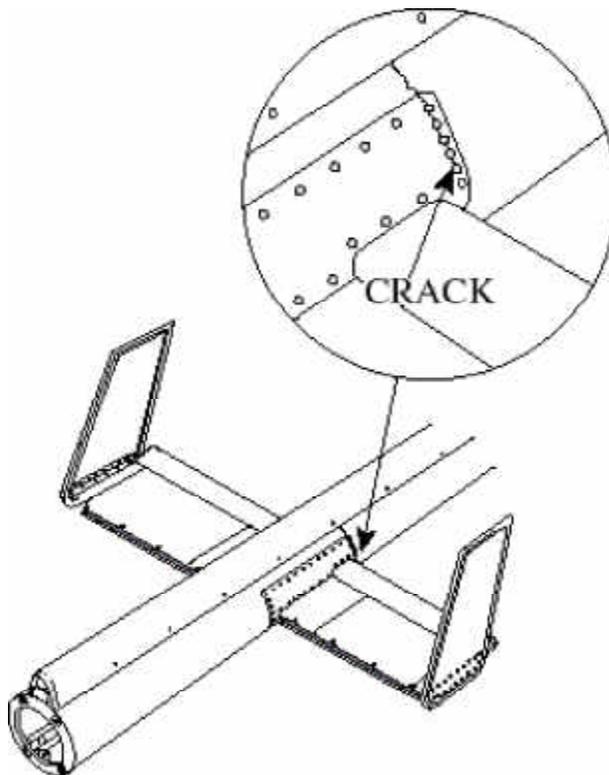
### Bell; Model 206I-1; Long Ranger; Tail Boom Crack; ATA 5302

During an inspection, the technician discovered a crack in the tail boom.

The crack was located at the aft end of an access panel on the left side, and the crack ran vertically. The crack originated at the fifth panel fastener hole down from the top of the panel, ran upward passing through the other fastener holes, and terminated in the upper part of the tail boom. (Refer to the following illustration.)

The submitter did not offer a cause for this defect.

Part total time-9,945 hours.

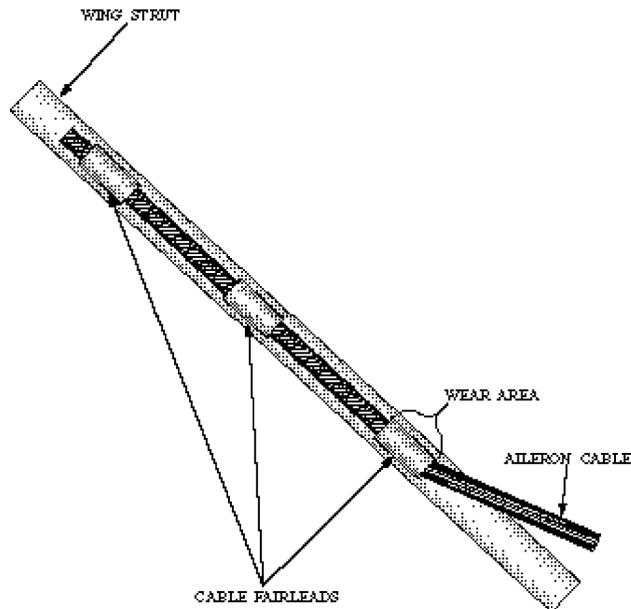
During a scheduled inspection, the technician found a "slightly flat spot" on an aileron control cable.

The flat spot was on the right aileron cable adjacent to the inboard fairlead on the wing strut. After cleaning the cable, a rag test revealed broken and badly worn cable strands. The left aileron control cable was also inspected, and it exhibited the same type of damage. The damaged area on the left cable was not easily detected because material, which was abraded from the adjacent fairlead, filled in the cable. After the cable was cleaned, the damage was evident.

It appeared that the aileron cable damage on both sides was due to the misalignment of the cable and the fairlead. (Refer to the following illustration.) The submitter stated that

Part total time-392 hours.

a pulley installed at this location would eliminate interference of the cable and fairlead.

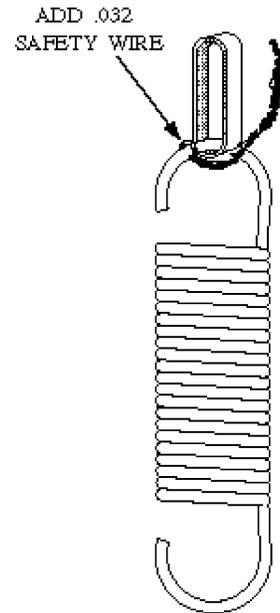
Aircraft total time not reported.

This problem may manifest itself in any aircraft configured with similar tailwheel spring retention clips. It was recommended that the retention clips be safety wired for security. (Refer to the following illustration.)
