Aviation Maintenance Alerts

AC No. 43-16A

**ALERT NO. 249
APRIL 1999**

**Improve Reliability-
Interchange Service
Experience**

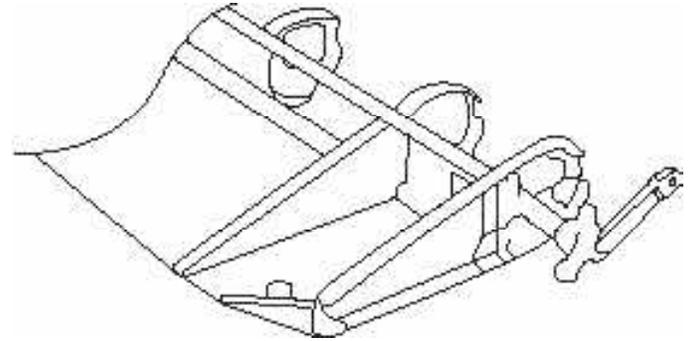
Beech; Model B99; Airliner; Defective Elevator Control System; ATA 2730

During a scheduled inspection, the technician discovered the elevator torque tube support was cracked.

The torque tube assembly (P/N 115-610010-325) support cracked where it is attached to the elevator. (Refer to the following illustration.)

Structural failure at this location can result in a loss of aircraft control.

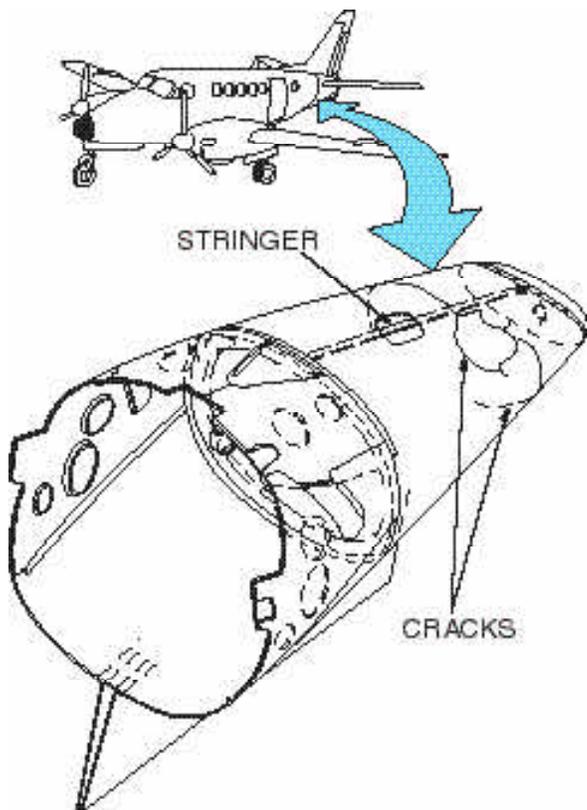
Beech; Model B100; King Air; Tail Cone Structural Damage; ATA 5500

An investigation revealed the tail cone (P/N 50-410052-9) was cracked around approximately 60 percent of its circumference. The crack was located about 18 inches from the aft end of the tail cone. There were several smaller cracks originating at the

stringer fasteners. The stringer (P/N 115-440029-85) was broken, at two locations, where the skin crack intersected. (Refer to the following illustration.) There was evidence of chafing wear on the broken ends of the stringer which appeared to be the starting point of the cracks.

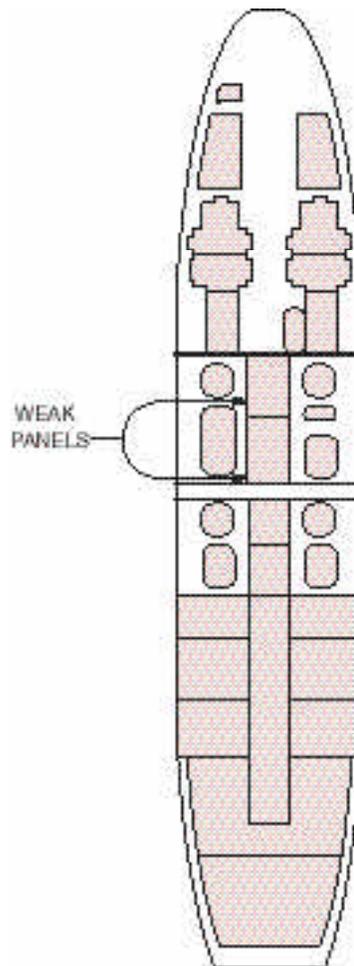
Beech; Model B200; King Air; Weak Floor Panel Structure; ATA 5321

Two of the fuselage's center floor panels, which are attached by a "Camlock" fastener, flexed downward under normal passenger weight.

following illustration.) The technician contacted the manufacturer and recommended the installation of cross braces to prevent floor panel flexing.

The submitter stated older B200 models used a single floor panel instead of two floor panels. The single floor panel design was more structurally substantial and did not flex. Even though the single floor panel design is more difficult to remove, it does not flex and allow interference with electrical components.

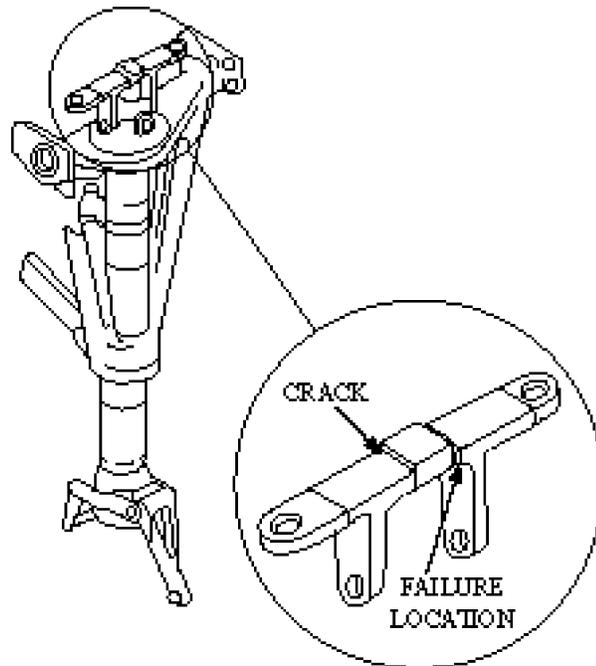
Cessna; Model T303; Crusader; Nosewheel Steering Failure; ATA 3250

A technician inspected the steering system and discovered the bellcrank (P/N 2543012-1) located at the top of the strut housing was broken. The bellcrank was damaged on both sides of center, the right side was cracked, and the left side was broken. (Refer to the following illustration.)

On page 7, of the December 1998 edition of this publication, an article recounted a very similar occurrence on a Cessna, Model 402B aircraft. A bit of research indicates that although the Model 303 lists a different bellcrank part number than the Model 402B, the parts appear to be the same. The FAA Service Difficulty Program data base contains 12 additional failure reports listing part

number 5042010-1 and one additional failure report listing part number 2543012-1. The 5042010-1 part numbers are used on Cessna Models 310R, T310R, T310Q, 402A, 402B, 404, and possibly others. It would be an excellent idea to check these bellcranks closely at every opportunity.

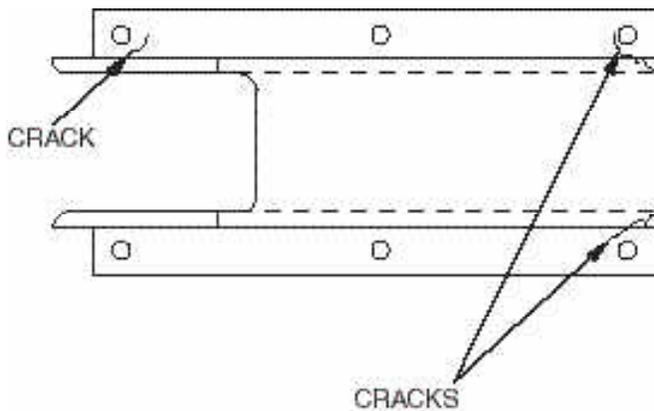
Piper; Model PA28-140 (PA28A); Cherokee 140; Cracked Flap Handle Bracket; ATA 2700

While performing routine maintenance in compliance with Airworthiness Directive (AD) 96-11-03 pertaining to the flap handle attach bolts the technician discovered that three of the four corners of the flap lever bracket (P/N 62738-00) were cracked. The cracks emanated at the radius stress-relief cuts on the mounting flanges. (Refer to the following illustration.)

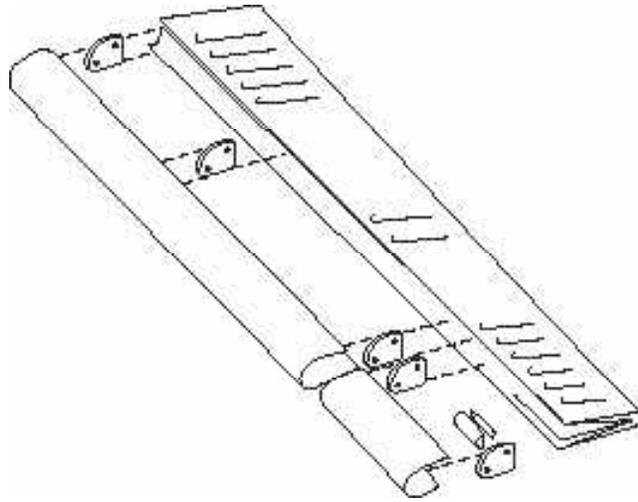
Piper Service Bulletin (SB) No. 1011 requires an inspection of the "inboard" hinge area. While complying with SB No. 1011, the submitter noted the area requiring inspection is actually the "outboard" hinge area. (Refer to the following SB No. 1011 illustration.)

The submitter stated the drawing is correct; however, the first page of SB No. 1011 erroneously refers to the "inboard" hinge when it should address the outboard hinge.

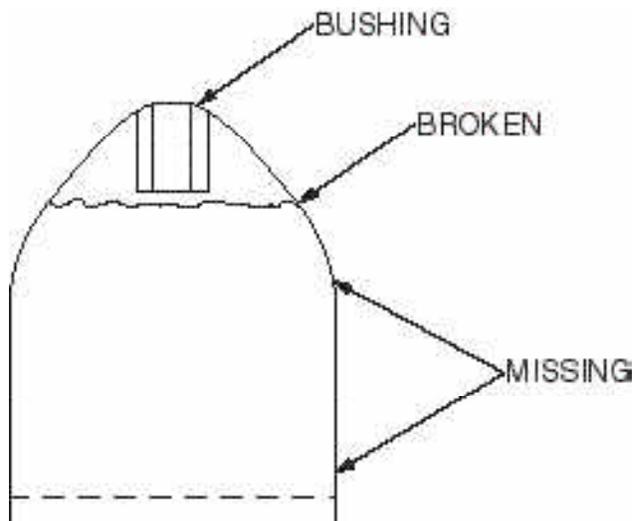
While performing an annual inspection, the technician noted the left intercooler clip (P/N 89082-003) was separated from its attach point. When the clip separated, the majority of the clip was missing, and only the screw and welded bushing remained. (Refer to the following illustration.)

The submitter suggested the manufacturer should consider bonding the clip to the side of the intercooler with a high-temperature adhesive which would prevent the device from separating.

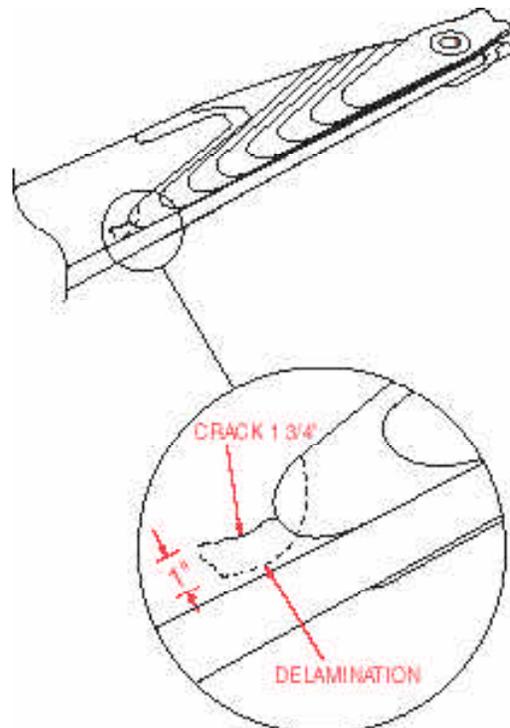
Bell; Model 206L-1; Long Ranger; Main Rotor Blade Damage; ATA 6210

During a daily inspection, a technician discovered a crack in the lower skin of a main rotor blade (P/N 206-015-001-107).

The crack was approximately 1.75 inches long, and it appeared to originate at the end of a "finger doubler" on the lower blade surface. Also, an area of approximately 1 inch by .5 inch was discovered under the doubler. (Refer to the following illustration.)

The technician replaced the blade, but he did not give a cause for this defect.

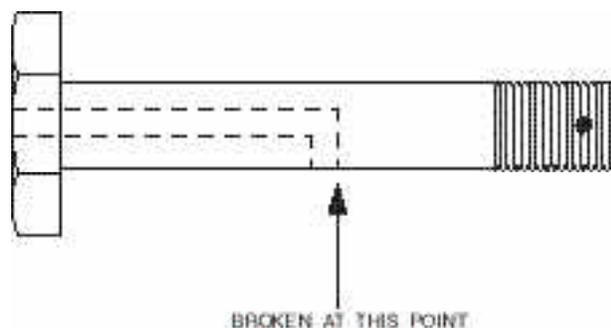
**AGRICULTURAL
AIRCRAFT****AYRES THRUSH****Ayres Thrush; Model S2R; Commander; Main Landing Gear Attachment Failures; ATA 3211**

It is possible the damage was caused by a hard landing. The main landing gear attachment deserves your full attention during inspections and maintenance.

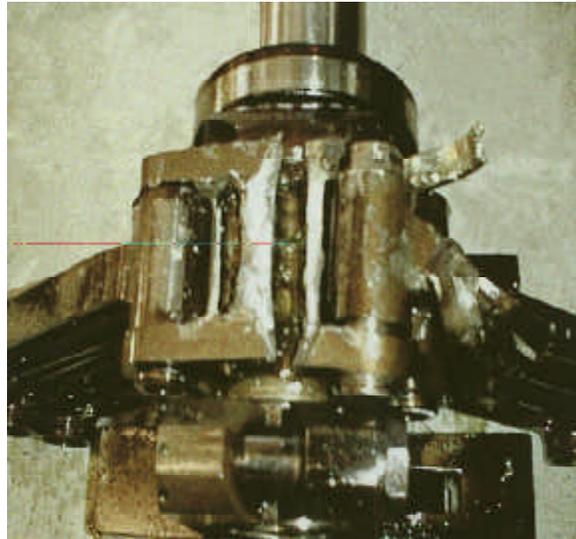
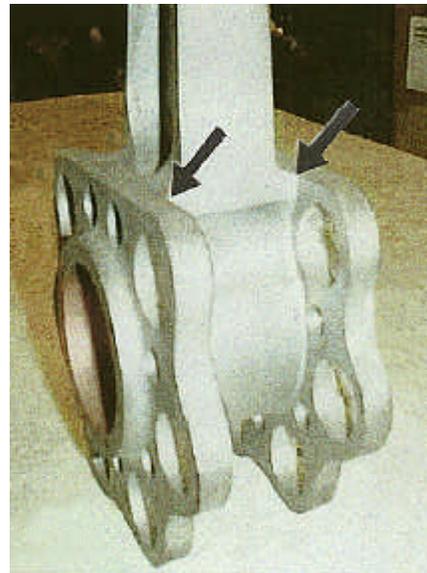
3. Due to the depth of the holes and the locations of the holes, it is difficult to properly magnaflux the area.

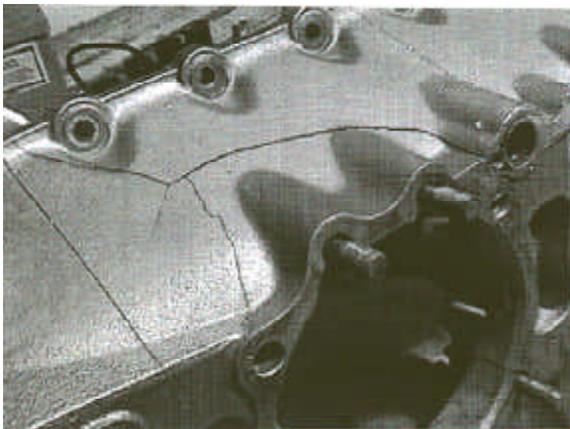
Teledyne Continental; Model IO-520; Engine Case Failure; ATA 8520

This engine was installed in a Beech, Model 58 Baron aircraft. The pilot reported that during flight, the right engine began running rough. The pilot made a safe landing.

The submitter stated an engine oil leak was very evident, and approximately 9.5 quarts of oil was lost. The source of the oil leak was a multiple fracture in the engine case at the base of the number 4 cylinder. The technician removed and disassembled the engine, and discovered cracks running through the case stud boss area. (Refer to the following illustration.) The cracks allowed the cylinder base stud nut to loosen, and the stud migrated inward until it contacted a crankshaft throw. The stud was propelled outward causing a "star-burst" shaped series of cracks. The opposite case half showed signs of hairline cracks at several of the stud bosses. Hairline cracks at these locations, which are not visible if the cylinders are installed, may indicate pending failure.

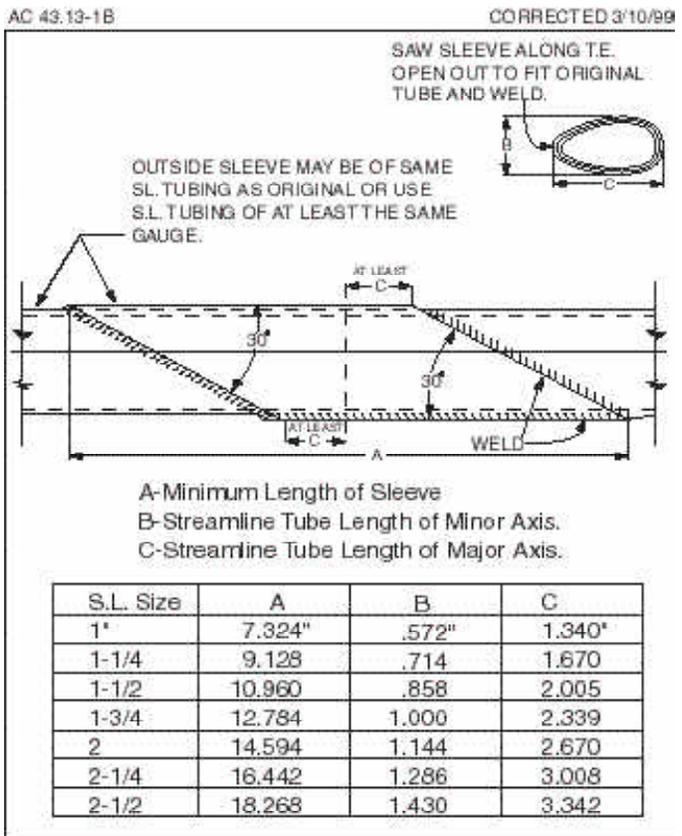
Figure 4-43. Streamline tube splice using split sleeve (applicable to wing and tail surface brace struts and other members).

The error appears on page 4-74, figure 4-43, of Chapter 4, Metal Structure, Welding, and Brazing. A table is included in figure 4-43, and the numbers in the table are not correct. (Refer to the following "corrected" table.)

This notice is intended to provide the correct data until AC 43.13-1B is revised. If you have questions or comments, please contact Mr. George Torres, AFS-610. The telephone number is (405) 954-6923, and the FAX number is (405) 954-4104.
