U.S. Department
of Transportation
**Federal Aviation
Administration**

Aviation Maintenance Alerts

AC No. 43-16A

**ALERT NO. 256
NOVEMBER 1999**

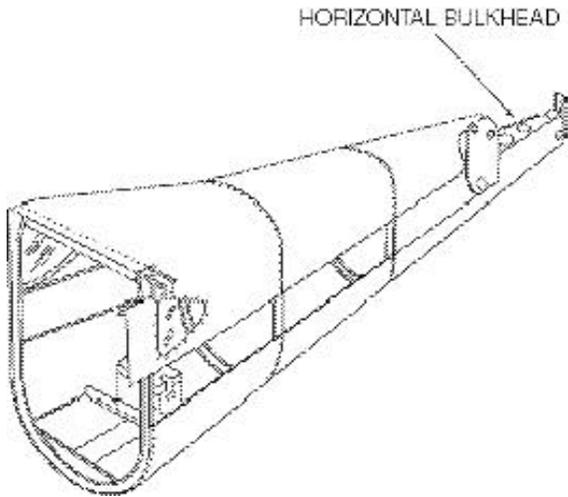
Cessna; Model 140; Empennage Structural Damage; ATA 5312

During an annual inspection, the technician found the elevator control cable tension low. Several attempts to adjust the cable tension failed to produce proper test results.

The technician inspected the elevator cable routing and discovered there was no pulley movement in conjunction with movement of the cable. Since there are no access panels in the tail section, it was necessary to remove the entire tail group structure for inspection. The technician found the aft horizontal bulkhead (P/N 0412112) cracked at several locations, and the elevator cables were "stretched." (Refer to the following illustration.)

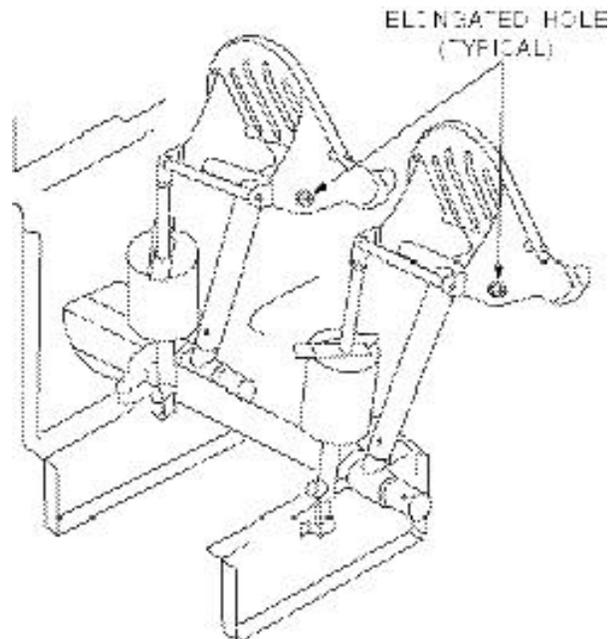
Cessna; Model 170A; Defective Rudder Pedals; ATA 2720

While removing the rudder pedals to facilitate other maintenance, the technician discovered severely elongated attachment holes.

The attachment holes on all four rudder pedals were elongated in the same wear pattern. (Refer to the following illustration.) The technician installed a doubler (.125 inch, 6061-T6 aluminum) on both sides of each attachment hole.

The submitter attributed this defect to “normal wear” following approximately 48 years of operation. He recommended that this area receive a close inspection, especially on older aircraft.

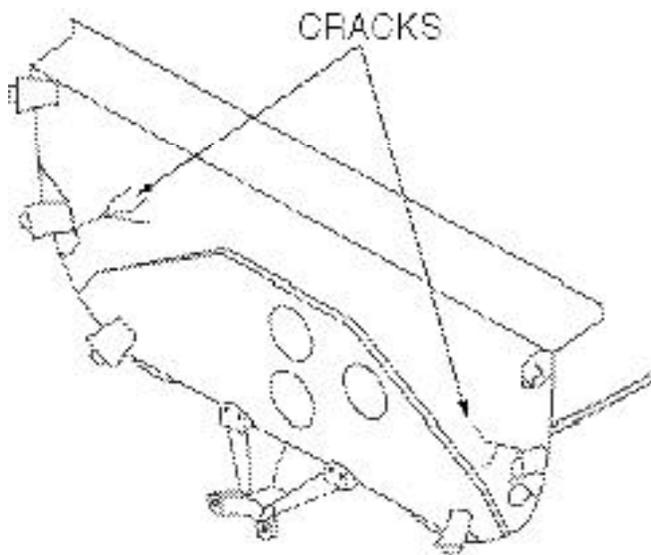
Cessna; Model 172R; Skyhawk; Firewall Cracks; ATA 5312

After removing the engine cowling for a 100-hour inspection, the technician discovered firewall cracks adjacent to the cowling shock mounts.

The technician found the firewall (P/N 0553031-1) cracked in the area of the left and right middle cowling mounts. (Refer to the following illustration.) Cessna Service Bulletin (SB) 98-53-02 deals with this subject.

Technicians complied with the inspection phase after 195 hours of operation with no defects found. There are three cowling shock mounts on each side of the firewall, the SB states that cracks may develop at any of these locations. Also, the SB gives a repair scheme for cracked firewalls. The submitter found cracked firewalls on three of four like aircraft. The SB applies to specific serial numbers of 172R and 172S model aircraft. Refer to the SB for specific aircraft applicability. The submitter urges all operators to comply with the SB as soon as possible. He also stated that this area deserves close attention during scheduled inspections.

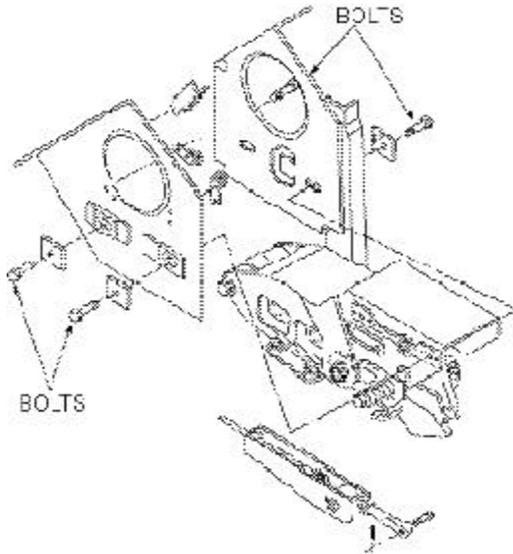
Cessna; Model 650; Citation; Defective Main Landing Gear Uplock Assembly; ATA 3230

During a scheduled inspection, the technician discovered a loose left main landing gear uplock assembly.

All four of the bolts (P/N AN4-7A) used to secure the uplock assembly (P/N 6214102-7) to the aircraft structure were loose. The bolts thread into self-locking nut plates (P/N MS21069L4) and have no other safety device. (Refer to the following illustration.) The technician applied "Loctite 271" to the bolt threads, and torqued the bolts to the proper setting. The right main gear uplock assembly was tight; however, the bolts were at less than the specified torque value. The submitter suggested that the manufacturer

use “drilled head” bolts (P/N AN4H-7A) at this location. The “drilled head” bolts can be safety wired.

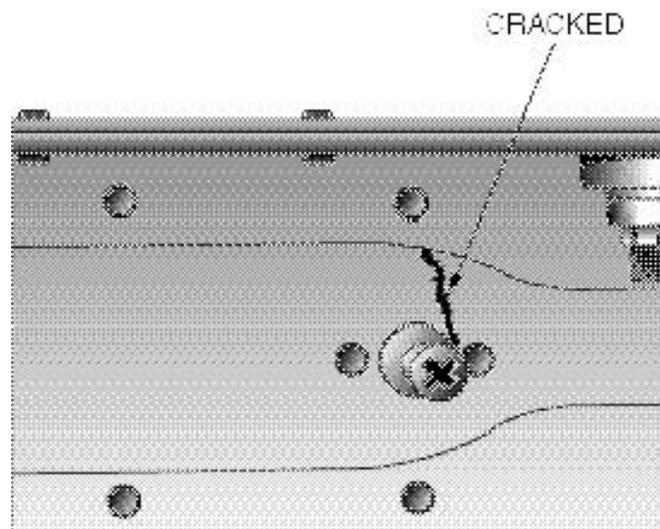
Piper; Model PA31T-620; Cheyenne; Horizontal Stabilizer Crack; ATA 5511

During a scheduled inspection, the technician discovered a crack on the horizontal stabilizer.

The crack appeared on the left horizontal stabilizer (P/N 46538-024) rear spar web. (Refer to the following illustration.) The crack traveled from an upper rivet, used to attach the spar web, to a bonding strap hole. The submitter did not offer a cause for this defect.

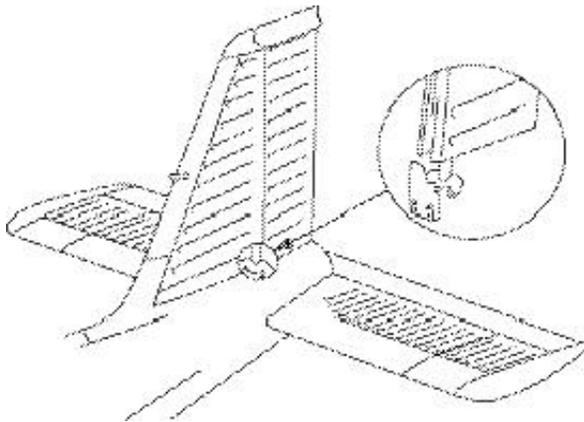
**Piper; Model PA32R-301T; Turbo Saratoga;
Defective Vertical Stabilizer Attachment;
ATA 5530**

During an annual inspection, the technician noticed movement when he exerted hand pressure against the top of the vertical stabilizer. At the same time, he heard a noise which seemed to come from the lower attachment point.

The technician removed the four rear spar attachment bolts (P/N AN-4-6A). He discovered wear marks made by movement of the attachment point surfaces. (Refer to the following illustration.) The torque on the attachment bolts was less than the required 100-inch pounds. The submitter stated this was the third similar defect he has found on like aircraft within the past year. He recommended that the manufacturer replace the stabilizer attachment bolts with, ream-to-fit, AN-174-series close tolerance bolts.

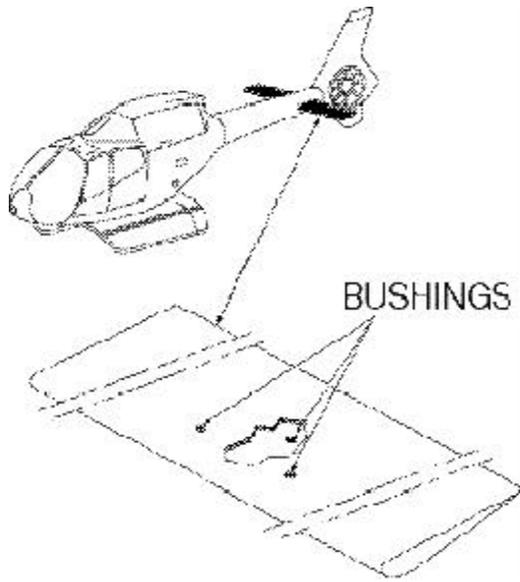
Eurocopter; Model EC 120B; Horizontal Stabilizer Bushing Loose; ATA 5510

During a daily inspection, the technician discovered that the left horizontal stabilizer support bushing was pulled out of the stabilizer. The bushings bond into the composite stabilizer structure. (Refer to the following illustration.) No other damage appeared on the stabilizer mount brackets or the tail boom. As a precaution, the submitter conducted a balance inspection on the "Fenestron" at 100 percent flat pitch on the ground. The inspection revealed an out-of-balance condition.

The submitter speculated that inadequate adhesion between the bushing inserts and the composite material caused this problem.

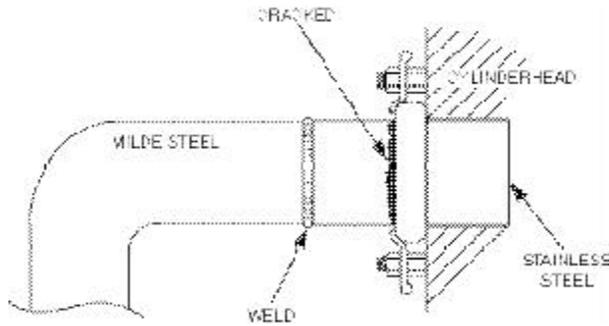
Avid; Model Catalina; Engine Exhaust System Failure; ATA 7810

After making several water landings, the pilot climbed to 1,000 feet for a flight to another lake. During cruise flight, he heard a loud bang, felt a severe vibration, and the engine stopped. The pilot made an emergency landing. The two occupants did not receive any injuries; however, the aircraft sustained substantial damage.

The pilot/owner/builder modified the aircraft’s engine exhaust system by removing the mufflers. The stainless steel insert which fits into the cylinder head was welded to a 6-inch long section of mild steel. The stainless steel insert cracked and separated at the location adjacent to the cylinder hold-down clamp. (Refer to the following illustration.)
