Aviation Maintenance Alerts

AC No. 43-16A

**ALERT NO. 259
FEBRUARY 2000**

**Improve Reliability-
Interchange Service
Experience**

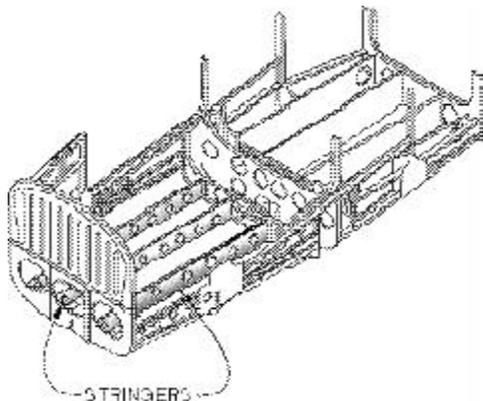
The technician disassembled the cockpit and removed the left and right floor panels. An inspection revealed two cracked stringers (P/N's 105-420000-47 right and 169-400005-473 left). (Refer to the following illustration.) The 1-inch long cracks appeared at the point where the rudder pedal torque tube brackets attach to the floor structure.

The submitter found this condition on three other like aircraft from this fleet. Without removing the floor panels, these defects are detectable only by moving the rudder pedals by hand while feeling for movement of the floor panels. He suggested that this inspection method be conducted during appropriate scheduled inspections.

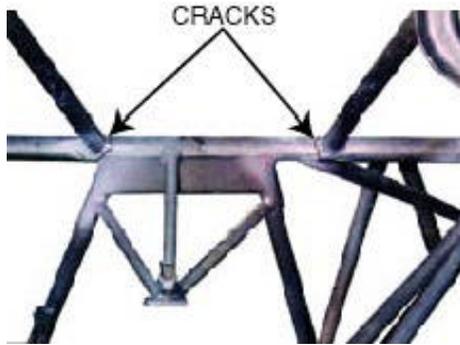
During other maintenance, the technician noticed cracks at the base of the two vertical engine mount support tubes.

The two vertical tubes were cracked adjacent to the weldment joining them to the engine mount assembly (P/N 67119-57). After removing the engine, cleaning the area, and a dye penetrant inspection the technician discovered that the tubes were completely broken around the circumference of their respective welds. These defects were not visible initially because they were covered by paint. (Refer to the following illustration.)

The submitter attributed this defect to hard landings and the use of the aircraft for commercial flight training. Also, there was some suspicion that the support tubes had not been properly welded during a previous major repair. The major repair and hard landings were not documented in the aircraft maintenance records. The submitter has knowledge of a prior landing gear collapse incident and he speculated that the major repair was accomplished to repair damage which resulted from the gear collapse. It was recommended that the engine mount area be checked closely during scheduled inspection, especially on aircraft used for flight training. Also, proper documentation of the aircraft maintenance records is not only necessary, it is required by Title 14 of the Code of Federal Regulations (14 CFR) part 43.

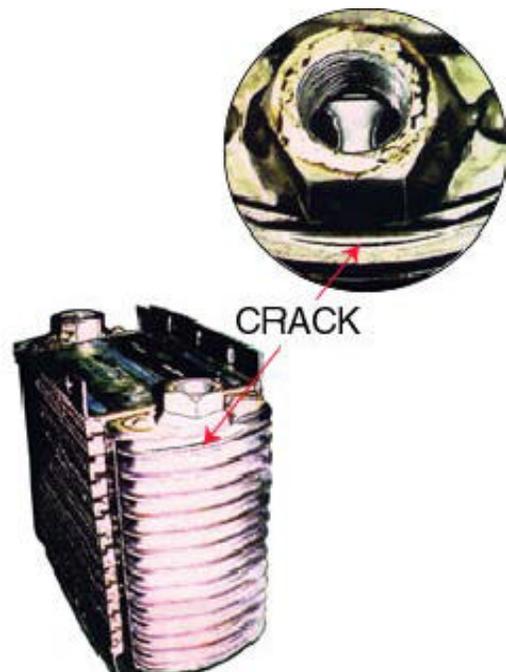
The technician found approximately 4 quarts of oil in the engine. A crack in the oil cooler (P/N 20006A) caused the leak. Supplemental Type Certificate (STC) SA3736WE was installed on this aircraft which incorporated a cowling modification and included installation of an oil cooler on the engine. The Niagara Development and Manufacturing Company manufactures the oil cooler. The Lopresti Speed Merchants own the STC and distribute the oil cooler.

The oil cooler cracked at the base of the top cooling fin just below the hose fitting base. (Refer to the following illustration.)

An FAA-certified repair station, the manufacturer, and the STC owner evaluated the oil cooler and could not determine the exact cause of the defect. There are several possible causes (e.g., normal engine vibration, the unsupported length of the hose and fitting, and preload stress imposed on the oil cooler structure during installation).

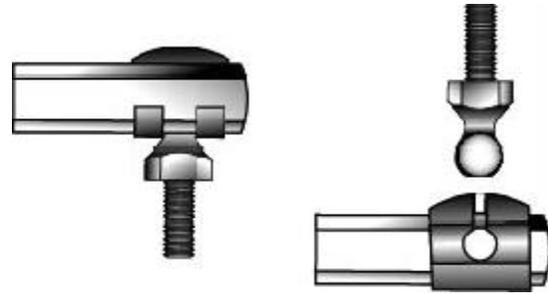
A technician discovered that the throttle cable arm separated from the rod-end (socket) (P/N 89307-00) attachment at the fuel servo. (Refer to the following illustration.) The maintenance records indicated this was a relatively new part and should not have been subject to excessive wear or damage. The submitter did not offer a reason for this premature failure.

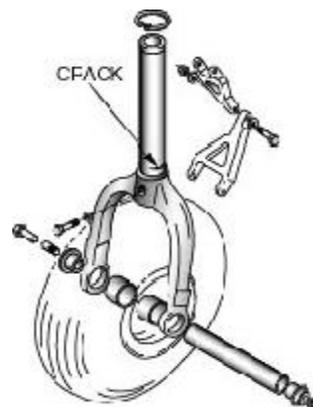
While towing the aircraft, the nosewheel assembly (P/N 39461-03) separated from the aircraft.

The evidence indicated a pre-existing crack on the nose gear lower strut tube which caused complete failure of the tube. The crack was located on the aft side of the strut tube and ran horizontally. The strut tube separated just above the scissor attachment point. (Refer to the following illustration.) The submitter operates a fleet of three like aircraft. He found the nose gear lower strut tubes cracked at similar locations on all three aircraft. This crack location seems odd, since the major loads imposed on the strut tube should be aft and upward. The submitter did not give a possible cause for this defect.

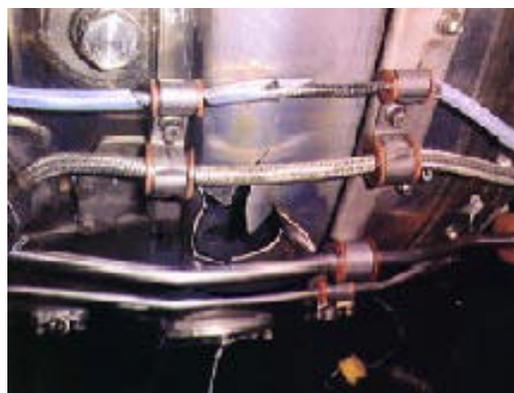
The engine was in operation approximately 45 minutes before this incident happened and all operating parameters were in the normal range. A technician recently installed this new air bleed manifold. The technician removed the damaged part and sent it to the manufacturer for an evaluation.

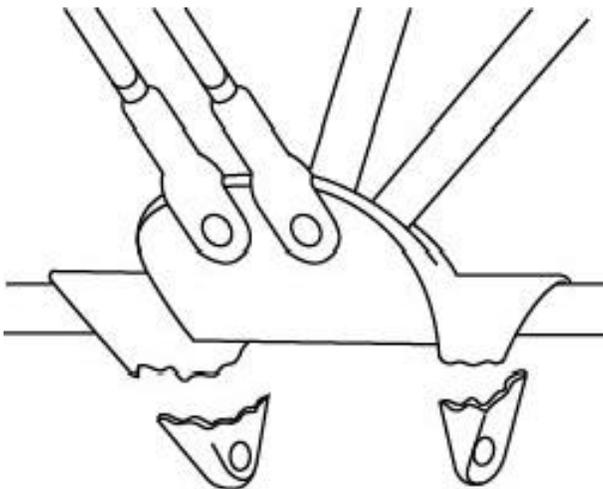
While inspecting the aircraft, a technician found the right main gear forward attachment point broken. (Refer to the following illustration.) The failure occurred adjacent to a weld on both of the attachment ears. The submitter did not offer a reason for this failure; however, a metallurgical evaluation of the broken gear attachment might reveal some interesting information!
