# **Aviation Maintenance Alerts**

**AC No. 43-16A**

**ALERT NO. 260  
MARCH 2000**

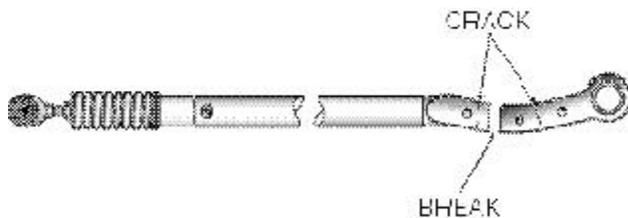
An inspection by maintenance technicians disclosed a broken right main gear retraction rod assembly (P/N 35-815125-14). The retraction rod laminated bracket failed approximately 5 inches from the gearbox attachment. (Refer to the following illustration.) In addition to the broken

retraction rod, the technician found two cracks in the upper part of the laminated bracket. One crack began at the forward edge of the upper bracket laminate 3.5 inches outboard of the gearbox attachment, and traveled approximately three-fourths of the way across the upper bracket laminate. The other crack was 5.5 inches outboard of the gearbox attachment and traveled approximately half way across the lower bracket laminate beginning at the aft edge. The damaged area between the cracks was twisted to a 45-degree angle prior to failure. It appeared that both cracks began sometime prior to this event.

The retraction rod assembly is subjected to both compression and tension stress during normal operation. If the limit switch fails to stop the gearbox, it places ever-increasing pressure on the retraction rods resulting in ultimate failure.

Several other Beech aircraft models use the same or similar main landing gear activation system and may be subject to the defects reported here. We recommended giving critical scrutiny at every opportunity to the gear retraction system, especially the inboard laminated section of the retraction rod.

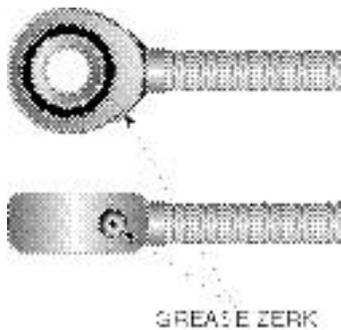
A technician discovered that the rod-end broke on the drag brace end of the nose gear retraction rod. The rod-end (P/N ADNE5-323) outer case failed and distorted into an “egg” shape at the grease zerk. This allowed the rod-end bearing to separate from the outer case. (Refer to the following illustration.)

The submitter recommended giving special attention to the grease zerk area and all rod-ends during scheduled inspections.

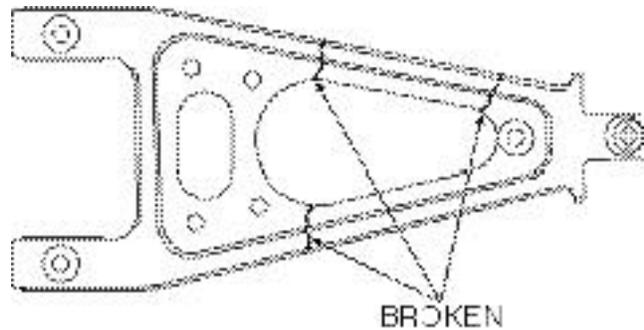
An investigation disclosed the right main landing gear torque knee broke. The upper half of the torque knee assembly (P/N 50-810032-4) had cracked/broken at three locations. (Refer to the following illustration.)

This failure allowed the main gear wheel assembly to rotate on the lower section of the strut causing loss of directional control.

The torque knee assembly is constructed of aluminum. Beech issued Service Bulletin (SB) 32-3134 giving an inspection procedure and stating that replacement torque knee parts will be constructed of a steel alloy. For specific aircraft applicability consult SB 32-3134.

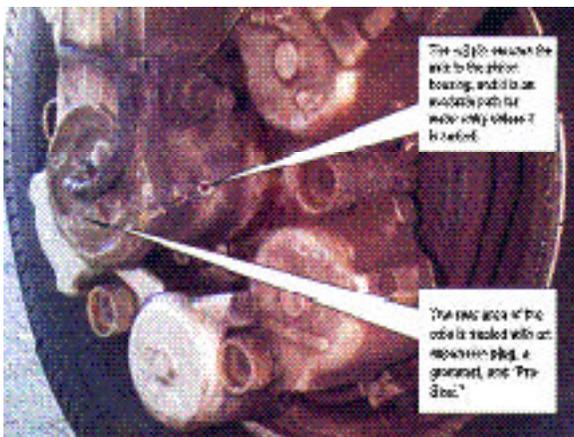
Normally, the technician can align the antiskid transducer by hand with light finger pressure. In this case, the antiskid transducer became jammed inside the axle, and he had to use a large pair of pliers. After removing the transducer, he discovered severe corrosion on the body of the unit, wiring harness, plug

assembly, and expansion plug. The interior lower surface of the inboard end of the axle also displayed severe corrosion damage.

The submitter recommended that technicians inspect the antiskid transducer and the axle interior at every opportunity. He also suggested that technicians make sure the axle interior is properly sealed, inspected, and repaired.
