U.S. Department
of Transportation
**Federal Aviation
Administration**

Aviation Maintenance Alerts

**ALERT NO. 264
JULY 2000**

**Improve Reliability-
Interchange Service
Experience**

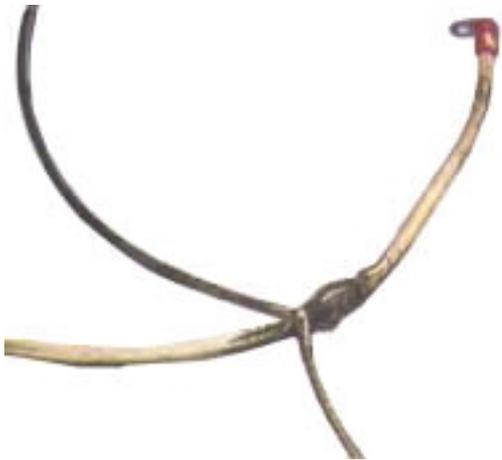
During an initial investigation, the technician discovered the aircraft battery smoking; however, none of the circuit breakers, fuses, or current limiters had opened (popped). When the technician disconnected the battery cables and removed the battery cell caps, he found each cell was almost completely dry. During further investigation, he discovered an electrical short circuit between the positive

battery cable and the throttle cable (P/N 36-380061-1). The throttle cable chafed against the battery cable and penetrated the cable insulation which caused a direct electrical short from the positive battery cable "to ground." (Refer to the following illustration.)

The restricted area of the engine compartment makes maintaining proper security and clearance of critical components difficult and very important.

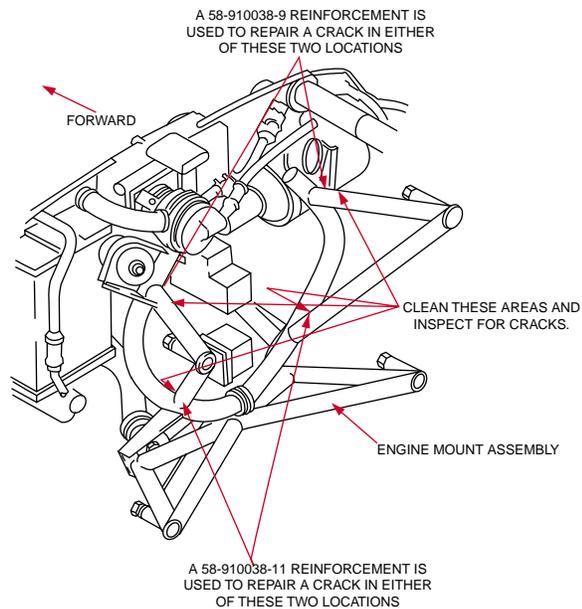
During a scheduled inspection, the inspector discovered a crack in the left engine mount.

The technician found the crack located in the upper crossover tube adjacent to a weld at the upper inboard engine attachment point. (Refer to the following illustration.) Airworthiness Directive (AD) 91-15-20, dated September 3, 1991, deals with this subject and references Beech Service Bulletin 2362, Revision 1. The requirements of AD 91-15-20 were complied with on this aircraft 2,344 operating hours prior to this finding. The repair action taken at that time, in accordance with paragraph (a)(2)(i) of AD 91-15-20 and Beech Kit 58-9007-1S, terminated the

While reviewing the maintenance records, the technician discovered an entry for "sudden engine stoppage" 1,161 operating hours prior to this finding. Maintenance records showed the technician overhauled the engine and inspected the engine mount tube for damage. The submitter speculated the sudden engine stoppage caused metal fatigue in the mount tubes which culminated in the development of the reported crack.

repetitive inspection requirements. The repair kit gives instructions for repair or replacement of the original engine mount tube (P/N 96-910010-61) with a new tube (P/N 96-910010-67).

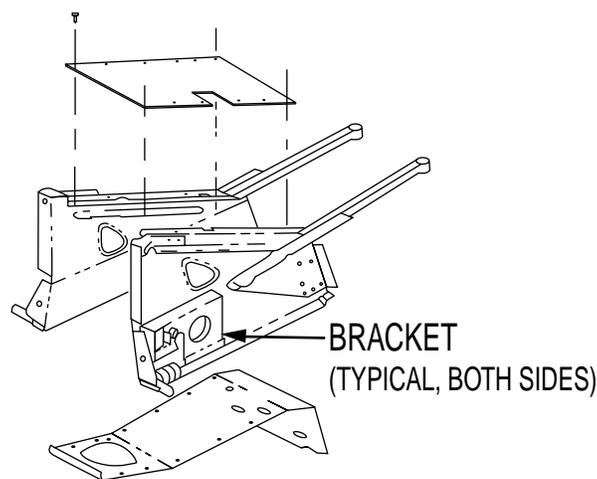
During an annual inspection, he discovered cracks in the inboard rudder pedal bar bearing block brackets. In order to inspect the area, he moved the rudder pedals and noticed the bearing blocks flexed. After he cleaned the area, he discovered the cracks on the left and right bracket assemblies (P/N's 0713628-5 and -6). (Refer to the following illustration.) The submitter suggested that all maintenance personnel clean the area well and conduct a diligent inspection of the brackets during scheduled inspections.

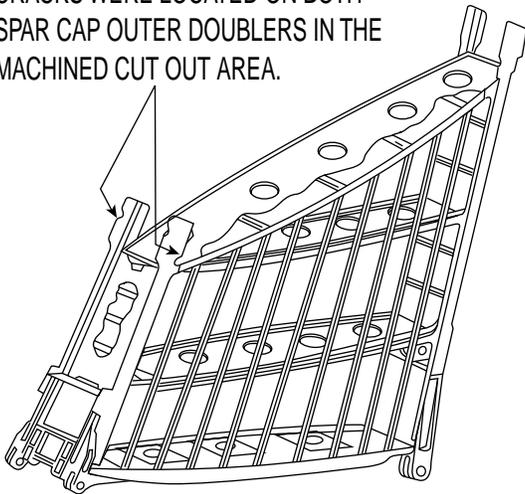
During a scheduled inspection, the technician found cracks in the vertical stabilizer front spar cap doublers.

The cracks appeared on both the left and right outer spar cap doublers. (Refer to the following illustration.) The submitter reported this is the fourth instance of this defect he found in the past month. He recommended using an eddy-current inspection technique to inspect the vertical stabilizer front spar cap doublers during each applicable scheduled inspection. He also recommended this area immediately receive a one-time inspection on all Models 1329-23 and 1329-25 series aircraft.

CRACKS WERE LOCATED ON BOTH SPAR CAP OUTER DOUBLERS IN THE MACHINED CUT OUT AREA.

The FAA published two Airworthiness Directives (AD) 84-23-01 and 91-11-13 which deal with a similar subject on the rear spar. The submitter suggested that maintenance personnel inspect the front spar cap at the same time they comply with these ADs. The manufacturer does not stock replacement doublers; however, authorized repair procedures, on a case-by-case basis, include fabrication of new doublers.

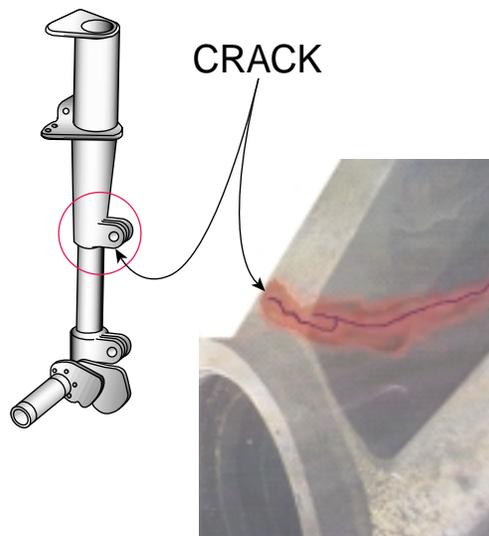
A maintenance technician investigated and found the left main gear strut (P/N 65319-04) attachment ears for the upper torque link broken. (Refer to the following illustration.) The broken ears left the wheel assembly free to rotate, restrained only by the brake line.

The submitter speculated side loads imposed on the gear during landing might have caused this damage. Also, age, metal fatigue, and improper landing techniques may be contributing factors.

The FAA Service Difficulty Program data base contains 11 additional reports concerning similar failures. Piper Service Letter 760, dated November 12, 1975, deals with this subject and gives inspection procedures. Although the "dash number" following the strut part number varies, the basic part design, with the upper torque link attachment ears, is the same for models PA28-140, -151, -161, -181, and PA32 aircraft. Most of these defects occurred on aircraft with operating time equal to, or greater than, this aircraft.

All maintenance personnel should be aware of these findings and exercise due diligence during maintenance and inspections.

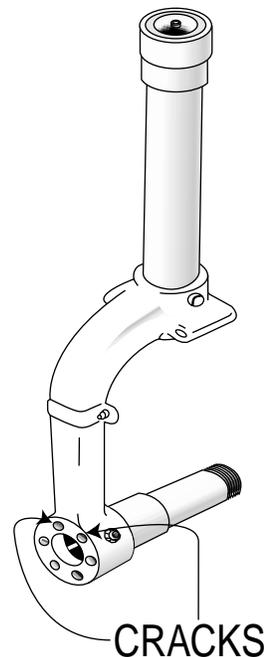
During an annual inspection, a technician found cracks in both of the main landing gear strut assemblies.

Using a magnifying glass, the technician discovered cracks adjacent to the two top axle bolt holes on both the left and right strut assemblies. (Refer to the following illustration.) These six holes attach the wheel brake anchor plate to the strut. The metal is thinnest at this location. The aircraft maintenance records did not include any damage history or hard landings. The submitter stated this defect resulted from age and metal fatigue.
