ADVISORY CIRCULAR 43-16A

AVIATION MAINTENANCE ALERTS

ALERT NO.
265

AUGUST
2000

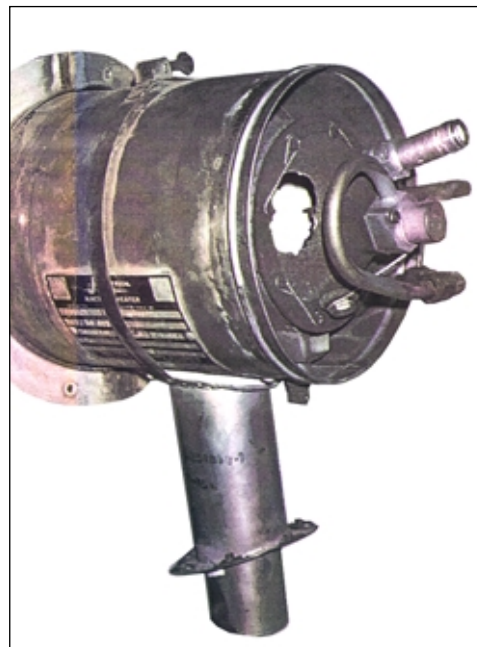
Beech; Model B95; Travel Air; Defective Cabin Heater; ATA 2140

The heater combustion head assembly (Janitrol P/N 51A45) had a hole approximately 1 inch in diameter in the end of the canister fitting. (Refer to the following illustration.) The area surrounding the hole, as well as the entire unit, was severely corroded. The submitter believes this unit had been in service since 1960 (the aircraft manufacture date).

The heater manufacturer's technical data contains required regular scheduled inspection and maintenance procedures for the Model 83A28 heater. The submitter stated maintenance technicians do not always follow these procedures and recommended the FAA issue an Airworthiness Directive with recurring inspection requirements to address this subject.

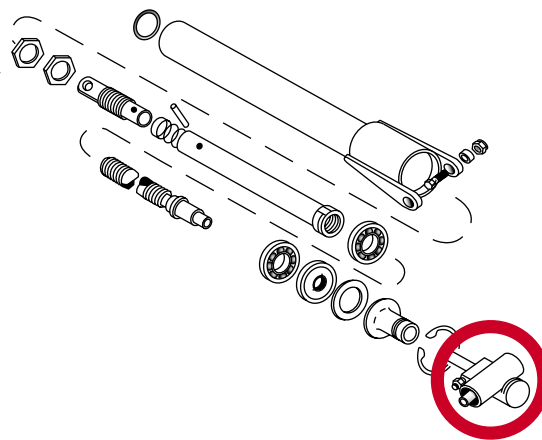
Beech; Model 99; Airliner; Defective Wing Flap Actuator; ATA 2750

During the test, the left inboard wing flap bound up, and the drive motor failed. The technician removed the flap actuator drive (P/N 50-380153-1) and determined the drive assembly was attempting to move the flap opposite the selected direction. (Refer to the

following illustration.) This aircraft uses four different wing flap actuators, and the left inboard actuator (P/N 50-521222-3) was defective. The actuator was a newly-overhauled unit, and the drive unit, which has a 10,000-cycle life limit, was incorrectly manufactured. It might be wise to perform a bench test of these units to check for proper operation prior to installation.

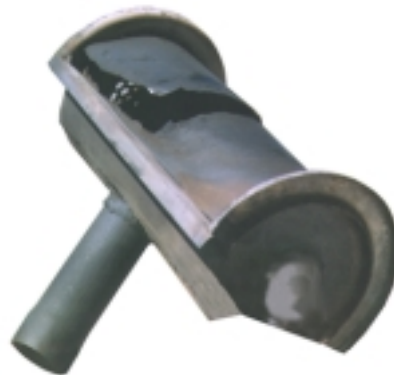
MAULE**Maule; Model MX 7-180; Star Rocket; Engine Exhaust Failure; ATA 7820**

After parking the aircraft, the pilot found the right outer muffler shroud loose. After removing the shroud, he discovered the muffler severely ruptured. (Refer to the following illustration.) The submitter stated this failure motivated him to begin inspecting the entire engine exhaust system at 50-hour intervals.

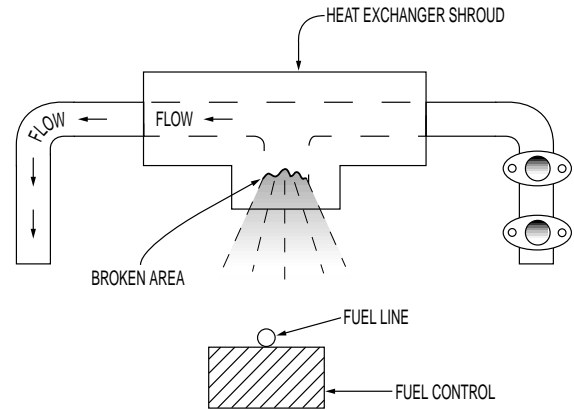
Piper; Model PA 23-250; Aztec; Engine Exhaust System Failure; ATA 7800

While investigating, the technician discovered a broken left inboard engine exhaust header. (Refer to the following illustration.) The exhaust header failed under the heat exchanger shroud adjacent to the crossover pipe. This failure directed hot exhaust system gases at the fuel control and associated fuel plumbing which created a hazardous condition.

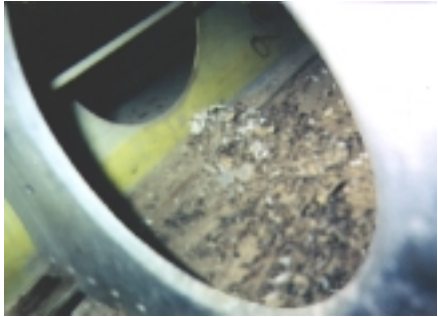
Piper; Model PA 28-160; Cherokee; Structural Wing Damage; ATA 5711

The forward edge of the aft main wing spar, located behind the fuel tank, suffered corrosion exfoliation, which consumed approximately 50 percent of the spar thickness. This damage was attributed to the presence of a large nest and fecal matter deposited by the rodent residents. (Refer to the following illustration.)

The damage inflicted by rodents and other "creatures" was well documented in the past by this and many other publications. Once again, we remind readers to be aware of the severe and possible catastrophic damage these uninvited guests may impose. The submitter recommended conducting a thorough inspection of this area at every opportunity. Also, it is wise to take all appropriate precautions to exclude the entry of "creatures" into any part of our aircraft.

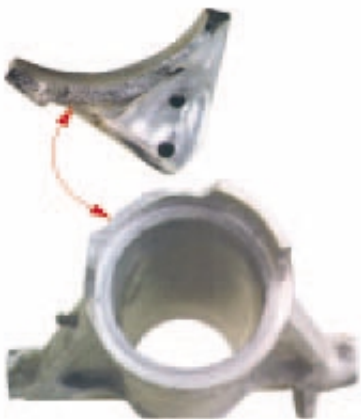
Piper; Model PA 28RT-201; Arrow; Nose Landing Gear Trunnion Failure; ATA 3222

While investigating, the technician found the trunnion (P/N 67054-03) was cracked in three locations. (Refer to the following illustration.) These areas displayed evidence of discontinuity in the interior structure of the metal. Another area had metal porosity at the surface. According to the aircraft maintenance records, the nose gear trunnion was installed as original equipment when the aircraft was manufactured.

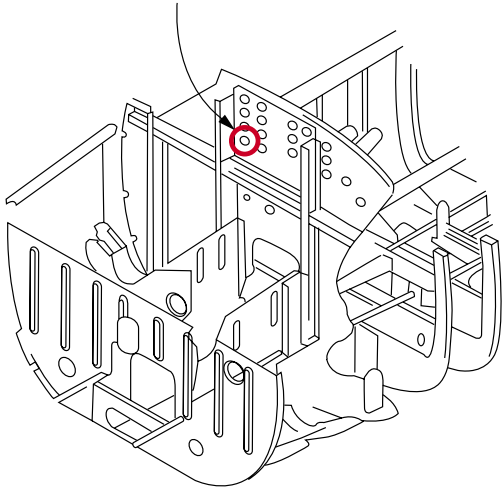
LOCATION OF ELECTRICAL CONNECTOR E433

Piper; Model PA 42-720; Cheyenne III; Electrical System Failure; ATA 2440

During an investigation, the technician found the source of the burning odor in the left nose access panel. After removing all of the avionics equipment from the top shelf, the technician discovered an electrical connector (E433) severely heat damaged. This is a three-part connector (P/N 556-416) consisting of a forward plug (P/N 206370-1), a feed-through (P/N 207201-1), and an aft plug (P/N 206369-1). (Refer to the following illustration for the connector location.) The connector contains 37 pins, 30 of which were damaged and shorted when the plastic connector assembly melted. Various aircraft components were either damaged or rendered inoperative by this electrical failure.

It is the submitter's opinion this damage was caused by exposure of the connector to constant cycling of pressurization and temperature during operation. In addition, vibration and other environmental factors over the 20-year life of this part were very likely causal factors. The location of the connector assembly makes it very difficult to properly inspect. However, it was suggested that all operators of like aircraft ensure this area is checked closely during scheduled inspections.

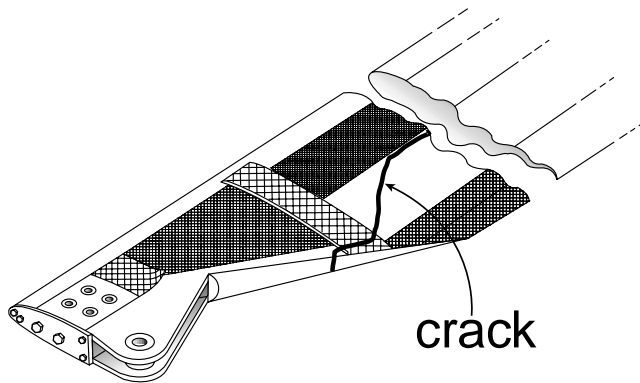
Sikorsky; Model S-76B; Blade Crack; ATA 6210

During a postflight inspection, the maintenance technician found a large crack in a main rotor blade.

At the time of this report, the cause of this defect had not been determined. If further information is received, it will be printed in a future edition of this publication.
