U.S. Department  
of Transportation  
**Federal Aviation  
Administration**

## ADVISORY CIRCULAR 43-16A

# AVIATION MAINTENANCE ALERTS

**ALERT  
NUMBER  
267**

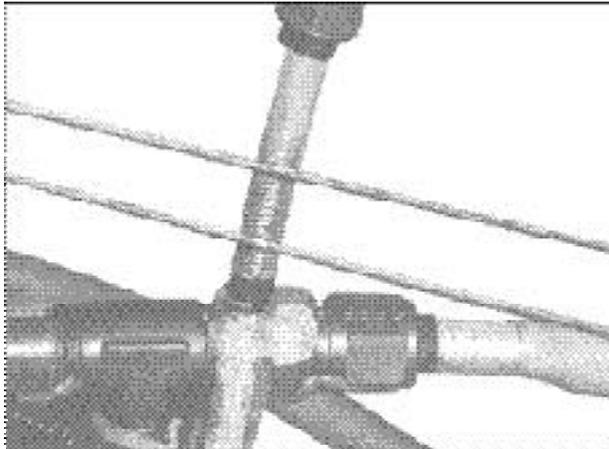
During a scheduled inspection, the technician discovered the aileron trim tab control cables chafing against an air-conditioning system freon line.

This defect was located between fuselage stations 100.0 and 118.5, under the floor on the left side of the aircraft. Both the cables and the freon line (P/N 58-555028-13) were damaged. (Refer to the following illustration.)

this location and recommended this area be given close attention during maintenance and inspections.

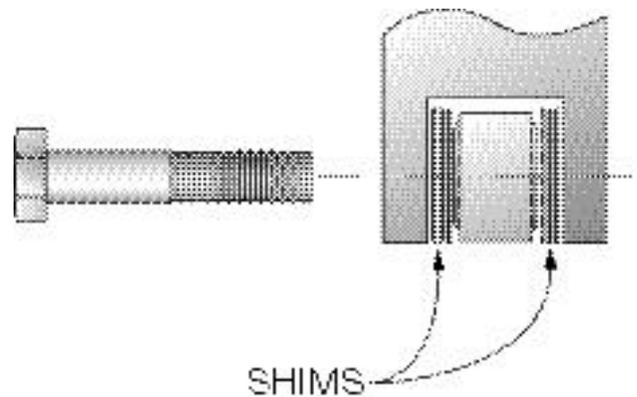
During an inspection of the nose steering system, the technician found the pilot's right rudder pedal arm (P/N 50-524326-10) pivot holes were severely elongated. Also, the steering torque arm (P/N 35-825054-5) hole used to attach it to the actuator was elongated.

The submitter stated these hole elongations could have been prevented by proper lubrication and the installation of shims between the clevis arm and the rod-end. (Refer to the following illustration.) Even though it is not specifically required by the manufacturer's technical data, he recommended lubricating this assembly periodically. The exceptionally high number of operating hours on this aircraft may have been an important factor contributing to this defect.

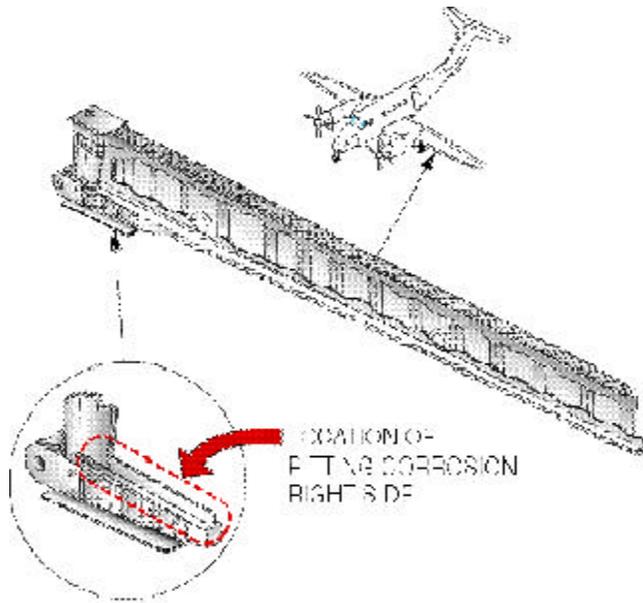
**Beech; Model 300; King Air; Structural Corrosion; ATA 5711**

After removing the right inboard leading edge fuel cell to repair a leak, the technician discovered severe corrosion.

The corrosion was located on the upper surface of the inboard spar cap casting. (Refer to the following illustration.) The available evidence indicated the corrosion was caused by entrapment of water behind the protective tape used to line the interior of the fuel cell bay. There were five areas of very severe corrosion that penetrated to as much as .15 inch in depth.

The submitter urged all operators of like aircraft to inspect this area at the earliest opportunity.

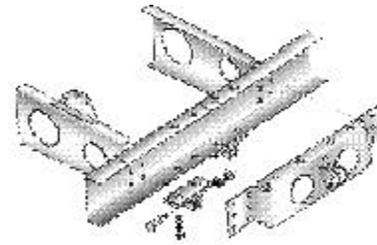
The FAA has become aware that during compliance with the requirements of Airworthiness Directive (AD) 80-11-04, maintenance technicians are finding cracks in the vertical fin attachment bracket (P/N 0432004-9). The AD deals with cracking failure of the vertical fin attachment bracket nut plates. Approximately 80 percent of the attachment bracket cracks found are associated with Cessna model 152-series airplanes that were manufactured in 1978, including models 152, A152, F152, and FA152.

Cracks in the vertical fin attachment brackets (P/N's 0432004-1 and 0432004-9) have also been found in Cessna models 150F, 150H, 150J, 150L, and 150M. Therefore, all Cessna model 150/152 airplanes built between 1966 and 1980, should be inspected. This part should be inspected initially within the next 100 hours of time in service and every 100 hours of time in service thereafter or during inspections required by the AD.

The prevalent crack location is along the edge of the plate welded on the back of the attachment bracket. Some cracks turn and run diagonally across the plate. (Refer to the following illustration.) Use of mirrors and extra light to look through the holes in the back face will help to find these cracks.

In addition, cracks in both the stabilizer spar (P/N 0432001-56) and its reinforcement (P/N 0432001-15) are being reported to the FAA. The vertical fin attachment bracket (as shown in the following illustration) is attached to this spar and reinforcement. Therefore, the spar and reinforcement need to be inspected during the inspection intervals mentioned above.

If these cracks are allowed to go undetected, the vertical and/or horizontal tail assembly could possibly separate from the airplane.

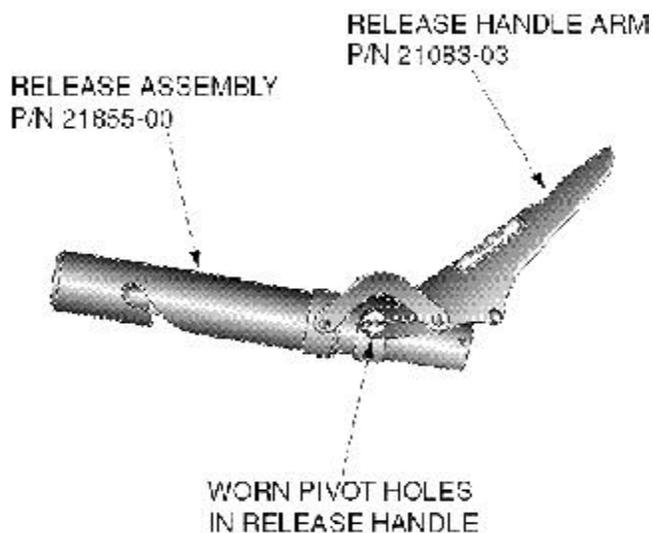
**Piper; Model PA 24-260; Comanche; Landing Gear Emergency-Extension System Failure; ATA 3230**

During an annual inspection, the landing gear emergency-extension system failed during testing.

The technician found the emergency-release assembly (P/N 21855-00) would not disengage the landing gear linkage from the transmission assembly. He discovered the emergency-release handle arm (P/N 21083-03) travel was restricted when it hit the forward edge of an access cutout in a floorboard panel (P/N 22720-00). With the floor panel removed, the emergency gear-release mechanism functioned properly. However, the release mechanism demonstrated excessive wear at the pivot points. (Refer to the following illustration.) The excessive wear resulted in free-play and lost motion in the release mechanism which required extra forward movement of the release handle arm to achieve emergency operation of the gear.

The submitter suspects this condition existed for some time considering the amount of wear at the pivot point holes. Also, he believes this defect was not discovered during previous annual inspection because the landing gear emergency-extension tests were conducted with the floor panel removed. He recommended that the emergency gear extension tests be conducted with the floor panel installed and the aircraft configured as it would be in normal service.

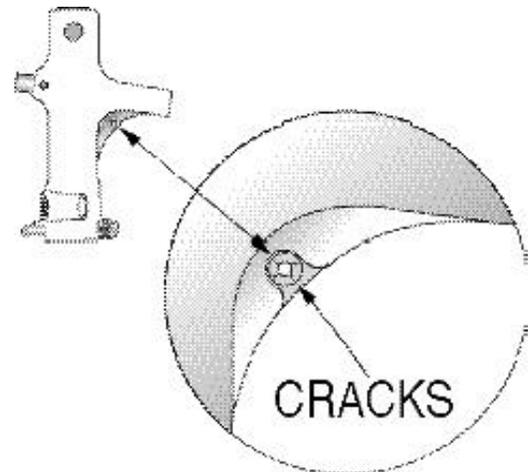
**Piper; Model PA 28R-180; Arrow; Landing Gear Defect; ATA 3213**

While conducting an annual inspection, the inspector discovered a crack in the left main landing gear trunnion.

The trunnion (P/N 67735-00V) was cracked through the web area and into the casting approximately .75 inch. The crack originated at the edge of the hole (.191-inch diameter) in the web. Piper Service Letter 616 allows for the removal of cracks adjacent to the .191-inch hole in the web by enlarging the hole to .5 inch. (Refer to the following illustration.) In this case, however, the crack traveled well beyond repairable limits and required replacement of the trunnion assembly. The replacement trunnion incorporates a much thicker web area.

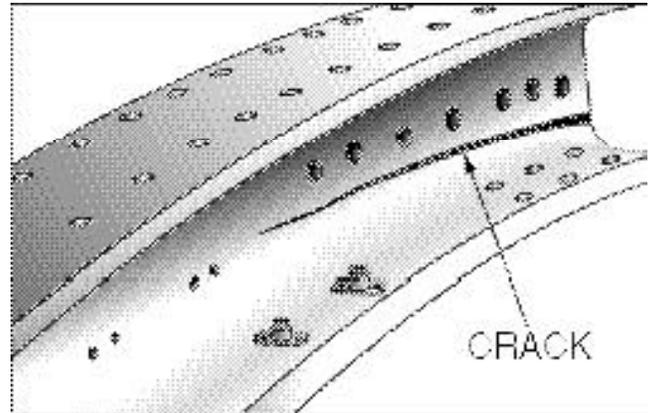
**Rockwell International; Model NA265-65; Sabreliner; Structural Defect; ATA 5311**

While complying with the requirements of a scheduled fuselage inspection, the technician discovered a severe crack in a fuselage mainframe.

The submitter recommended a thorough inspection of this area at every opportunity. The failure of this structural frame could have a catastrophic effect on flight safety. He urged all operators to give this area close attention.
