ADVISORY CIRCULAR 43-16A

AVIATION MAINTENANCE ALERTS

**ALERT
NUMBER
274**

**MAY
2001**

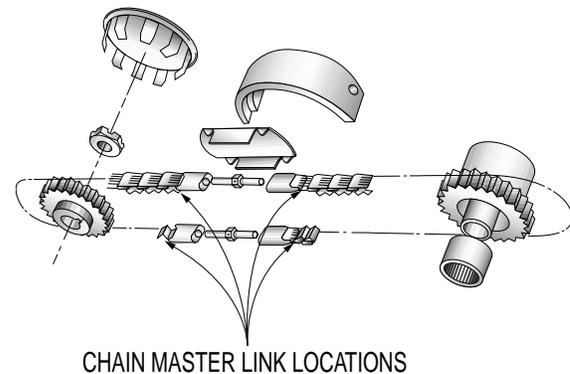
During an annual inspection, the technician discovered a serious problem with the flight-control yoke chain linkage. The chain (P/N 35-524139) master link plate and clip were missing where the lower left chain attaches to the fitting (P/N 35-524140-2). (Refer to the illustration.) If any flight-control system chain connection fails, it may cause a serious accident.

The submitter stated this area deserves close attention at every opportunity.

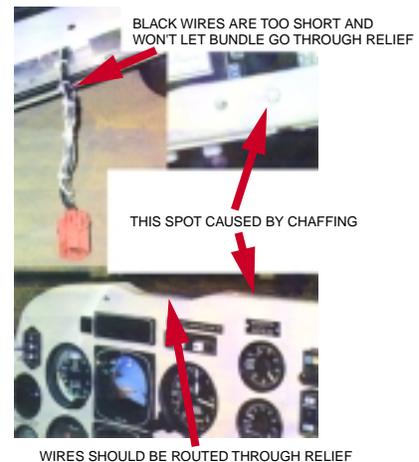
The owner sent the new aircraft to a repair station for installation of avionics equipment.

The submitter stated this was the second like aircraft he has found with this problem.

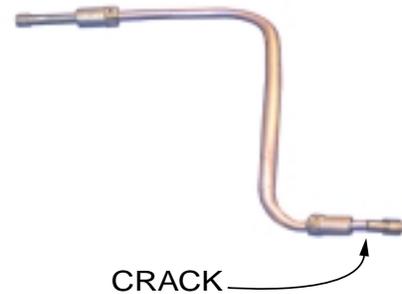
A technician found a fuel tube assembly leaking from a crack adjacent to a "B-nut." The tube (P/N 3011857) runs from the engine fuel control and supplies fuel pressure to the "start flow control valve." The tube was cracked at the manufacturing joint next to the "B-nut" at the start flow control valve. (Refer to the illustration.)

The submitter did not state a cause for this failure.

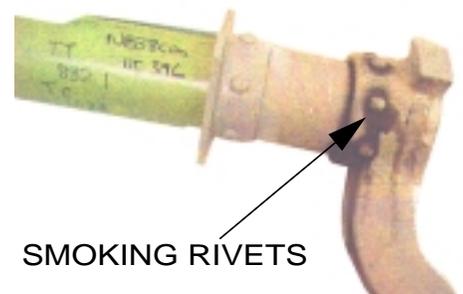
During a scheduled inspection, the technician found excessive free play associated with the elevator control system.

Investigating further, the technician discovered the attachment of the right elevator torque tube to the end fitting/bellcrank was loose. The rivets, used to attach the end fitting to the torque tube, were extremely loose and "smoking." (Refer to the illustration.) These rivets were in imminent danger of complete failure which could have catastrophic results.

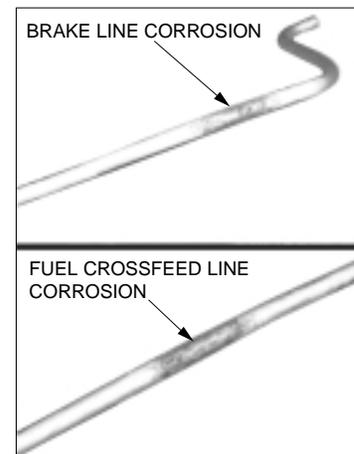
While investigating the fuel odor report, the technician found the fuel crossfeed line (P/N 5300108-41), located beneath the floor, was leaking. This line attaches directly to the main fuel tank. The line wall thickness was penetrated by severe corrosion. (Refer to the illustration.) He believes the fuel line corroded from the inside when water did not drain from the sumps. Since there is no way to shut off the fuel supply to this line, it created a serious hazard to flight safety.

The technician found the source of the hydraulic leak was the pilot's right brake line. The leak was located under the floor, and a pressure test of the line revealed a "pin hole." He attributed the corrosion to the "pin hole." The brake line routing placed it in contact with a heater duct hose. He speculated heat and the presence of moisture caused the corrosion.

The submitter suggested inspecting this area and rerouting and/or insulating the brake line, if necessary.

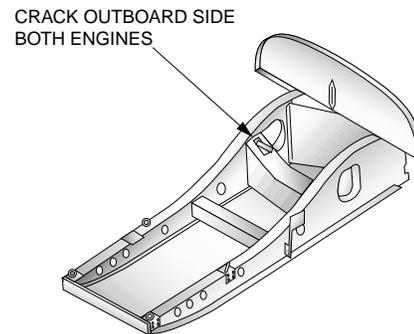
During a scheduled inspection, the technician found the engine beam assemblies cracked.

Both the left and right beams aft assemblies (P/N 5054030-42) were cracked on the outboard side of each engine. Both cracks were approximately 1.5-inches long. They were located in the bend radius of the top strap of the beam assembly close to the junction of the fore and aft running engine mount beams. (Refer to the illustration.)

This structural deficiency could result in a catastrophic aircraft accident had the inspector not found the defect.

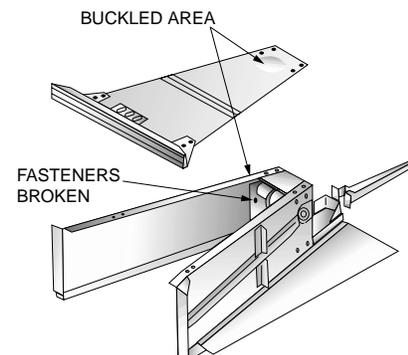
While conducting a "hard and overweight landing inspection," the technician found the nose wheel well upper structure cracked just forward and left of the mount for the uplock assembly. Numerous structural rivets attaching the uplock forward mount were pulled through the wheel well skin.

After removing the nose gear actuator, the technician found the actuator aft attachment structure was buckled and four fasteners adjacent to the attachment fitting were broken. (Refer to the illustration for the damage locations.)

Under these conditions, it is critical to conduct a thorough and searching inspection of all the affected areas, as well as, areas where there may be "hidden damage."

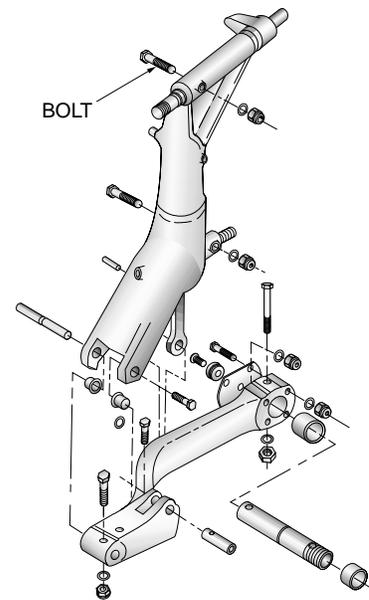
A technician inspected the landing gear and found the right main gear forward trunnion bolt, washer, and nut were missing. (Refer to the illustration.) He suspects the bolt sheared and caused it to come out of the trunnion. Due to this finding, he inspected the trunnion bolt on the left main gear and discovered it was extremely worn.

The submitter suggested the manufacturer establish a frequent inspection schedule for this bolt and a life limit of 3 to 5 years and/or 500 landings.

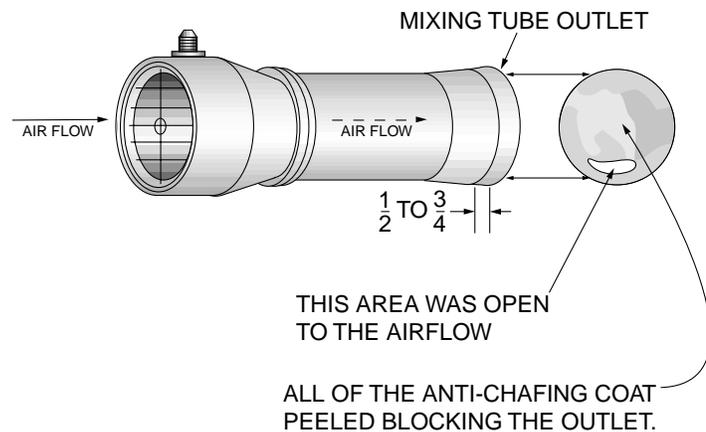
The test revealed the number one inflation tube would not properly inflate. The technician discovered the aspirator airflow was severely restricted. The “antichafing” coating in the aspirator outlet was loose and blocking approximately 90 percent of the outlet. (Refer to the illustration.) The “antichafing” coating is usually applied during the manufacturing process or while complying with the manufacturer’s Service Bulletin (SB) number 4600-25-01. The coating is applied to cover the aspirator area of “faster airflow.” The area normally covered with the “antichafing” coating is between .5 and .75-inch. However, in this case, the coating was approximately 2-inches long. The aspirator inlet “antichafing” coating was also excessively long but had not yet separated.

The submitter speculated the excessive length of the area covered caused the coating failure. Since the coated area of the aspirator is not normally inspected during scheduled maintenance and inspection unless the liferaft fails the functional test, he recommended giving this area more and closer attention at every opportunity.
