ADVISORY CIRCULAR 43-16A

AVIATION MAINTENANCE ALERTS

ALERT
NUMBER
278

SEPT.
2001

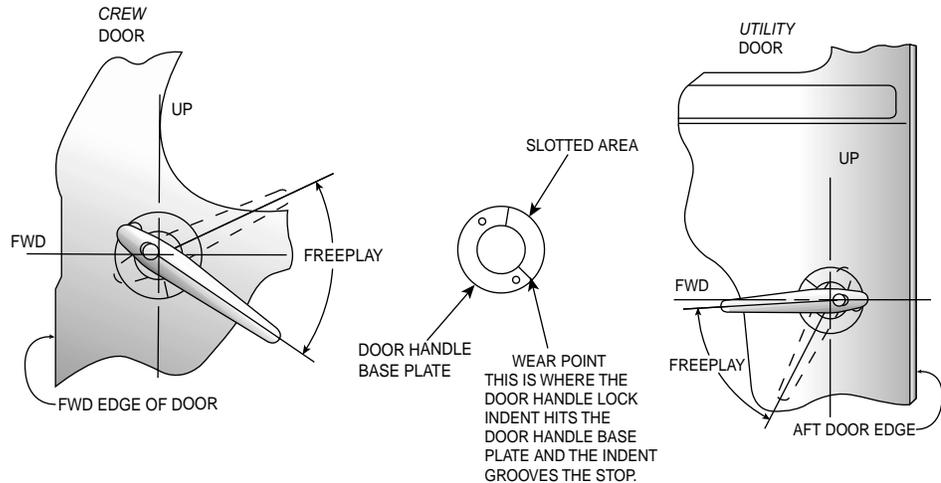
Regular maintenance should identify incorrectly installed door handles or a door handle that has a worn stop on the handle base plate. (See the illustration.)

If the handle is properly positioned and the door opens without depressing the door lock release button, the handle base plate may be worn.

If the door handle opens the door when rotated, without depressing the handle lock release button, it should be repaired prior to further flight. To correct the door handle lock, remove the door handle, and reinstall it so that the lock release button locks the door in accordance with Raytheon Aircraft Service Bulletin 2693.

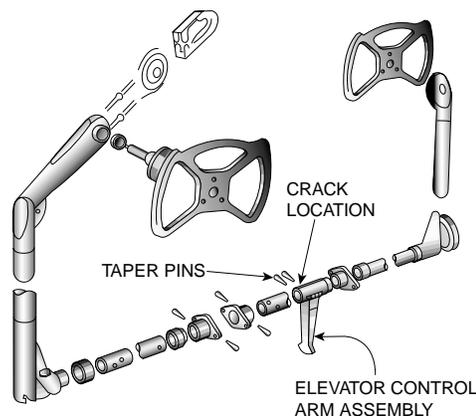
While complying with the recurring requirements of Airworthiness Directive (AD) 77-19-07, the technician discovered a crack in the elevator control arm.

The crack originated adjacent to the aft side of the taper pin hole and traveled to the left side of the elevator control arm (P/N 187504) casting. (Refer to the illustration.) The submitter stated that when the aircraft was parked, it was exposed to rotor wash from a helicopter landing nearby. He speculated the damage found resulted when turbulence generated by the helicopter caused the elevator to move violently from one stop to the other.

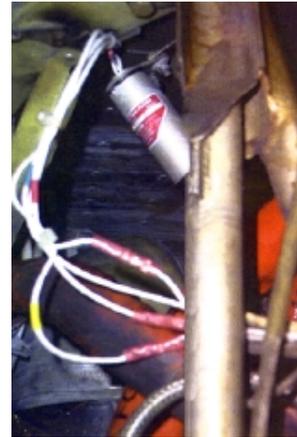
A technician found three fire detectors (P/N 473275) installed with “butt splices.” (Refer to the illustration.) The use of “butt splices” in the fire-detection system is contrary to the manufacturer’s technical data. The manufacturer’s data requires the use of “sealed” connectors.

The submitter stated that all maintenance personnel should be made aware of this requirement before they perform maintenance on a fire-detection system.

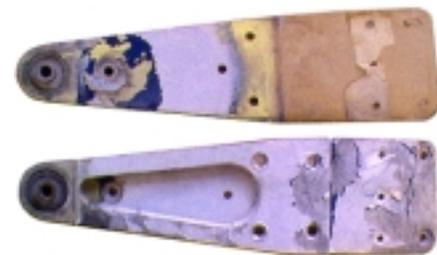
ELEVATOR HINGE BRACKET

While conducting a scheduled inspection, the inspector discovered severe structural corrosion on the horizontal stabilizer and the elevator.

The right rear lower spar cap (P/N 101-620014-48) extrusion exhibited metal corrosion exfoliation on the outboard 6 inches. Also the right outboard and middle elevator hinge brackets (P/N 101-620011-3) were corroded beyond repair. (Refer to the illustration.)

The submitter attributed these defects to age, stress, and metal fatigue. This aircraft was manufactured in 1984 and has accumulated a considerable number of operating hours. The age and number of operating hours on an aircraft are directly proportional to the maintenance and care required to maintain it in an airworthy condition. Therefore, exercise due diligence during inspections and maintenance.

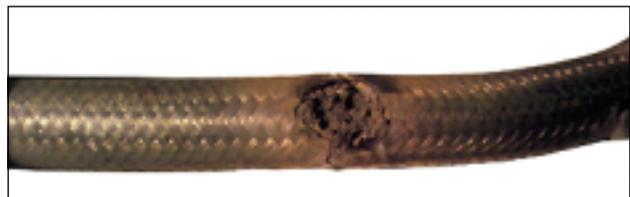
While conducting an annual inspection, the inspector discovered that the flexible fuel vapor vent line was defective.

The steel braided outer covering of the flexible line chafed against the "positive" battery cable, which supplies electrical power to the engine starter contact solenoid. When the battery cable insulation wore through the steel braiding, arcing occurred causing a very hazardous condition. (Refer to the illustration.)

The submitter stated this type defect could be avoided by proper routing and security of these components.

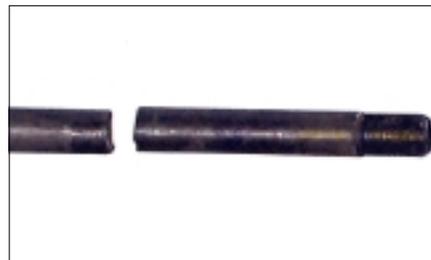
During an annual inspection, the technician discovered a broken nose landing gear bolt.

The bolt (P/N AN6-43) is used to attach the upper nose gear drag link to the airframe structure. (Refer to the illustration.) For some time, the aircraft has been operated from both turf and paved runway surfaces. The submitter gave no further details concerning the circumstances leading up to this bolt failure.

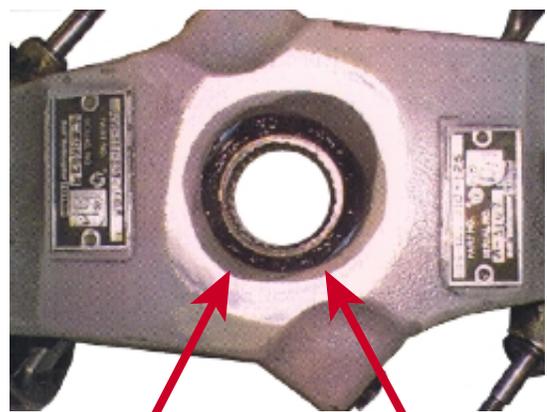
CUT-OUT FOR FLAPPING ANGLE FLAPPING AXIS

While installing a new tail rotor hub and blade assembly (P/N 206-011-810-153), the technician discovered the new assembly was defective.

The technician discovered the “flapping” angle could not be properly adjusted. After investigating this problem, he discovered the yoke assembly (P/N 206-011-819-109) was machined 90 degrees to where the “flapping” cutouts were. This resulted in the static stop (P/N 206-010-742-003) contacting the side and not the stop face. This decreased the hub assembly travel. (Refer to the illustration.)
