U.S. Department
of Transportation
**Federal Aviation
Administration**

ADVISORY CIRCULAR 43-16A

AVIATION MAINTENANCE ALERTS

ALERT
NUMBER
279

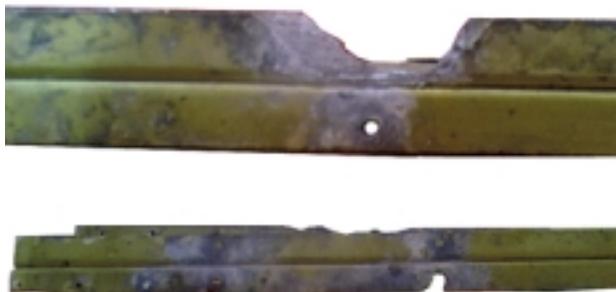
Beech; Model V35A; Bonanza; Severe Structural Corrosion; ATA 5313

When the technician removed the floorboards, it appeared the floorboards had not been taken up since the aircraft was new. He removed the large floorboard section, just aft of the wing spar, and found severe structural corrosion on the two center/middle channel assemblies (P/N's 95-420015-49 and -50). These channels are used to accommodate mounting for seat rails. The corrosion had progressed to the extent that one channel had a 2-inch section completely consumed, and the other channel had a 1-inch section completely consumed. (Refer to the illustration.) He speculated dissimilar metals, the steel attachment screws, and the aluminum channels contacted each other and caused the corrosion.

From this report, it seems evident that past inspections were not properly accomplished. This area should be inspected and discrepancies repaired during each annual inspection. A word to the wise should be sufficient.

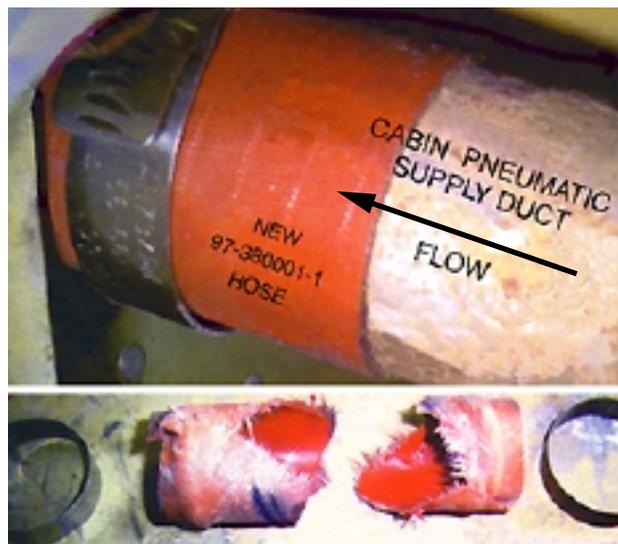
While troubleshooting a flightcrew report of poor cabin pressurization system operation, the technician discovered that an air supply line had failed.

The hose (P/N 97-380001-1), located in the left engine airline supplying air to the cabin, was completely separated. (Refer to the illustration.) Failure of the hose eliminated input air to the cabin from the left flow pack. The technician stated the “cure date” on the hose was not readable; however, it appeared the hose failed due to excessive age. Other similar hoses in the system had “cure dates” ranging from 1976 to 1996. The manufacturer’s technical data lists a life limit of 5 years for these hoses.

The age of the hose was in excess of 5 years.

The location of the failed hose makes proper inspection very difficult, and the submitter believes they are commonly overlooked during scheduled inspections. He recommended that maintenance personnel expend the extra effort necessary to properly assess the condition of the pressurization system hoses during inspections. He also suggested strict adherence to the established life limits.

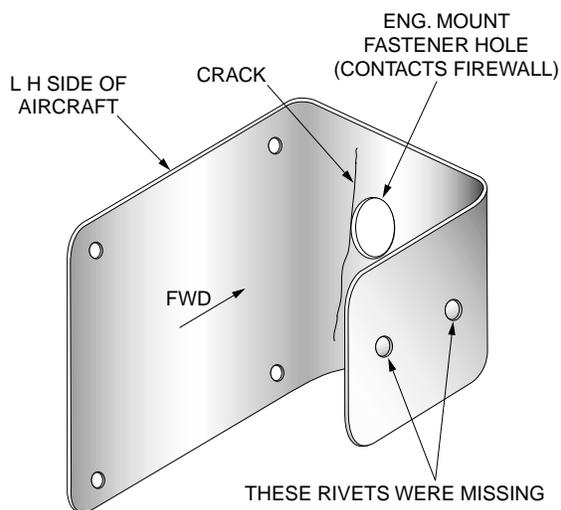
Cessna; Model 172RG; Cutlass; Firewall Crack; ATA 5412

The technician discovered the upper left engine mount bracket (P/N 2413024-11) was cracked at the mount fastener hole. (Refer to the illustration.) The inboard two rivets, used to attach the bracket to the longeron hat section, were missing. He speculated the missing fasteners caused the crack.

The submitter recommended inspecting this area for the presence of all fasteners at every opportunity.

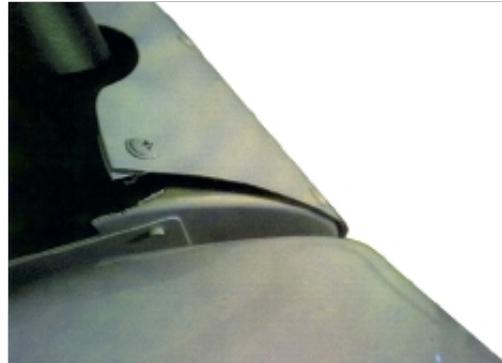
Cessna; Model 172S; Skyhawk; Defective Propeller Spinner; ATA 6113

While conducting a postflight inspection, the technician discovered the propeller spinner bulkhead was cracked.

The corner of the spinner bulkhead assembly (P/N 0550321-10) was completely ripped away, and the edge of the spinner was beginning to peel up. (Refer to the illustration.) The submitter suspects this defect was caused by a manufacturing defect.

The FAA Service Difficulty Program data base contains three additional reports concerning propeller spinner defects. The part total times for these reports are 143, 50, and 41 hours operating time. Considering the low number of operating hours for these failures, it seems appropriate to conduct frequent and rigorous inspections of the propeller spinner assembly.

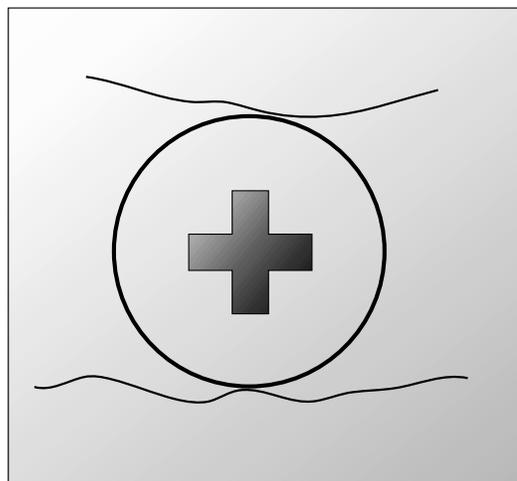
Cessna; Model C550; Citation; Aileron Structural Defect; ATA 5751

During a scheduled inspection, the technician removed the aileron and discovered a structural defect associated with the balance weight.

After removal of the aileron (P/N 6524126-3) leading edge skin, the technician found two parallel cracks adjacent to a loose balance weight attachment screw (P/N MS24694S62). The cracks were approximately .5 inch long and were located on either side of the screw. (Refer to the illustration.) The technician inspected the right aileron and found two loose balance weight attachment screws; however, cracks had not developed.

The submitter suspects the small diameter nuts and washers, used to secure the aileron balance weights, are not sufficient for the loads imposed during flight. This is the third occurrence of this defect he has found in this operator's fleet of like aircraft.

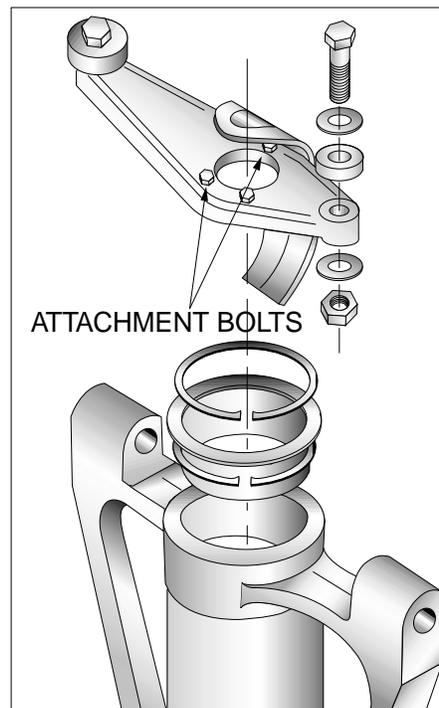
Piper; Model PA 31T1; Cheyenne; Nose Gear Steering Failure; ATA 3251

The pilot reported losing directional control after landing the aircraft. Before he could stop the aircraft, it departed the runway. This resulted in an aircraft incident and damage to the aircraft.

A technician discovered the nose gear steering arm (P/N 44386-00), attached to the top of the nose gear strut (P/N 45333-07) housing, had separated. It appeared the attachment bolts had loosened before they sheared. (Refer to the illustration.) He did not give a reason for the attachment bolts loosening.

The submitter recommended checking for proper torque on the steering arm attachment bolts during scheduled inspections and maintenance.

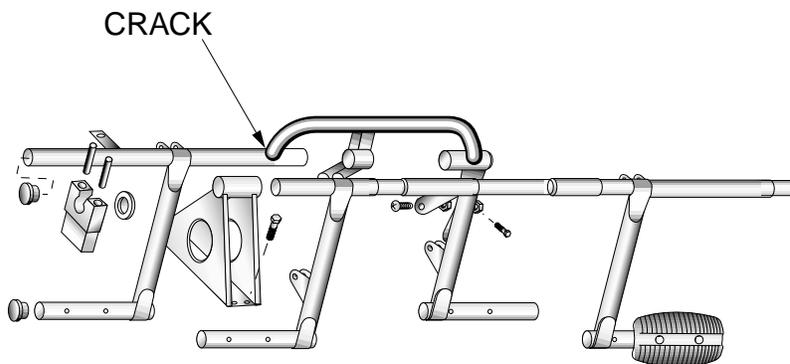
Piper; Model PA 32-260; Cherokee Six; Defective Rudder Control Linkage; ATA 2720

During a scheduled inspection, the technician discovered the rudder pedal linkage was cracked.

The left rudder bar (P/N 63420-04) was cracked at a weld that attaches the straight tube to the carry-through tube (P/N 63459-13). (Refer to the illustration.) The submitter reported finding numerous similar defects numerous on like aircraft. The crack rendered the assembly in imminent danger of complete failure and a hazard to flight safety.

On later model aircraft, the rudder bar assembly is reinforced with a gusset plate welded on at the failure location. Considering the long service life of this part, it seems likely that metal fatigue contributed to this failure.

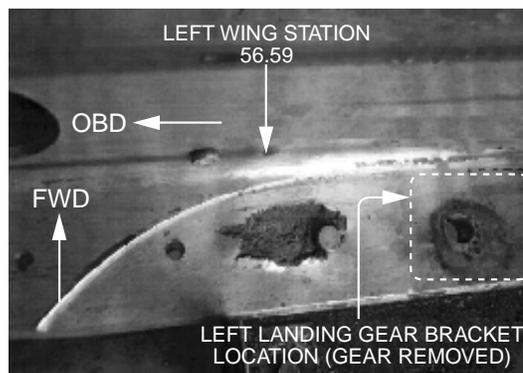
Piper; Model PA 32-300; Cherokee Six; Wing Spar Structural Damage; ATA 5711

While replacing a wing skin, a technician discovered severe corrosion damage on a wing spar.

The left wing lower aft surface of the forward spar (P/N 62070-06) was damaged just outboard of the main gear attachment casting. (Refer to the illustration.) The corrosion was centered around a rivet, and the metal was badly exfoliated. There were several other corrosion sites in the same area that had not progressed to the severe stage. Also, a fastener hole for the attachment of the main gear casting displayed signs of serious corrosion.

The remainder of the wing interior had no evidence of corrosion and was in good condition. The corrosion noted in this case may have resulted from an inclusion in the metal causing intergranular corrosion.
