## ADVISORY CIRCULAR 43-16A

# AVIATION MAINTENANCE ALERTS

**ALERT  
NUMBER  
282**

**JANUARY  
2002**

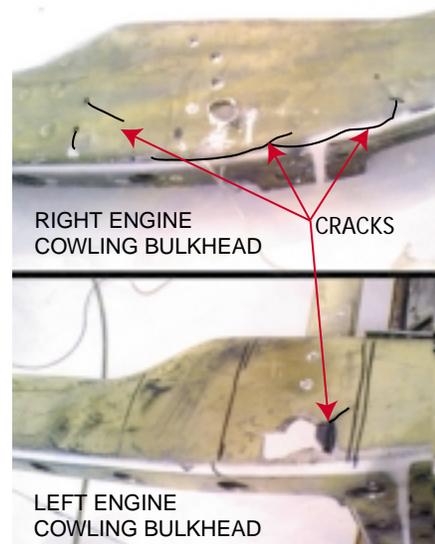
### **Beech; Model 1900; Airliner; Nacelle Structural Defects; ATA 7110**

While conducting a scheduled inspection, the technician discovered several cracks in the left and right nacelles.

The cracks on the right engine were found in the cowling bulkhead (P/N 1189100421) at station 238.18. This location is where the lower front engine cowling attaches. The cracks were located on the right lower side. (Refer to the illustration.)

The submitter found similar cracks on the left engine cowling bulkhead. He did not offer a cause or cure for this type of defect; however, he suggested that technicians be vigilant for problems in this area. It is possible that the high number of operating hours on this airframe contributed to these defects.

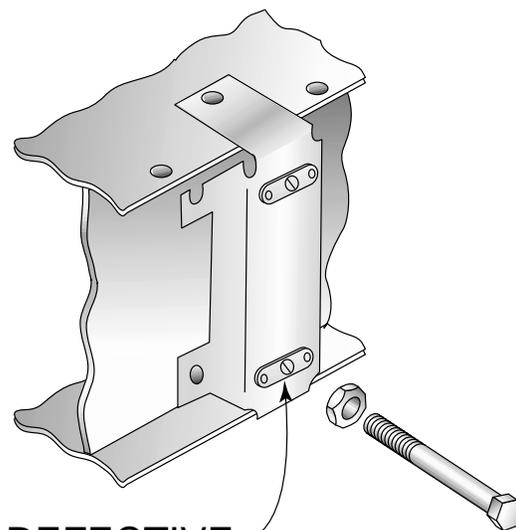
**DEFECTIVE  
NUT PLATE**

**Cessna; Model 172R; Skyhawk; Elevator Defect; ATA 2722**

The lower elevator stop nut plate (P/N MS21078-3) was broken and the fiber lock portion had separated from the rest of the nut plate. (Refer to the illustration.) The dysfunctional nut plate allowed the stop bolt to move freely in the assembly. It appeared the nut plate failure began as small cracks and culminated in complete failure.

The submitter speculated this defect was caused by repeated elevator contact with the stop bolt while parked on the ramp during gusty and strong wind conditions.

This area deserves extra attention during inspections and maintenance.

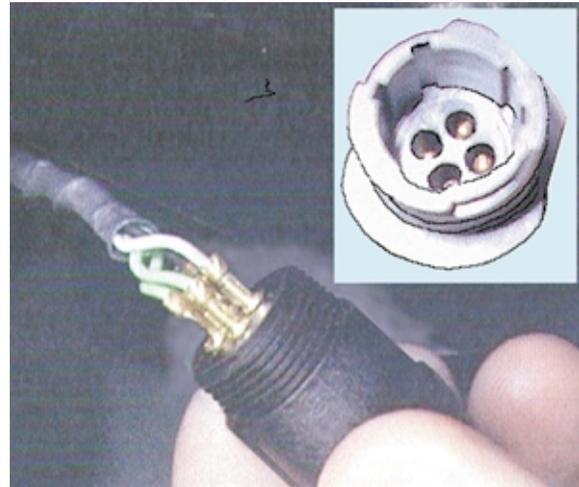
**Cessna; Model 550; Citation; Cabin Pressurization System Defect; ATA 2131**

After installation of a “repaired” cabin pressure controller unit, the technician found that the system would not test or pressurize the aircraft.

The technician conducted rigorous troubleshooting procedures, during which he discovered the cabin pressurization controller (P/N 130356-16) “Cannon plug” was defective. The four “Cannon plug” pins were bent slightly and were recessed in the plug far enough to prevent electrical contact. In addition, the wires installed into the pins were not stripped, but crimped into the pins with the insulation still in place. (Refer to the illustration.)

Needless to say the workmanship in this case was far less than satisfactory. Technicians are urged to pay close attention to detail and current technical data while repairing aviation equipment.

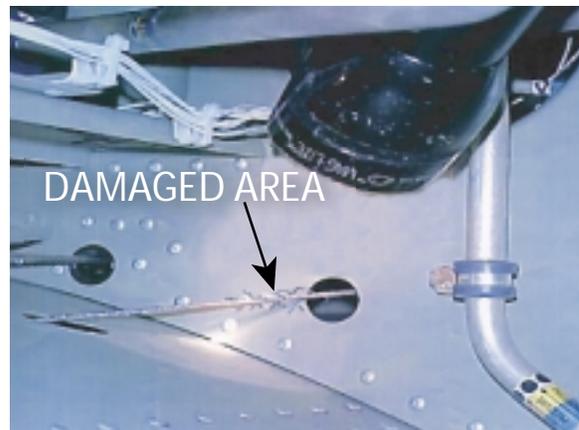
**Cessna; Model 560; Citation; Landing Gear Emergency Release System Defect; ATA 3230**

During a scheduled inspection, the inspector discovered the landing gear emergency release cable was damaged.

The severity of damage to the cable made replacement necessary. Since this is a relatively new aircraft, it makes one wonder if other like aircraft may suffer the same problem.

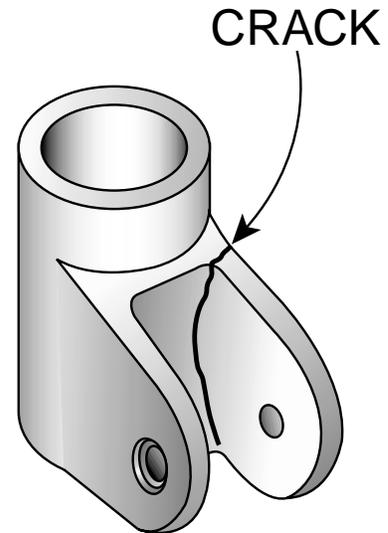
**Piper; Model PA 28-151; Warrior; Main Landing Gear Structural Defect; ATA 3213**

During a scheduled inspection, a technician discovered the left main gear strut was damaged.

One of the lower strut (P/N 48738-02) torque link attachment ears was cracked and in danger of complete failure. It appeared the crack originated at the top of the casting and traveled down following the radius. (Refer to the illustration.) The submitter stated this defect has been discovered many times, especially on middle-time aircraft and high-time aircraft that are used for flight instruction. Previous cracks have been found on either torque link attachment ear originating from either the top or bottom and following the radius.

The submitter urged all technicians to give this area special attention during inspections and maintenance.

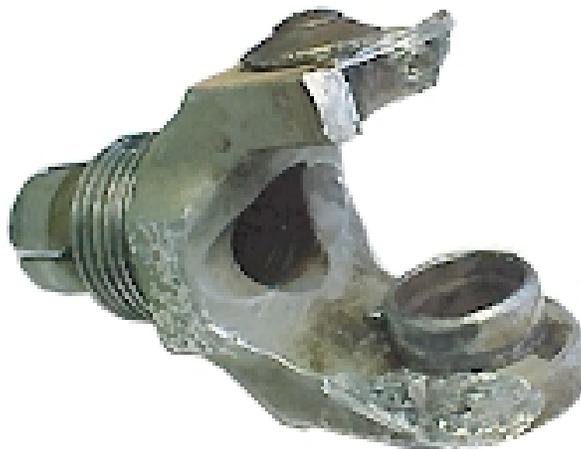
#### **Bell; Model 47; Tail Rotor Drive System Defect; ATA 6510**

While investigating, a technician discovered the tail rotor drive shaft universal joint (P/N 47-644-33-5) was broken. (Refer to the illustration.)

After examining the broken universal joint, he determined that only half of the assembly was receiving grease during scheduled lubrication. The lack of adequate lubrication caused this failure. It is important that all parts of a component receive proper lubrication to prevent this type of failure.

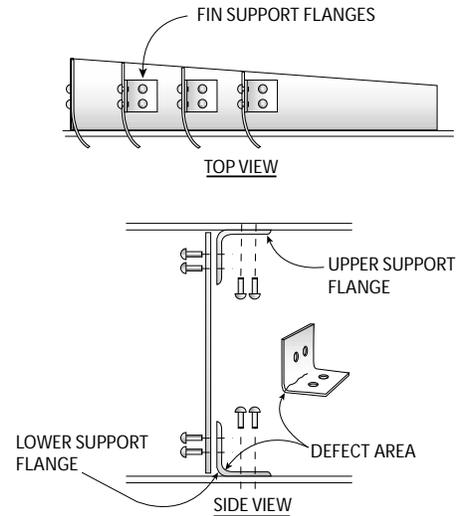
#### **Eurocopter; Model AS 350BA; Ecureuil; Structural Failure; ATA 2100**

The technician discovered one of the air-intake fins broke and separated from the helicopter. When the air-intake fin separated, it contacted and damaged the tail rotor assembly.

It appeared the upper fin support flange (P/N 260952) cracked and ultimately broke, which led to failure of the lower support flange. Failure of the support flanges allowed the fin to separate from the aircraft. (Refer to the illustration.) The fin traveled aft in the airstream and struck the tail rotor assembly.

The FAA, Rotorcraft Certification Directorate, is currently reviewing the data for STC 3509SW and evaluating the structural integrity of this installation.
