ADVISORY CIRCULAR 43-16A

AVIATION MAINTENANCE ALERTS

**ALERT
NUMBER
285**

**APRIL
2002**

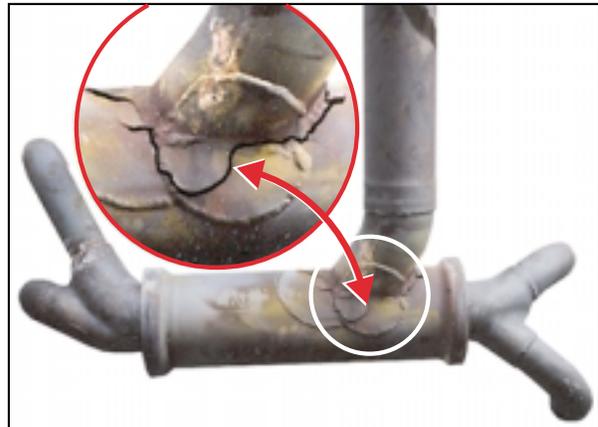
American General; Model AA-1; Clipper; Defective Engine Exhaust System; ATA 7810

There were numerous "spider web" cracks at the junction of the tail pipe and the muffler (P/N 099001-113) can. The cracks were adjacent to a weldment that attaches the two components. In addition, a large welded repair was previously installed at the same location. (Refer to the illustration.)

The cause of this defect may be related to improper welding practices, the induction of hydrogen embrittlement in the metal adjoining welds, and "flash cooling." The submitter stated, "Better inspection techniques might provide early detection of this type defect."

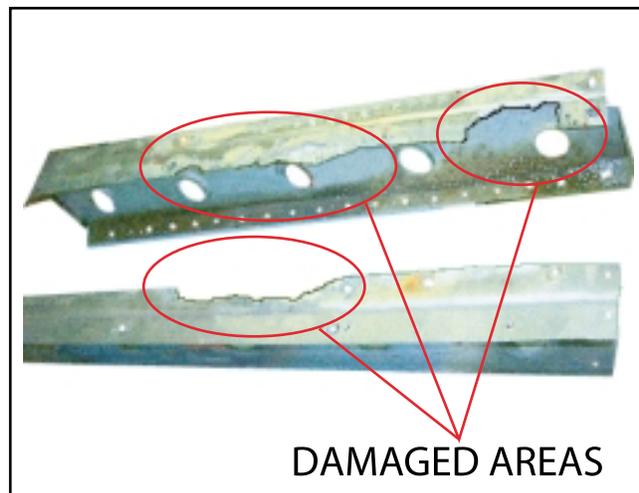
Beech; Model 95-B55; Baron; Structural Corrosion; ATA 5315

While conducting a scheduled inspection, the technician noticed several small cracks in the baggage compartment door area.

The technician removed the baggage compartment floor and discovered severe corrosion on several structural members. (Refer to the illustration.) The insulation/sound-proofing material, used on the under side of the floor panels, was wet. The material retained moisture and held it in contact with the floor panels and the supporting structure.

The submitter suggested Raytheon issue a Service Bulletin to address and correct the corrosion problem in this, as well as other areas of the aircraft. Corrosion is a habitual problem with aviation products, especially older and high-time aircraft, and deserves close attention by owners, operators, and maintenance personnel.

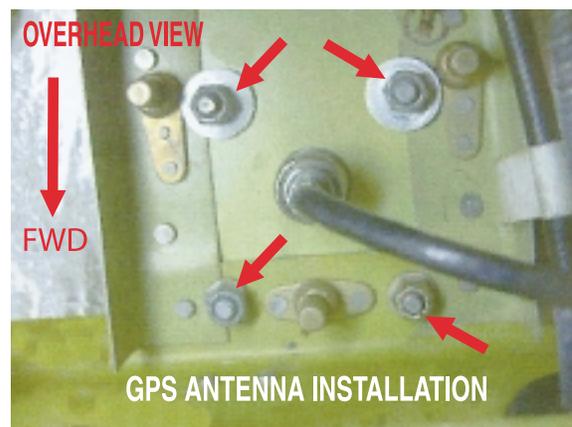
Beech; Model 200; King Air; Defective GPS Installation; ATA 5330

The technician reviewed the aircraft maintenance records and found no record that a GPS antenna was installed. The antenna installation penetrated the fuselage pressure vessel in five locations and was not accomplished in accordance with approved data. Both the selection and use of the mounting hardware for the antenna was incorrect, and there was no sealant or doubler used. (Refer to the illustration.)

The penetration of an aircraft pressure vessel is a very serious matter and must be accomplished using

only approved data. The technician removed the antenna and, using an approved repair procedure, returned the pressure vessel to its original structural integrity. This process included proper installation of the GPS antenna.

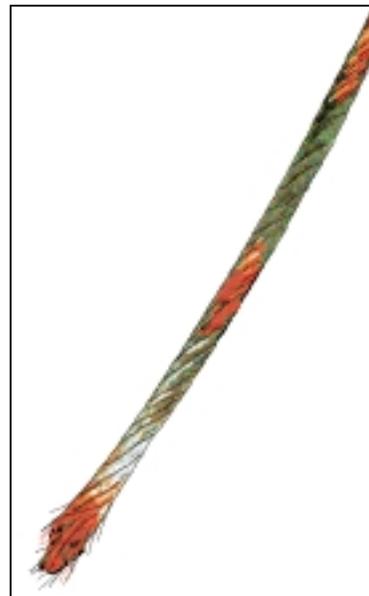
Cessna; Model 172P; Skyhawk; Aileron Control System Failure; ATA 2710

The inspector found the right aileron cable was severed. There was evidence of severe corrosion at the point where the cable separated, as well as other locations. The cable separated adjacent to a pulley in the cabin overhead area, which is covered by the headliner. The cable strands were very brittle, and several cable strands were broken prior to the separation. (Refer to the illustration.)

The submitter strongly recommended that technicians conducting scheduled inspections open the headliner area, disconnect the cable, and pull the cable out far enough to thoroughly inspect the flight control cables. Many like aircraft are susceptible to corrosion damage in the cabin overhead area, especially those with long-term exposure to outside environmental conditions. This particular aircraft is based in a location where it is exposed to a salt-air environment and large yearly rainfall amounts.

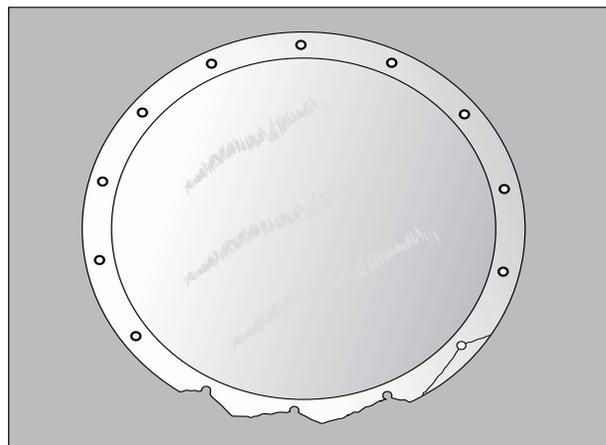
Cessna; Model 425; Conquest I; Defective Cabin Door Window; ATA 5210

The window, located in the upper cabin entrance door, had four adjacent mounting holes broken in the outer edge of the window. The broken holes were at the lower edge of the window. (Refer to the illustration.) He also discovered the retaining ring (P/N 5311260-9) was not installed.

After reviewing the available maintenance records, the submitter believes the manufacturer accomplished the previous window installation.

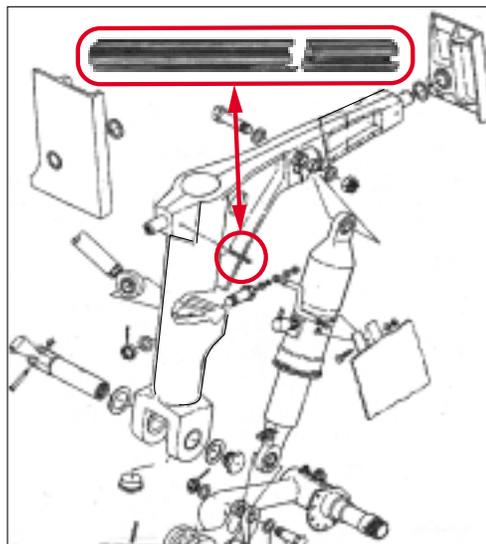
Cessna; Model 441; Conquest; Main Landing Gear Defect; ATA 3213

During a scheduled landing gear inspection, a technician discovered a defect on the left main gear pivot pin. He found the same discrepancy on two like aircraft from his fleet.

The inspection was initiated because of a landing gear pivot pin (P/N NAS 561P6-28) failure on another aircraft. (Refer to the illustration.) He disassembled the main gear from the two additional aircraft and discovered the left forward pins were broken, and one of the right side pins displayed signs of shearing.

The technician replaced all six pins and urged all technicians to be diligent in inspecting this area.

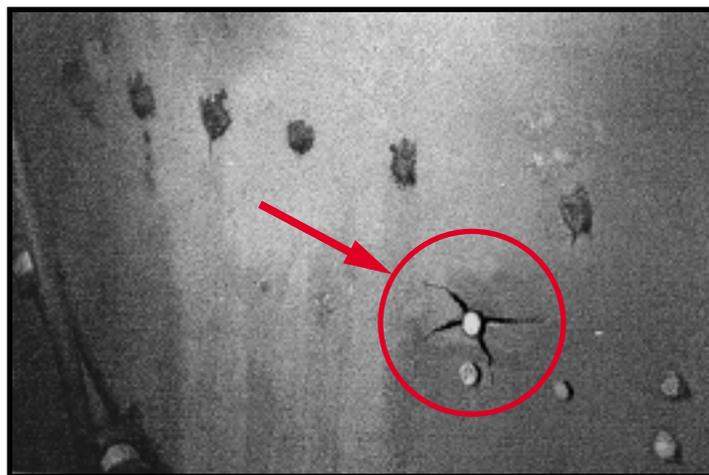
Cessna; Model 500; Citation; Pressure Bulkhead Structural Defect; ATA 5312

The technician found the forward pressure bulkhead (P/N 5511040-13) was cracked adjacent to a fastener. (Refer to the illustration.) He did not give a cause for this damage. The fastener was part of a repair that was installed in accordance with approved data and properly recorded in the aircraft maintenance records.

The submitter stated this was the fourth like aircraft he has found with similar defects. He recommended giving this area close attention (especially on older Citation Model 500 aircraft).

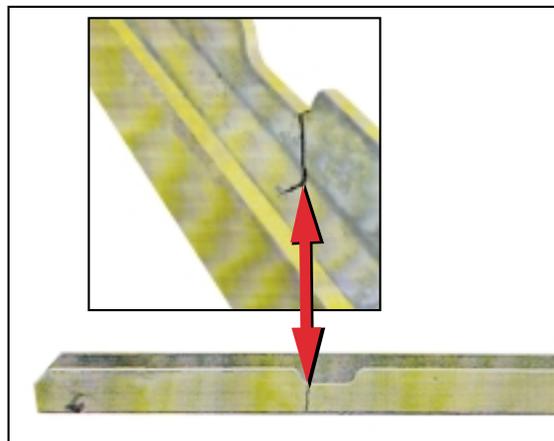
Piper; Model PA 31-350; Chieftain; Nose Landing Gear Structural Defect; ATA 3233

The upper nose landing gear actuator attachment support bracket (P/N 40987-2) was severely cracked. (Refer to the illustration.) The support bracket is in the form of a “U-channel” and has a cutout to accommodate a fitting for the hydraulic powerpack relief valve. The crack was located at the cutout radius and traveled down and into the lower portion of the support bracket “U-channel.”

The technician submitted three additional reports, on like aircraft that were very similar. He did not offer a conclusion concerning the cause of this defect; however, it may well have been the result of age, a high number of gear cycles, and/or high operating hours. Indeed, all four reports were on “high-time” aircraft.

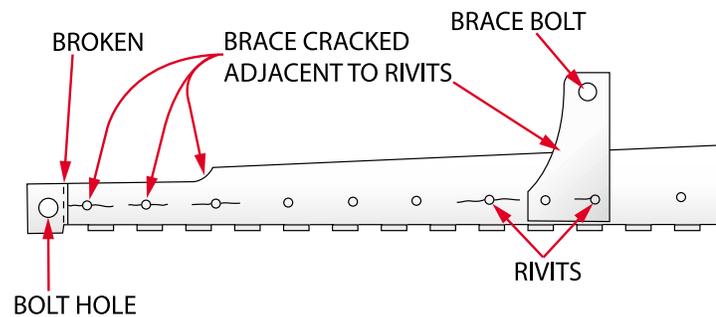
Piper; Model PA 32R-300; Cherokee Lance; Defective Nose Landing Gear Door; ATA 5280

All the failures occurred on the right nose gear door brace (P/N 38076-01). In each case, the door brace broke at the rear attachment point. The technician discovered several cracks adjacent to the attaching rivets. (Refer to the illustration.) The failures happened between 54 and 1,076 operating hours on each part.

The submitter did not give a cause for these defects. However, he stated, "This is a common problem with this make and model aircraft."
