ADVISORY CIRCULAR 43-16A

AVIATION MAINTENANCE ALERTS

**ALERT
NUMBER
286**

**May
2002**

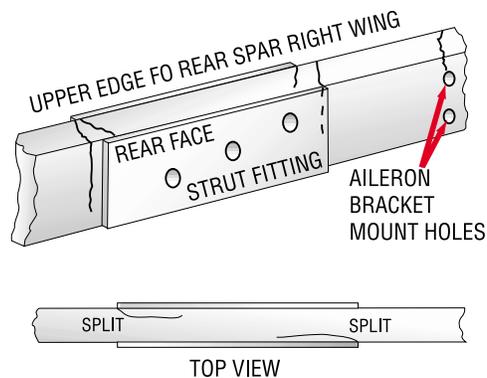
American Champion; Model 7-ECA; Citabria; Wing Spar Defects; ATA 5711

At first glance, the spars appeared to be in good condition. However, a high-intensity light revealed four compression cracks on the upper edge of the rear spar and one crack associated with an aileron bellcrank attachment hole. Two of the cracks extended down through the spar at the plywood plate through approximately 45 percent of the spar thickness. He found two splits that originated at the wing strut attachment reinforcing plywood plate and followed the edge grain of the wood for approximately 2.5 inches. (Refer to the illustration.)

The submitter stated he would not have found these defects using ordinary visual inspection techniques. None of the cracks were visible until the varnish, excess adhesive, and dirt were removed. He suggested chamfering the vertical edges of the plywood reinforcement plates by .75 inch might reduce the stress buildup at this location.

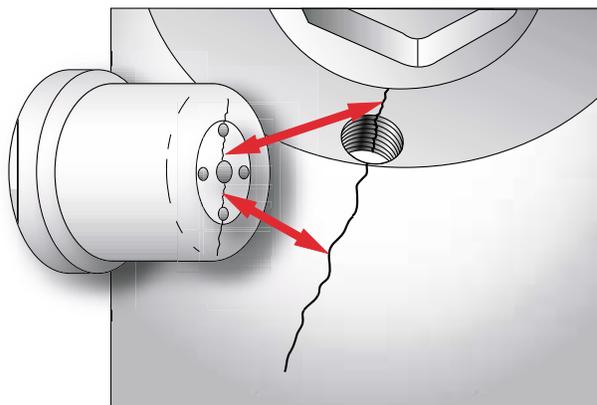
American Champion; Model 8KCAB; Decathlon; Defective Propeller Assembly; ATA 6110

The propeller pitch cylinder (hub) (P/N B-2428-2) was severely cracked on the forward end. The crack traveled outboard from both sides of the low pitch stop-nut. (Refer to the illustration.) Airworthiness Directive (AD) 2001-23-08 deals with this subject, and this aircraft was in compliance with the AD. Hartzell Service Bulletin (SB) HC-SB-61-227, Revision 2, dated May 8, 2000, is incorporated by reference in AD 2001-23-08.

The submitter stated this aircraft is used in a training environment for aerobatic instruction, and “hard” use may have contributed to the defect.

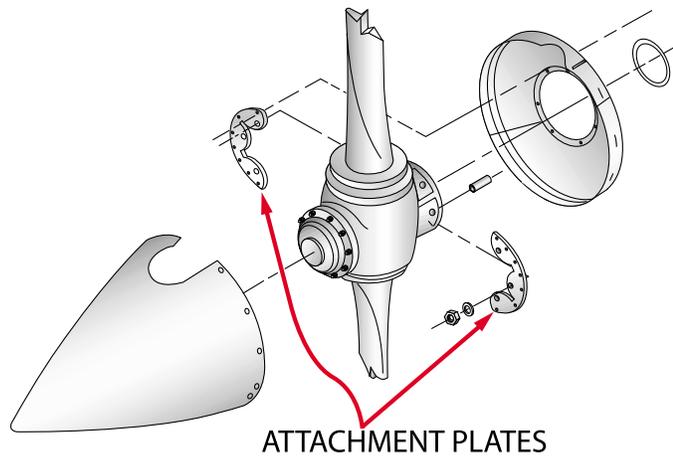
Cessna; Model R182; Skylane; Defective Propeller Spinner; ATA 6113

The technician found both propeller spinner attachment plates (McCauley P/N C5046) were severely cracked. The cracks traveled through four of the six attachment fastener holes on each attachment plate. It appeared the cracks originated from the corner of each fastener head and went to the outer edge of the plates. (Refer to the illustration.) There were three cracks on one of the attachment plates and one long crack on the other.

The technician removed the bolts from the plates and noticed that no washers had been installed as required by the manufacturer's technical data. Evidently, the washers were omitted when the propeller was installed. He inspected two other like aircraft and found the same 12 washers had been omitted. He discovered the washers were omitted from the propeller attachment bolts on all three aircraft.

The submitter suggested that proper adherence to the manufacturer's approved technical data would prevent recurrence of this type defect.

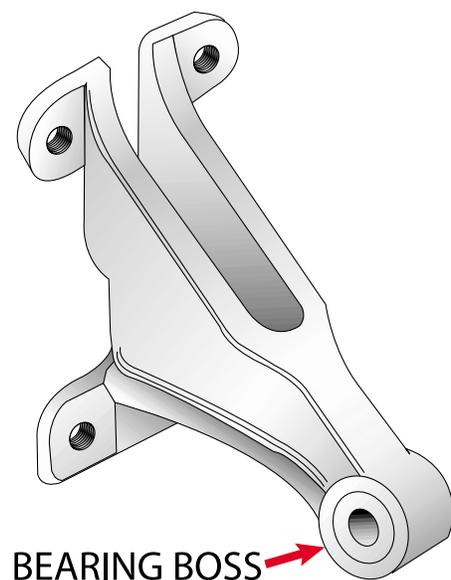
Cessna; Model 190; Flight Control Structural Defect; ATA 5751

The left and right inboard aileron hinge brackets (P/N's 0322709 and 0322709-1) were in a state of imminent failure. The technician discovered both hinge brackets were cracked completely across the bearing boss. There was severe corrosion on the aileron hinge brackets, and one of the bracket mounting legs was broken. (Refer to the illustration.)

The submitter believes corrosion caused the metal to become "brittle" and propagated this damage. The aileron hinge brackets are made of magnesium, which is highly susceptible to corrosion. The same type of aileron hinge bracket is used on 195A and 195B model aircraft.

Since this is a critical component, the submitter suggested giving the brackets a close inspection at every opportunity.

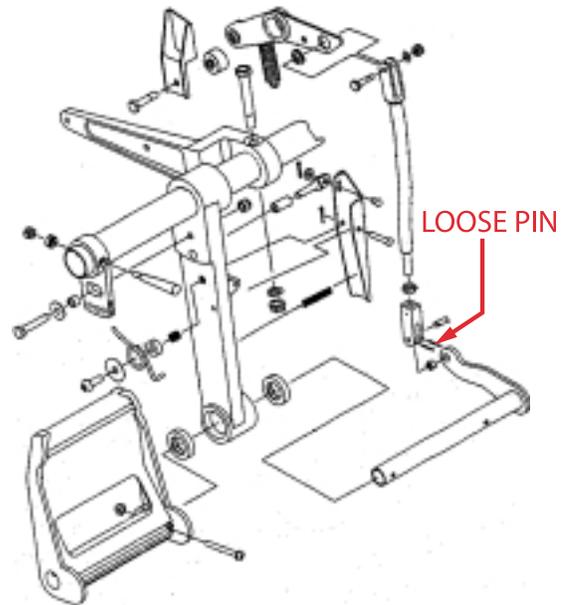
Cessna; Model 750; Citation; Rudder/Brake Pedal Linkage Defect; ATA 3242

The pin (P/N MS35675-4), used to secure the clevis-connecting pin (P/N 6261081-14), was exceptionally loose and working out of the clevis. (Refer to the illustration.) The pin, designed for a "press fit," could be removed by hand. It appeared the clevis material was worn sufficiently to allow the pin to become loose. If the two pins had come out, the pilot's right brake function would have been inoperative.

The submitter recommended the manufacturer consider replacing the clevis attachment pin with a device having a positive lock, such as a bolt and castle nut or a roll pin with safety wire.

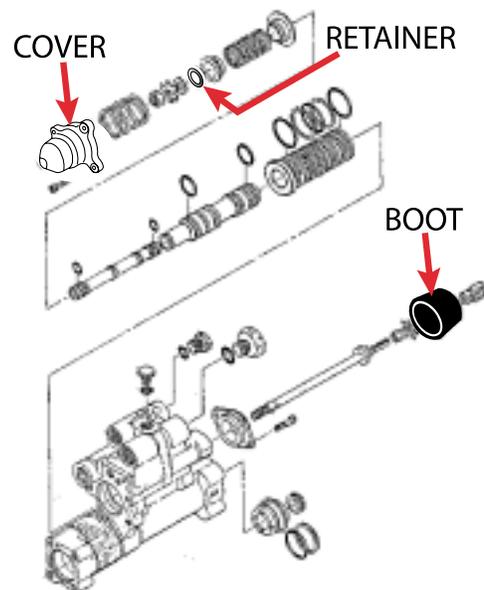
The submitter stated the available evidence indicated the corrosion caused this damage. Evidently, the “boot,” shown in the illustration, allowed water and contaminants to enter the unit and initiated the corrosion process. He suggested the manufacturer modify the cover by adding a water drain and/or improving the boot to exclude water from the unit.

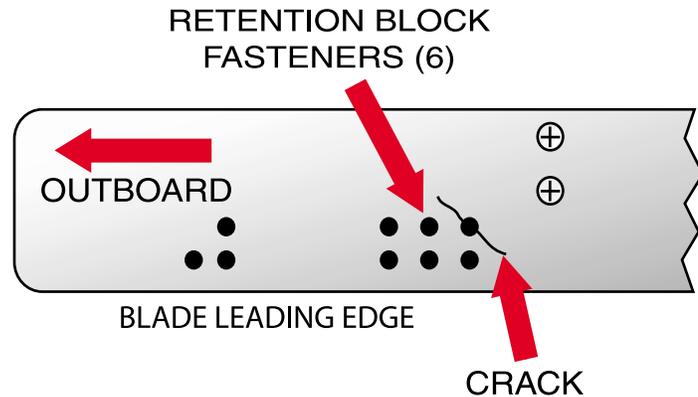
EUROCOPTER**Eurocopter; Model BK-117; MBB; Main Rotor Blade Damage; ATA 6210**

A repair station received a main rotor blade (P/N 117-150041) for inspection and evaluation of a crack in an abrasion strip.

The submitter did not determine a cause for this defect. He suggested giving the main rotor blades close scrutiny during inspections and maintenance.
