U.S. Department
of Transportation
**Federal Aviation
Administration**

ADVISORY CIRCULAR 43-16A

AVIATION MAINTENANCE ALERTS

**ALERT
NUMBER
293**

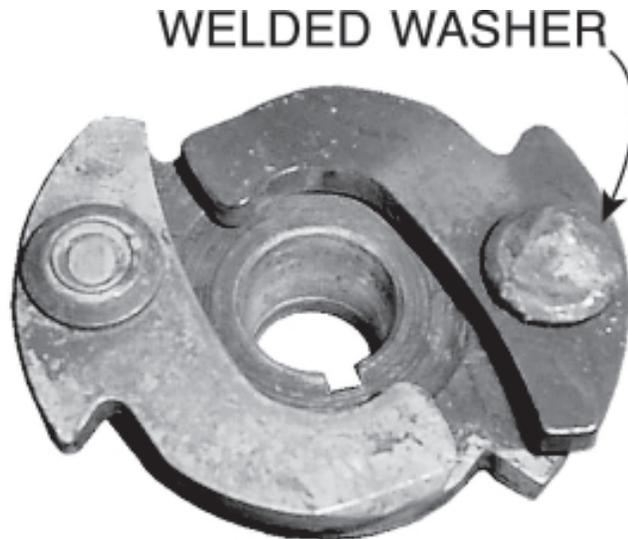
BENDIX MAGNETO DEFECT

The subject magneto (Bendix type S4LN-21) was installed on a Teledyne Continental Model C-90 engine being used on a Cessna Model 140A aircraft.

During an engine teardown because of a broken rocker boss, the owner decided to overhaul the engine due to performance degradation. When the engine was disassembled, a technician discovered the crankshaft was cracked. The engine maintenance records indicated the engine was involved in a "propeller strike" approximately 18 months prior. When the magnetos were removed, he found that the flyweights on one magneto were starting to rub on the posts. The washer was "welded" to the axle. (Refer to the illustration.) Normally, the flyweights are secured by countersunk washers that are "hot riveted" to the axle. In this case, someone had "brazed" the washers to the axle, evidently because it was loose.

The manufacturer's inspection requires checking the washers with hand pressure for rotation. Movement of the washer requires replacement of the cam/flyweight assembly. It was not possible to determine the identity of the person who improperly welded the washer in this assembly!
