# ADVISORY CIRCULAR 43-16A

## AVIATION MAINTENANCE ALERTS

ALERT  
NUMBER  
297

APRIL  
2003

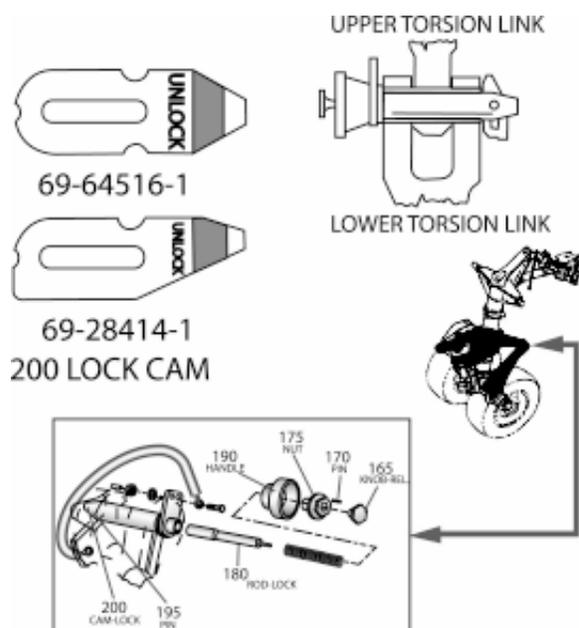
**A.** Lock Cam (#200) P/N 69-64516-1, detent ground deeper, worn beyond limits or additional detents added. Paint also was missing in required area.

**B.** Pin (#170) P/N MS39086-520, missing and hole utilized for safety wiring.

**C.** Nut (#175) P/N 69-28413, improperly safety wired.

**E.** Release Knob (#165) P/N 66-20304-1, missing or altered to reduce the effort needed to overcome the 20-pound spring force holding Lock Cam (#200).

**F.** Rod-Lock (#180) P/N 69-28412-1, missing half inch at tapered rod end. Condition exists when Release Knob (#165) is missing.

**G.** Pin (#195) P/N 6534878-2, incorrect hardware used as substitution or incorrectly installed.

The FAA Service Difficulty Reporting Program data base revealed 12 similar reports for the period of January 1, 1995, to March 18, 2003, on the Boeing Model 727 series aircraft nose landing gear scissors and apex pin assembly.

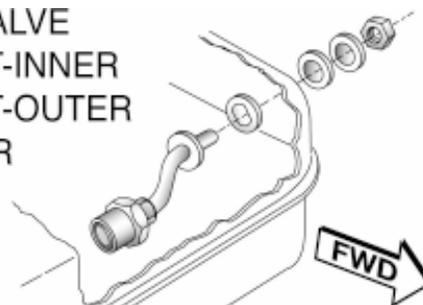
DETAIL A (LH TANK ONLY)

Recently the FAA received a Safety Recommendation applicable to the fuel tank vent installation description as shown in the maintenance manual for the Cessna Model 152 airplanes.

This article has been coordinated with Cessna Aircraft Company and is intended to provide early notification to these changes. (Refer to the illustration.)

TUBE FOR VENT VALVE  
EXTENDS INTO FUEL TANK,  
THEN FORWARD AND  
SLIGHTLY UPWARD

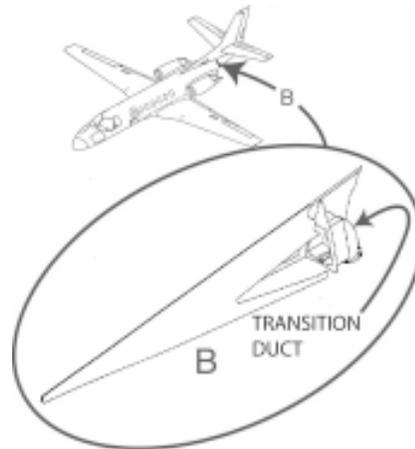
During a routine inspection of the dorsal fin airscoops, the technician discovered that material was missing from the air vanes (P/Ns 6512072-11 and 6512072-12) located in the transition duct (P/N 6512072-10-1). (Refer to the illustration.)

The location and route of the missing material was a concern. The material would have been routed into the ventilation J-box (air-mixing box) where it would have passed the cabin pressurization fresh air check valve and possibly wedge the valve open. With the valve open, the aircraft would not be able to hold pressurization.

The technician’s inspection revealed that a piece of the material was wedged in the check valve, and the valve could not seal. Pieces of the material also passed through the overhead blower and wedged in the duct work. The blower cage was not damaged.

Part total time-3,545 hours.

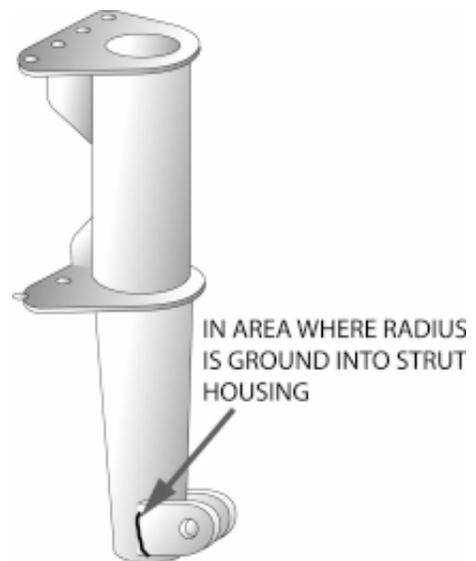
During routine 100-hour inspection, a technician discovered a crack in the main landing gear upper-strut housing (P/N 65319-04).

The crack was located at the attachment lobes for the landing gear torque link. (Refer to the illustration.)

A search of the FAA Service Difficulty Program data base (by P/Ns 65319-04 and 65319-004) revealed 25 reports on the Piper PA 28 series aircraft main landing gear failures. The data base can be accessed at: <<http://av-info.faa.gov/isdr/SDRQueryControl.asp?>>.

Part total time-9,722 hours.

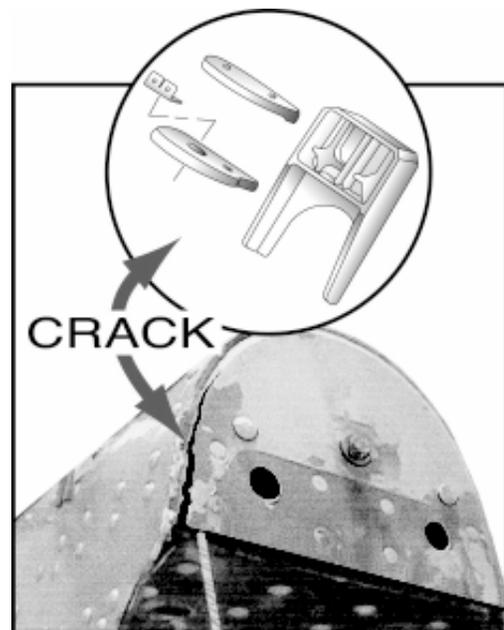
While conducting a daily inspection of the aircraft vertical fin area, the technician discovered cracks.

One crack was approximately 1.5 inches and was located on the nose rib assembly (P/N 105-304051). The other crack was approximately .5 inch and was located on the tail rotor gearbox attachment fitting (P/N 105-30414.15). (Refer to the illustration.)
