U.S. Department
of Transportation
**Federal Aviation
Administration**

ADVISORY CIRCULAR 43-16A

AVIATION MAINTENANCE ALERTS

ALERT
NUMBER
299

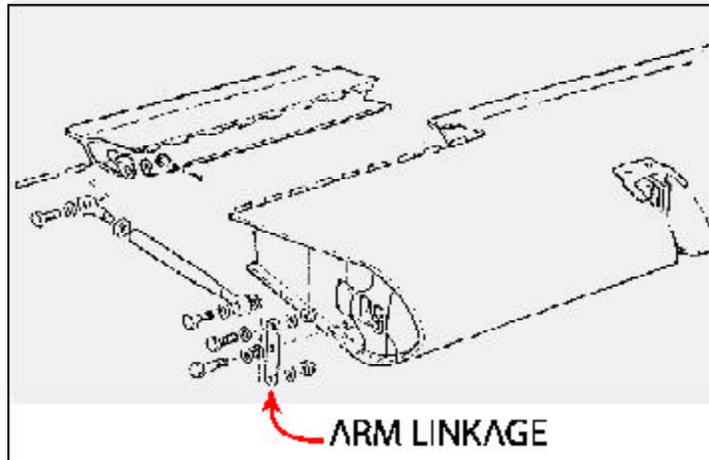
Beech; Model B-58; Baron; Aileron Trim Control; ATA 2711

During annual inspection, the technician discovered the aileron trim tab linkage (P/N 45-135039-3) was rubbing on the leading edge of the aileron.

He found the trim tab linkage arm was installed 180 degrees out, with the short end hooked to the actuator linkage, and the trim tab linkage attached to the long end. (Refer to the illustration.)

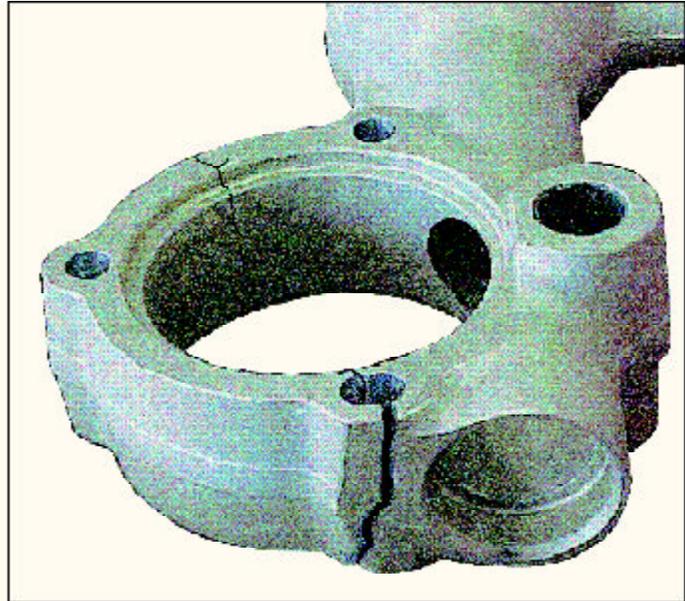
The technician investigated and discovered the Cessna (P/N 1281001-3) right main gear actuator body was cracked. (Refer to the illustration.) He found another crack starting where the landing gear casting attaches onto the spot face of the body. This defect cannot be seen without removing the actuator assembly. He discovered the piston assembly (P/N 9882004-1) and the sector gear (P/N 9882002-2) displayed signs of gear galling.

The submitter suspects the actuator body may have failed due to fatigue.

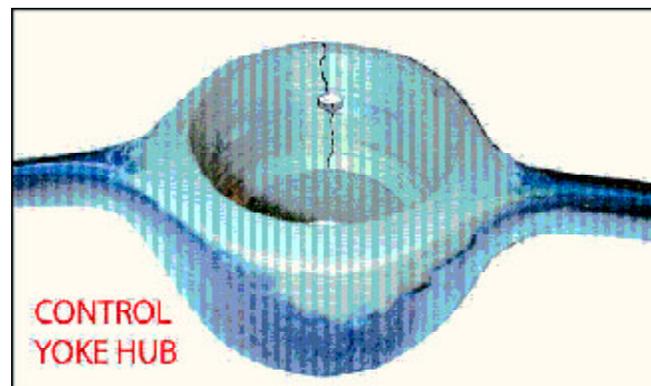
The technician discovered that both yokes were cracked on the lower side, through the hole for the roll pin. This condition was not visible until he removed the emblem and yoke.

According to the submitter, a plastic coating on the yoke exterior had not cracked even though the aluminum yoke beneath it was cracked fully through. (Refer to the illustration.)

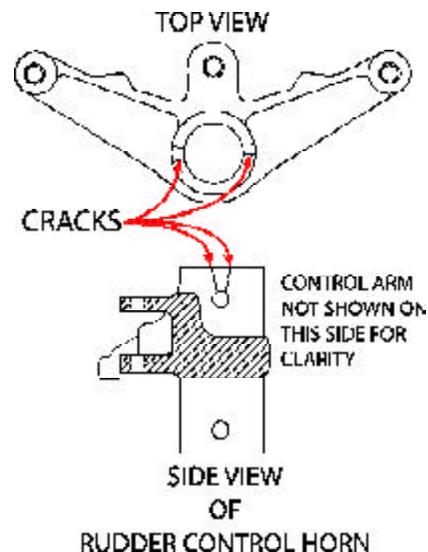
Piper; Model PA 30-160; Twin Comanche; Rudder Control; ATA 2720

The technician removed the rudder control horn (P/N 20185-5) due to wear between the horn and the rudder. He also found cracks going from the mount holes to the top of the rudder horn. (Refer to the illustration.)

The submitter stated that he is aware of several other rudder control horns that have cracked in the same manner.

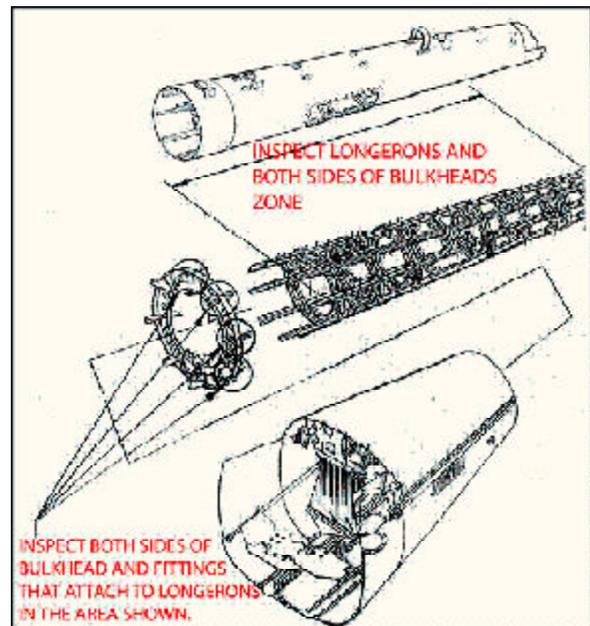
There have been a number of reported tailboom skin cracks located on the right hand side and top of the tailboom between tailboom stations TB 120-140 for 222, or TB 220-240 for 222B, U, and 230 models. During the inspection and repair of those cracks, there have been additional cracks discovered in the longerons and in the bulkhead flanges inside the tailboom.

The FAA recommends that aircraft/tailbooms that have accumulated more than 5,000 hours time-in-service be inspected closely within the next 300 hours and any time a skin crack is discovered on the left hand side of the tailboom or on the upper skin between the two most upper longerons adjacent to Buttock Line BL 0.0.

Most of the cracks on the right hand side could be prevented by the application of the existing BHT technical bulletins 222U-94-65 and 222-94-138. All cracks discovered in skins must be repaired. Inspections should be accomplished in the areas as shown in Figure 1. Access can be gained through removal of the access door (see Figure 2) and removal of the horizontal stabilizer.

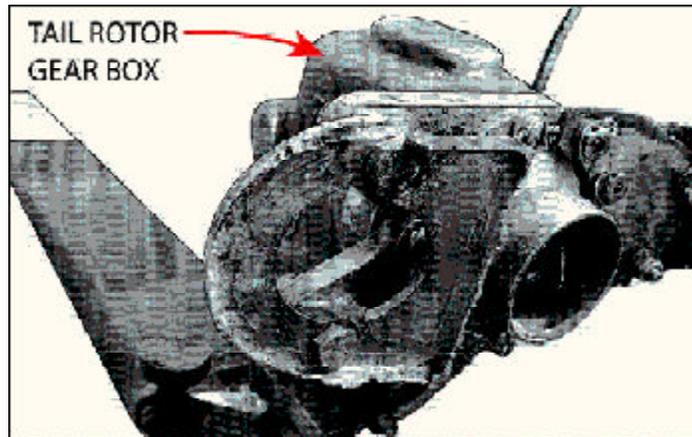
Brantly; Model B-2B; Tail Boom; ATA 5302

The investigator also discovered the tail rotor gearbox was still attached to bulkhead ring. The bulkhead ring had separated at the rivet attach point, just below the transition radius. Exiting cracks were found on the left and right side of the bulkhead. (Refer to the illustration.)

The submitter stated that inspection could be accomplished through a lightening hole at the top of the tail boom pylon.
