ADVISORY CIRCULAR 43-16A

AVIATION MAINTENANCE ALERTS

**ALERT
NUMBER
304**

**NOVEMBER
2003**

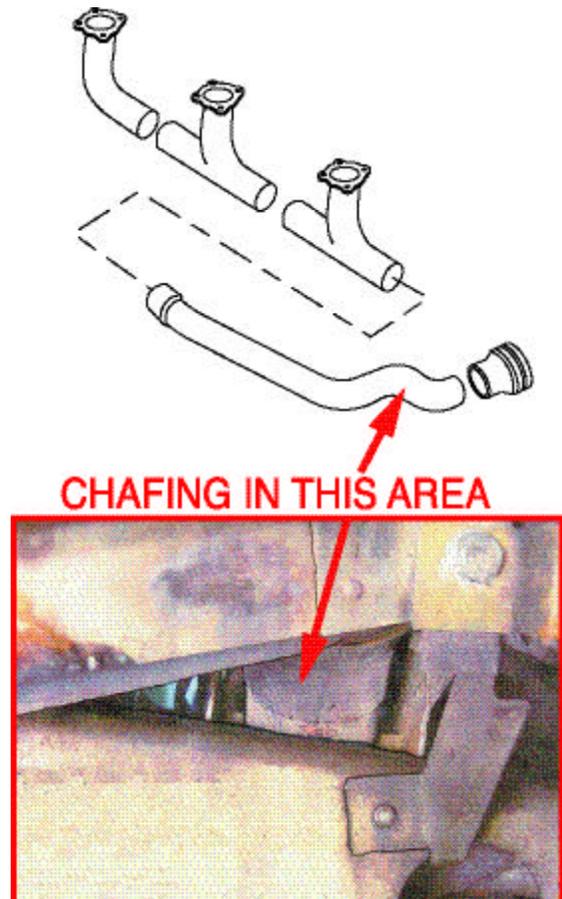
Beech; Model B58P; Baron; Chafing Engine Exhaust Crossover Tube; ATA 8110

The chafing was approximately half way through the thickness of the crossover tube. (Refer to the illustration.)

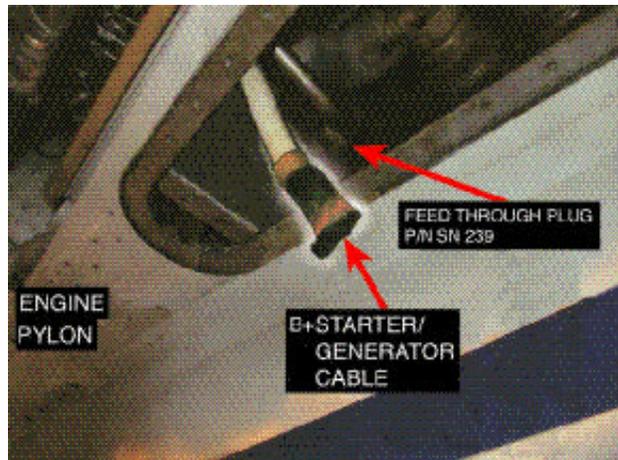
DASSAULT-BREGUET**Dassault-Breguet; Model Falcon 10; Engine Starting System Failure; ATA 8000**

The submitter stated that the local area's Falcon Technical Representative said this is a common problem with both the Falcon 10 and Falcon 50 aircraft. The submitter also stated that this problem was addressed with Service News Letter, number 52, dated 12/1986, entitled *Connection of Starter-Generator Positive Wire*.

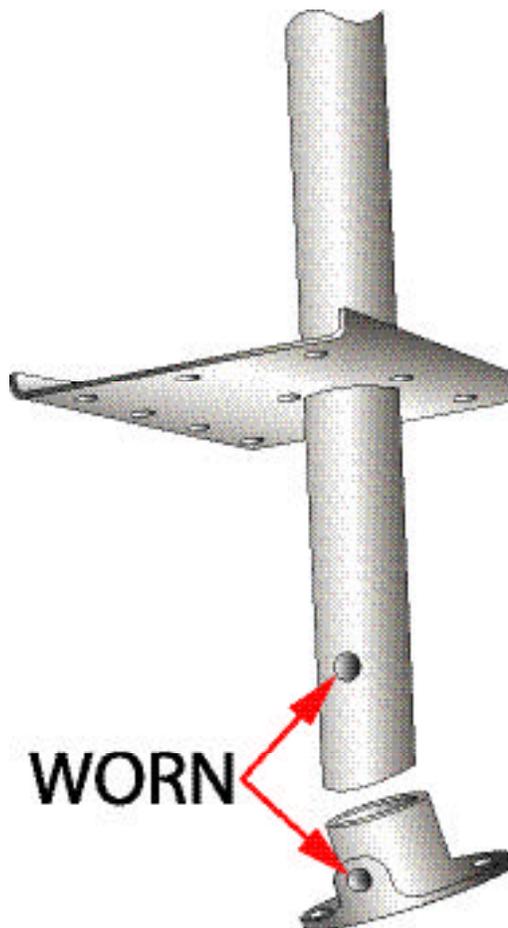
Piper; Model PA-34-200T; Seneca II; Loose Rudder Mast; ATA 2720

While inspecting the rudder on an annual inspection, the technician discovered the rudder torque tube (P/N 96212-00) attach bolts were loose. A teardown inspection revealed the bolt holes were oversized and elongated. (Refer to the illustration.)

A search of the FAA Service Difficulty Reporting Program data base revealed seven additional reports citing failure of the rudder torque tube on Piper PA-34-200T aircraft.
