ADVISORY CIRCULAR

43-16A

AVIATION MAINTENANCE ALERTS

**ALERT
NUMBER
310**

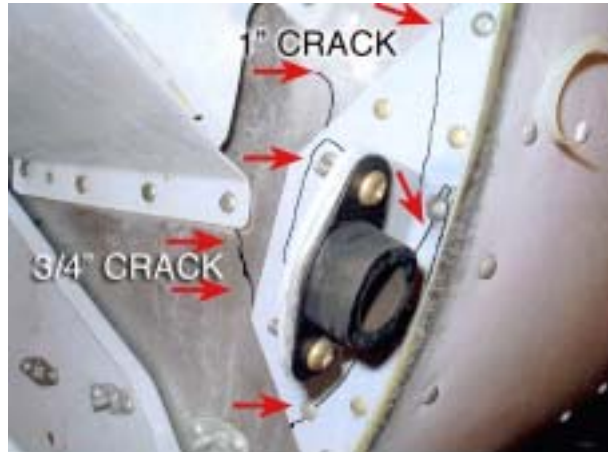
Cessna; Model 172R; Skyhawk; Cracks in Lower Firewall; ATA 5312

During an inspection, the technician found numerous cracks in the lower firewall (P/N 0553031-5) left side zone 124. The cracks radiated from the lower battery mount and cowling mount brackets. (Refer illustration.)

The submitter stated that he was aware of three additional like aircraft where the firewalls developed cracks in the same area.

A search of the FAA Service Difficulty Reporting Program data base contains 20 reports on Cessna 172R with firewall cracks. Most of the reports were generated while complying with Service Bulletin 98-53-02.

Part total time: 500 hours.

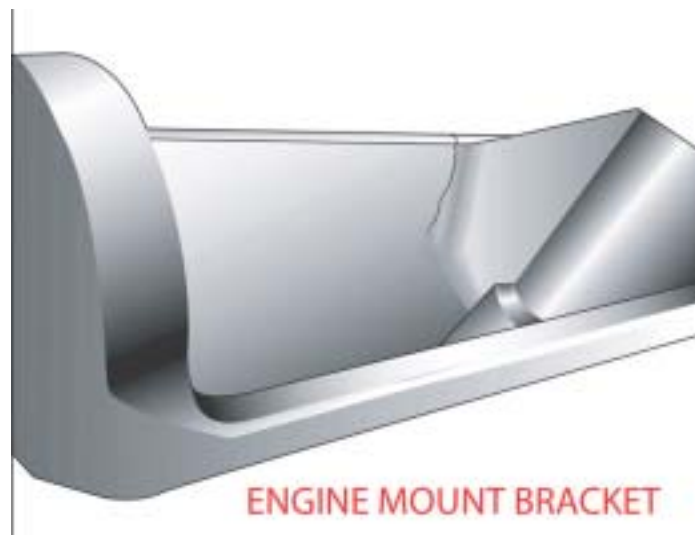
Cessna; Model T-303; Crusader; Cracked Engine Mount; ATA 7120

During an annual inspection, the technician discovered the inboard lower engine mount leg (P/N 643042) was cracked on the left engine.

The aircraft total time was 4,392 hours, and the engine total time was 685 hours since factory rebuilt. The crack was about 1-1/8 inches long and located at the lower edge 3 inches from the engine attach point.

The submitter also stated that it had a small porosity void 3/8 inch from the edge of the mount leg and in line with the crack. (Refer to the illustration.)

Part total time unknown.

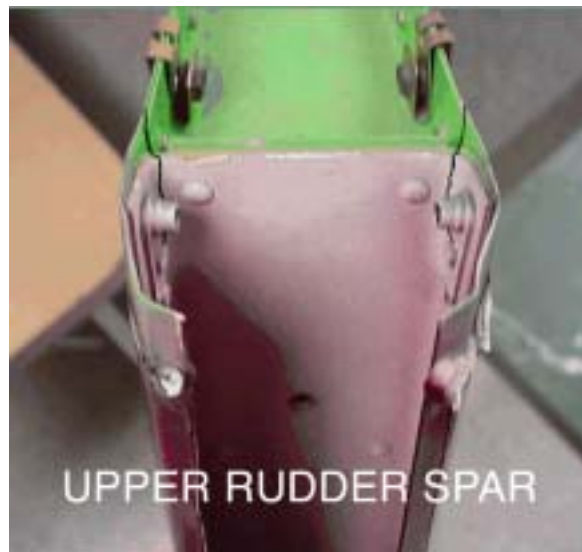
Piper; Model PA-28R-201; Arrow IV; Cracked Rudder Spar; ATA 5541

While inspecting the upper rudder spar (P/N 63543-00) and doublers (P/N 65341-00), the technician found cracks on both sides of the bend radius.

Both cracks were about $\frac{3}{4}$ to 1 inch in length from the top of the rudder to the nut plate. (Refer to the illustration.)

The operator inspected 13 additional PA-28R-201 aircraft in his fleet, and discovered two of the aircraft had spar cracks and four of the aircraft had cracked doublers.

Part total time: 2,639 hours.

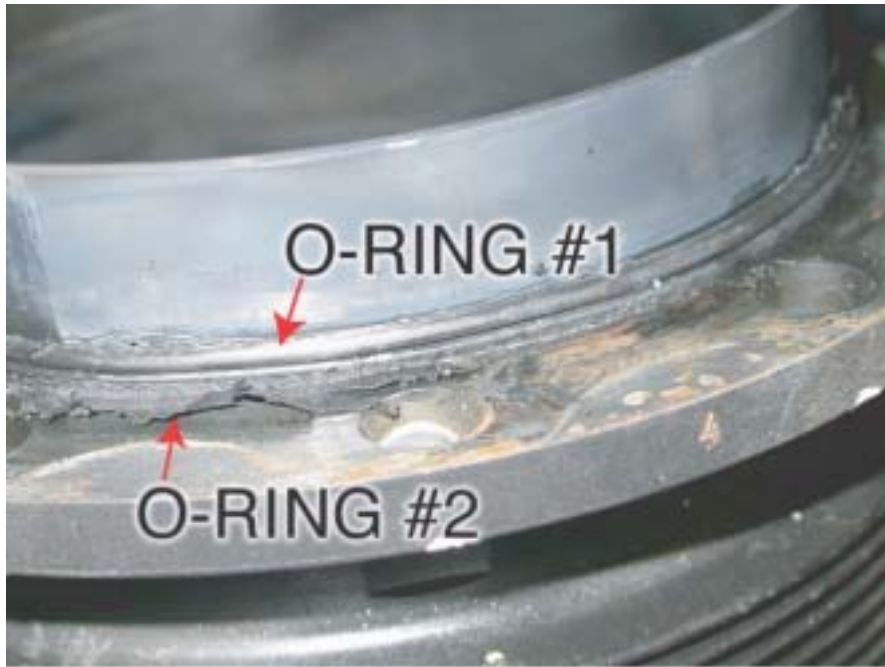
DUAL O-RING INSTALLED ON ENGINE CYLINDER BASE

The Small Airplane Directorate received the following report from a repair regarding a problem with a Teledyne-Continental TSIO-520 engine. *(The following report is published as it was received.)*

During an annual inspection, it was discovered that one of the cylinder hold down studs had a missing nut. The nut was found lying in the cylinder baffling area. A torque check of the remaining nuts showed that several had become loose. The cylinder was removed to investigate. Upon removal, the mechanic found that the suspect cylinder had two cylinder base seals installed. The o-rings were deformed and compressed. Due to the two o-rings installed the original torque values had changed allowing one nut to come completely off and several remaining nuts to loosen. If not found it is possible that the cylinder could have eventually come loose from the crankcase causing severe engine damage or failure. The engine had 121 hours since new. (Refer to the illustration).

Part total time: 121 hours.

Maintenance personnel should take precaution when finding cylinder hold down hardware missing or loose. This incident is probably an isolated production error but demonstrates that further investigation into a problem can lead to discovery of additional problems that may not be apparent from a visual inspection.
