U.S. Department
of Transportation
**Federal Aviation
Administration**

ADVISORY CIRCULAR

43-16A

**ALERT
NUMBER
317**

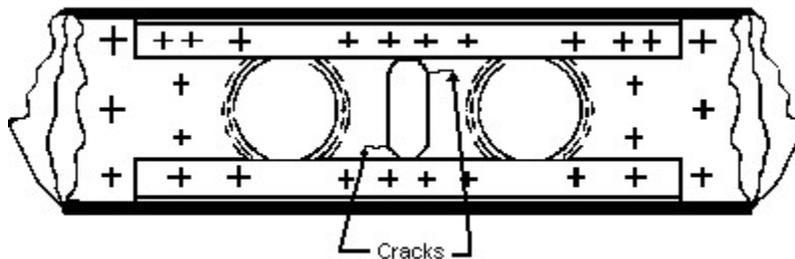
Cracks in the horizontal stabilizer front spar (P/N 1232622-23) have been reported on Cessna Series 210 airplanes. This spar is also used in Cessna Series 206 and 207 airplanes. The loss of strength in the spar could cause the airplane to become uncontrollable in flight.

The Australian AD requires visual inspection of the front and rear faces of the horizontal stabilizer front spar assembly center section for cracks around the cut-out in the front spar web, see the figure below. The front spar web must be repaired if any cracks are found before the airplane can be flown.

The front spar is fabricated from two channels, joined at the stabilizer centerline. The channels are spliced by a formed channel on the aft face of the spar, and by two splice angles along the upper and lower surfaces. Since the splice channel is sandwiched between the spar channels and the splice angles, it can only be examined from the edges of the slotted hole or from the aft edge of the spar cap. Cracks typically grow from the upper and lower edges of the slotted hole for the elevator trim tab cables as shown in the figure below. The cracks shown in the figure would be expected to develop from unsymmetrical horizontal tail loads. The right hand only trim tab produces some unsymmetric horizontal tail loads, but a more likely source is unsymmetric ground handling loads from forcing the tail down to clear the nose landing gear for moving the airplane. Another suggested source of cracks is rough field operations, where the rocking of the fuselage drives the horizontal tail. This condition would likely produce symmetric cracks (both sides at the upper and lower ends of the cutout.)

Only a few FAA Service Difficulty Reports have been documented. These cracks have been observed primarily on airplanes near or exceeding 10,000 hours time in service. These inspections are currently required by a general note in Cessna’s maintenance manuals to check metal parts for cracks.

Access to the spar assembly is accomplished by removing the fillet fairing. The front surface is then visible. The backside of the spar can be seen by inserting a mirror and light through a hole in the upper surface of the horizontal stabilizer. This inspection may require some experimenting to determine good viewing. Thus, the use of a borescope is recommended to make the inspection easier.

For compliance to the Australian AD, CASA states: “a. For aircraft with less than 10,000 hours time in service, inspect before exceeding 10,000 hours total time in service, and thereafter at intervals not exceeding 100 hours time in service. b. For aircraft with 10,000 or more hours time in service, inspect before 18 March 2002, and thereafter at intervals not exceeding 100 hours in service.”
