U.S. Department
of Transportation
**Federal Aviation
Administration**

ADVISORY CIRCULAR

43-16A

AVIATION MAINTENANCE ALERTS

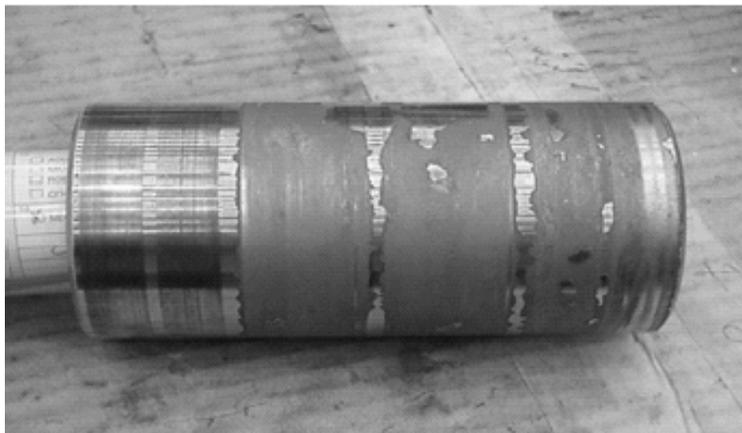
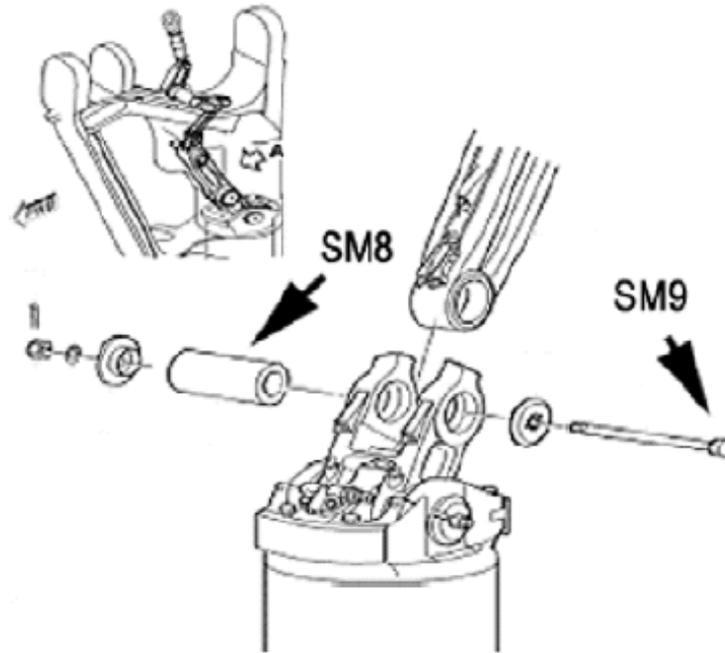
**Pin SM8 UNI 32-10-1337
Chrome Damage (rotated 180°)**

Main Landing Gear SM9 Pin Retention Bolt

Transport Canada has been informed, that an Airbus A330 was undergoing heavy maintenance (C2 check) and maintenance personnel discovered the main landing gear oleo upper retention bolt sheared. Transport Canada was informed by an operator, that an Airbus A330 was undergoing a C2 check in preparation for doing a seal change on the right main landing gear.

During the disassembly of the right main landing gear for a routine seal change, it was discovered that the SM9 pin retention bolt, CMM 32-12-02-51-50, was had sheared at the bolt head. The bolt, P/N NAS6605D136, retains the pin end caps. One end cap was found on the outer surface of the shock strut assembly. After a detailed examination, further collateral damage on the piston was discovered as well as 50% chrome loss on pin SM8.

The aircraft had accumulated approximately 13,548 flying hours and, 2,372 landings. Based on physical evidence, with the shank of the SM9 pin-retaining pin retaining bolt broke, this allowing the permitted the retaining end cap on the outboard end of the pin to fall off. Unrestrained, the SM8 pin migrated approximately 1" in outboard from its installed position, which is flush with the lower connecting link.

Transport Canada strongly recommends operators of this model aircraft inspect the main landing gear retention bolt at their earliest convenience.
